HARNESSING POTENTIAL IN HERITAGE SITES
THE ADAPTIVE REUSE OF OLD BUILDINGS IN OLD ACCRA

**A Thesis submitted to the Department of Architecture,
Kwame Nkrumah University of Science and
Technology
in partial fulfillment of requirements for the degree
of**

**MASTER OF ARCHITECTURE
Faculty of Architecture and Building Technology,
College of Architecture and Planning**

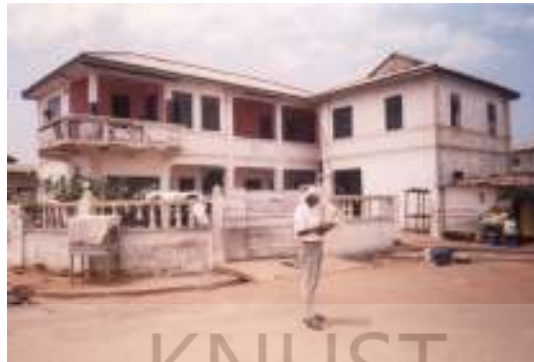
Fig.7 Type B building
(Source: Student Workshop on the Redevelopment of Old Accra)

- Type B: Structures, which are sound but are poorly maintained. Old Accra has an estimated 110 of these structures.

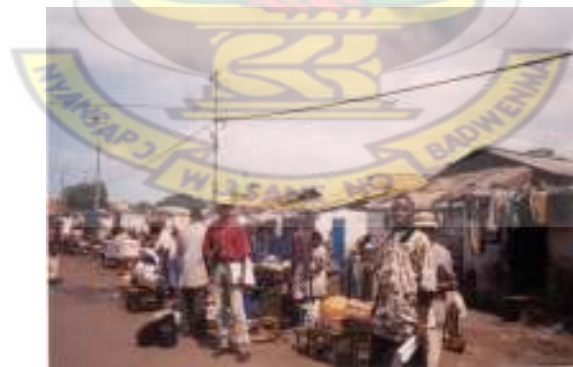
Fig.8 Type C building
(Source: Student Workshop on the Redevelopment of Old Accra)

- Type C: Structures, which are structurally weak and which would enjoy much upgrading work and maintenance. Such structures constitute the core of the housing stock within Old Accra, with about 1088 such buildings.

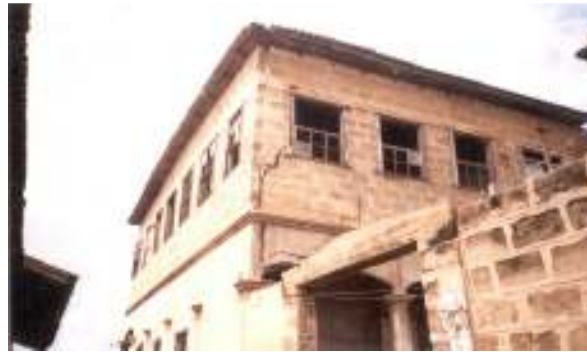
Fig.9 Type X building
(Source: Student Workshop on the Redevelopment of Old Accra)

- Type X: Structures that are dangerous structurally and generally deserted. There are roughly 96 of these structures in Old Accra.

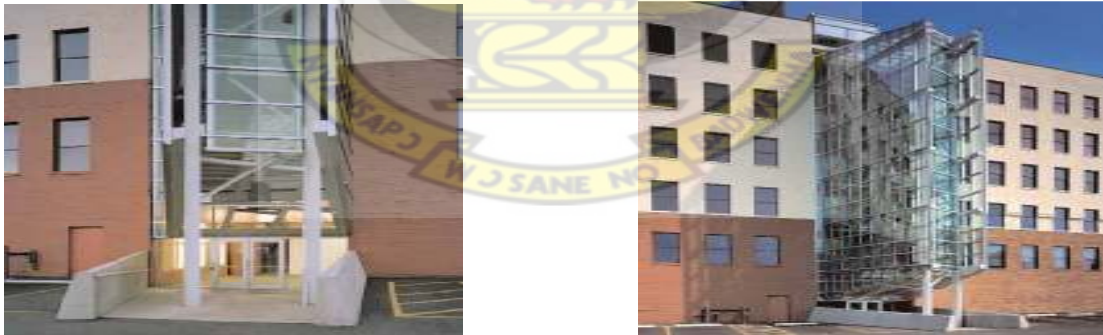
Fig.10 Hartman Building
(Source: *Merging Old and New*)

The historic street facades of the Hartman Building, built at the turn of the century as a medical hotel and now home to urban loft condos in downtown Columbus, Ohio, has a projecting six-story, steel and glass staircase that serves as the tenant entrance.

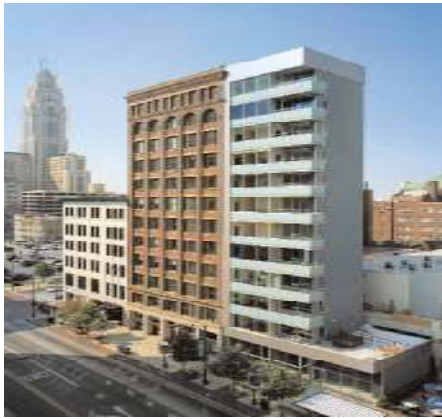
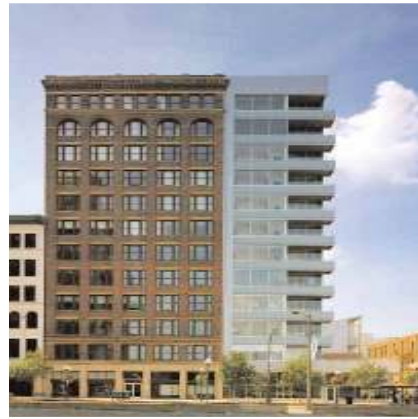
Fig.11 Brunson Building
(Source: *Merging Old and New*)

The Brunson Building—including a 12-story addition that contrasts strikingly with the architectural style of the original building. However, the old and the new parts are compositional equals, with the parabuilding reinterpreting the existing historic architectural features in a modern aesthetic and with today's materials. Stone lintels and brick banding align with adjacent two-toned glass spandrel panels, emphasizing continuous horizontal lines in both buildings. The Brunson Building was constructed in the early 1900s in the architectural tradition of the Chicago School. Decorative brick banding, arches, and a tripartite organization—base, shaft, capitol—distinguish the building as a prime example of tall buildings of its time. But by the turn of this century, the Brunson was nearly vacant, and dated as an office building. The new owners took advantage of the current upswing in the downtown Columbus residential real estate market and began plans to convert the building to high-end residential lofts. The extensive use of glass contrasts with the solid masonry of the original structure, and floods the interiors with sunlight. The exterior balconies, cantilevering beyond the building's corner like a diving board for a full 180-degree view of downtown, represent outdoor space, and, from the street, are the unmistakable clues to the building's residential use.

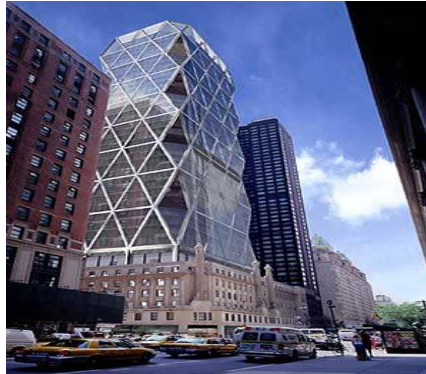
Fig.12 Hearst's Corporation building
(Image courtesy Norman Foster and Partners)

The host building for Norman Foster's design for the Hearst Corporation is Hearst's present home at 959 Eighth Avenue. The parabuilding, a faceted tower of steel and glass that rises 42 stories above the host, is enclosed on three sides by "buildings" formed from the upper floors of the existing building.

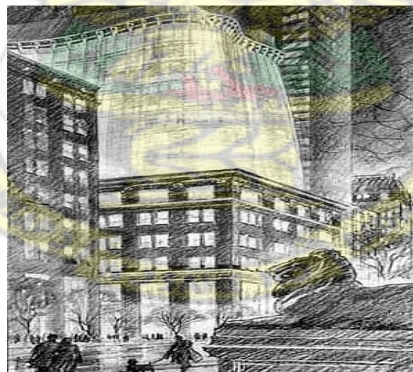
Fig.13 Mid-Manhattan Library
(Drawing courtesy Gwathmey Siegel)

The host building for Gwathmey Siegel's parabuilding design for the Mid-Manhattan Library is the former Arnold Constable building which The New York Public Library owns. The expansion will add an additional eight floors and 117,000 square feet for library service to the existing 139,000 square foot building.

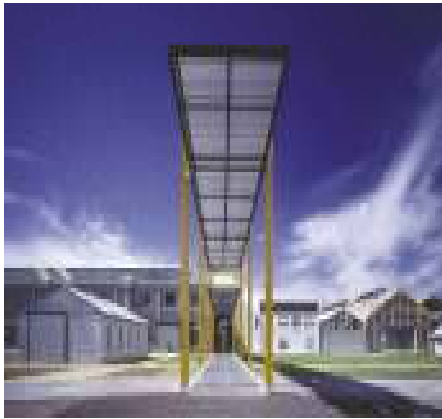
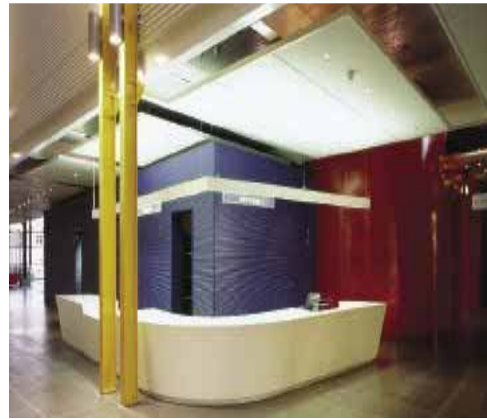
Fig.14 Queen Victoria Museum and Art Gallery
(Source: *Heritage NSW Newsletter, Does Heritage Make Good Economic Sense?*)

The redevelopment of the derelict Launceston Railway Workshops into a new cultural hub for the city of Launceston included the transformation in 2001 of a large proportion of the site into a new venue for The Queen Victoria Museum and Art Gallery. The Launceston City Council received support for this ambitious redevelopment of a disused site for the QVMAG not only from state and federal governments but also from a range of sponsors and benefactors. Listed on the Tasmanian Heritage Register and the Register of the National Estate, the workshops were the center of Tasmania's railway from 1868. Closed in 1994, they formed one of Tasmania's most intact 19th century industrial environments. True to best practice adaptive reuse principles, the project created a strong distinction between original and new works. While intact relics of the site's industrial past, including the unique Blacksmith Shop and Weighbridge were maintained as key interpretive features, references to the past are also present in the transformation of the Stone building and former foundry into the art gallery, exhibition spaces and visitors services area. New features adopted the primary colours used in industrial signage on the

site, such as the yellow walkway that now defines the building's main entrance. An energy efficient air conditioning system featuring geothermal heat exchange and supported by double-glazing allows the museum to maintain a stable environment required for the international standard gallery space.

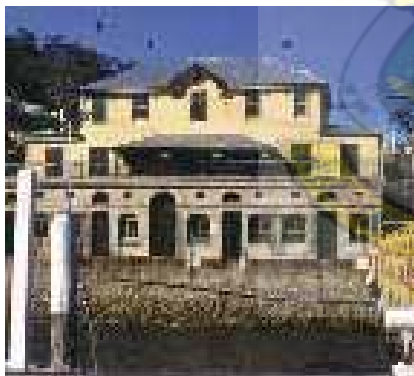
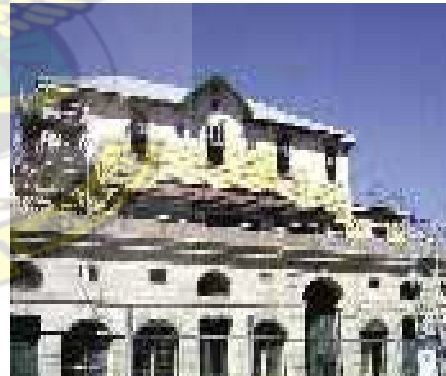
Fig.15 Submarine Mining Depot

the harbour in 1892. The Trust took over management of the site in 1999 and began to revitalise the property, which is listed on the Register of the National Estate. Alterations had concealed the building's original functions and layout, and water had damaged its timber, stone, paint and balustrades. Ad hoc renovations had replaced original fabric and the kitchen. The adaptive reuse project repaired and conserved the main building, removed renovations that confused interpretation of its heritage significance and introduced modern facilities and services to cater for a range of possible uses. As the final use had not yet been determined, it was given flexible services and fittings. Separate metering of each floor allows for a number of tenants or uses to occupy the building. Renovation methods and materials had minimum environmental impact to avoid polluting the harbour.

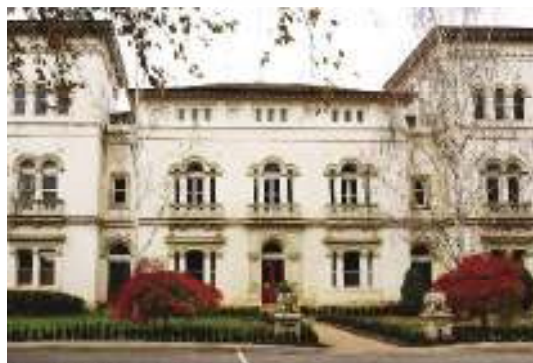
Fig.16 May Day Hills Hospital/ La Trobe University Campus
(Source: *Heritage NSW Newsletter, Does Heritage Make Good Economic Sense?*)

The conversion of a disused hospital for the mentally ill into a university campus has saved an important heritage site and provided space for specialist international hospitality training. Once known as the Beechworth Lunatic Asylum, May Day Hills Hospital was built between 1864 and 1867 and used in caring for the mentally ill until its closure in 1992. The institution comprised 54 buildings on 106 hectares of land, 11 hectares of which are gardens of significance, all in a park-like setting at the top end of Albert Road, Beechworth. While the complex held historical significance to the state, the need for its original purpose diminished over time. Much work was needed before La Trobe University could reuse the buildings. The team working on the project removed ailing trees, re-established services and carried out extensive sympathetic alterations for adaptive reuse as the University's professional development and conference venue. Today, around half of the buildings in the complex are still in use, albeit for quite different purposes. A major feature of the campus is the International Hotel School, where students study the finer points of the hospitality industry. La Trobe at Beechworth also provides accommodation to visitors both domestic and international. The hospital has gained a new lease of life as it adapted to the changing needs of society.

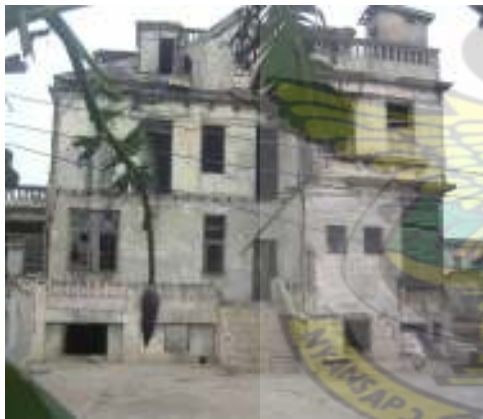
Fig.18 Adoso house, Jamestown
(Source: Author)

Most of the buildings in Jamestown and Ussher are currently used for residential purposes and for mixed purposes. Many of such buildings are in a better condition than those that have been abandoned for years apart from building that are being used currently. A number of the abandoned old buildings have broken windows and doors with cracked floors and rusty ironmongery and dilapidated roofs.

The Adoso House, a notable townhouse was built in 1910. It belonged to a wealthy merchant who lived there with his family. Later the building served as a guest house. Ever since the death of the original owner, management of the property has been difficult financially and this has led to its gradual deterioration. The building was sold to a church by the owners of the property however the building was listed to be restored under the urban redevelopment scheme for the area but before the new owners could be paid off they pulled down they demolished the building.

The building had severe structural defects and would have required major structural repair works with specialist know how. Funding needed to undertake this project was unavailable. No major changes had taken place on the structure however owing to lack of maintenance, parts of the building such as balconies and slabs have collapsed and the original facade cannot be easily appreciated. It was unsafe for children to play on the terraces of the building due to cracked screed and walls and exposed badly rusted ironmongery. The compound surrounding the structure has a smaller residential unit with the other areas bare. Adapting this building to a new use would have required consideration to the structural stability of the building as well as aesthetics. Also careful consideration would have been required for materials to be incorporated into the design to make it suitable for the environment. Owing to the size of the structure, it was impossible for the regular maintenance routine to be carried out on the building since there was no funding available this led to its gradual state of dilapidation.

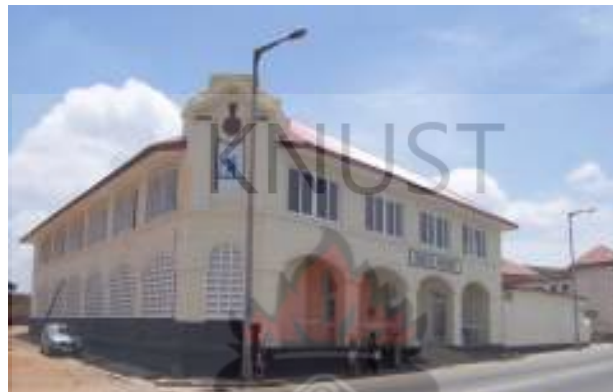
Fig.24 Bible House, Jamestown
(Source: Author)

The building presently known as the bible house has been used for several years ever since the original use ceased. The adaptive reuse of this building has kept it in good condition exhibiting its old architectural features while, satisfying the modern needs of its users.

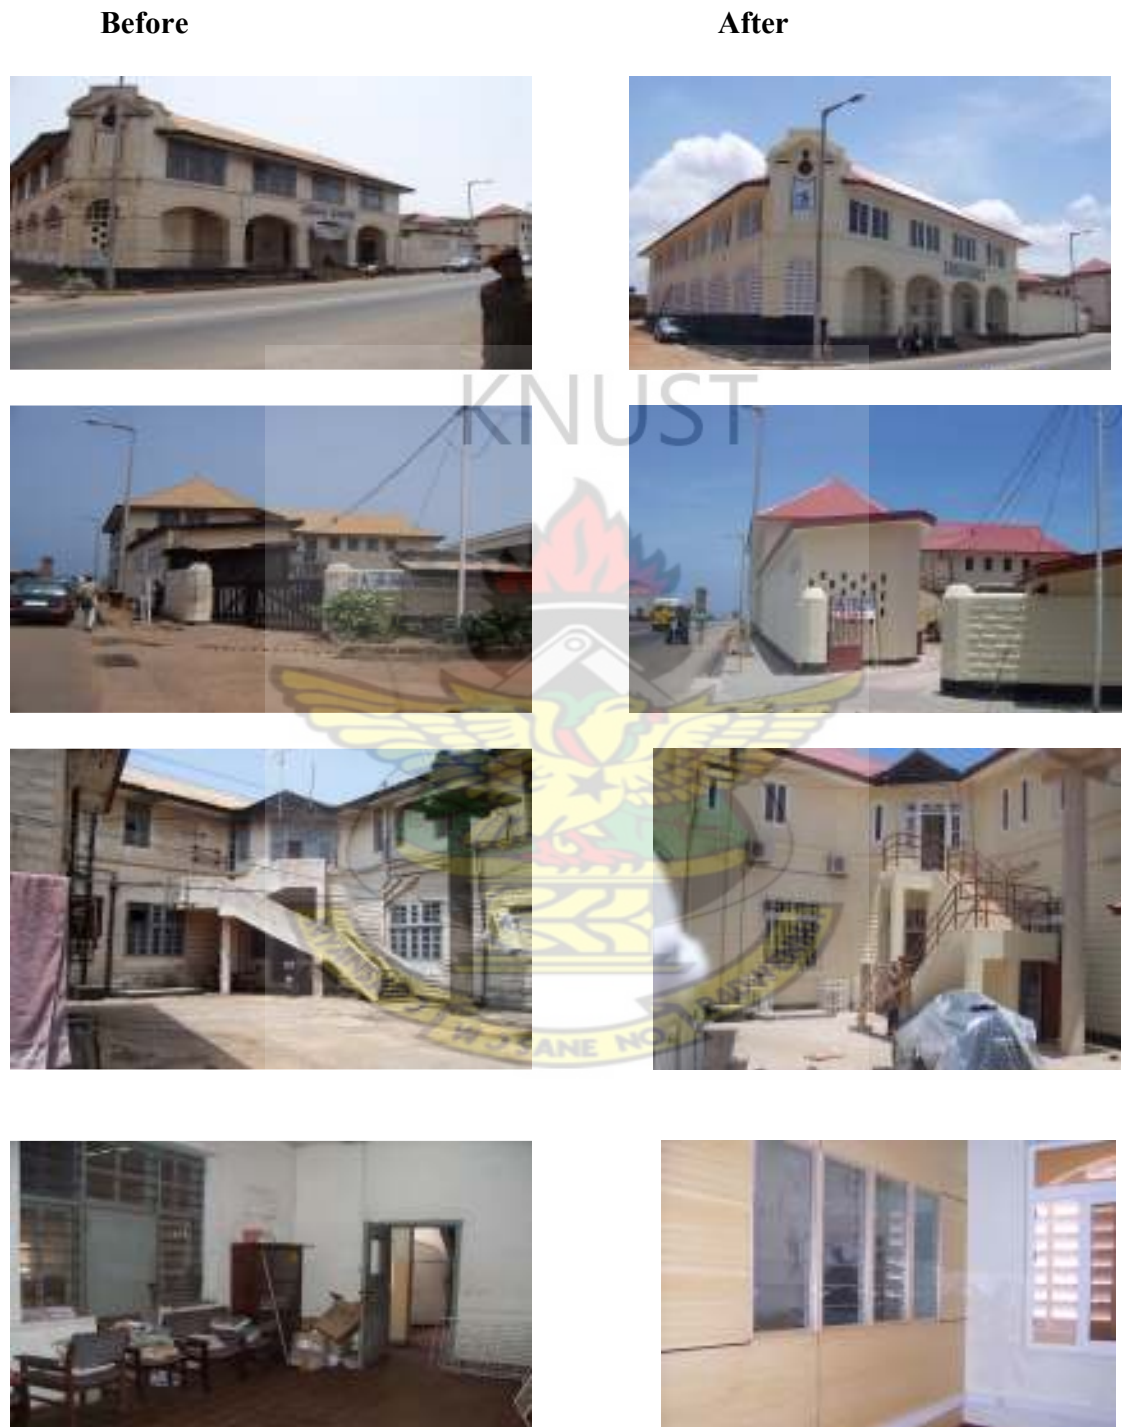
Fig.25 Bible House before and after renovation
(Source: Consortium)

office. The space available on the site has also allowed the provision of additional storage areas needed by its current users.
