**COASTAL EROSION IN GHANA: A CASE OF THE ELMINA-CAPE COAST-
MOREE AREA**

**A THESIS SUBMITTED TO THE DEPARTMENT OF FISHERIES AND
WATERSHED MANAGEMENT, KWAME NKRUMAH UNIVERSITY OF
SCIENCE AND TECHNOLOGY**

**MASTER OF PHILOSOPHY (MPHIL) IN AQUATIC RESOURCES
MANAGEMENT**

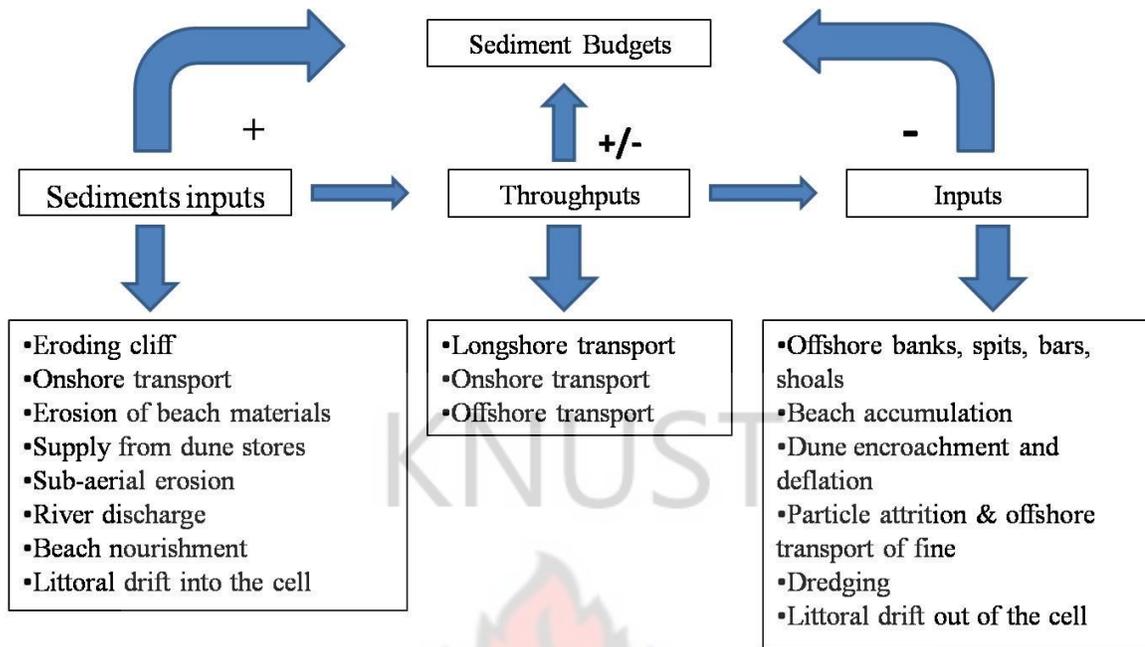
Figure 2.2: Components of Sediment Budget (Source: Boateng, 2006a)

Sediments are constantly exchanged with adjacent environments as energy conditions fluctuate with dunes eroding during storm surges to replenish the nearshore profile while material is pumped through spit-estuary complexes to retain a hydraulic balance, or overwashed to rebuild barrier islands further inland (Carter, 1991). These are natural processes that occur within self-compensating coastal systems the world over though the rates of changes are different from site to site due to local coastal dynamics. All the components of the coastal sediment (Figure 2.2) are important to the local coastal dynamics. When any of the components is altered, the balance of the coastal system becomes affected.

When sediments input exceed sediments output, beaches accrete or widen. Carter (1991) stated that coastal dunes develop as accumulating systems with very positive sediment budgets (i.e. input far exceeds output). Outputs may arise from the returning of sediment to the coastal system, or through landward eolian transfers, or by human activities (sand mining) (Carter, 1991). When there is a negative budget, a dissected dune system characterised by erosional landforms such as blowouts, deflation hollows and plains, reactivation dunes, erosion scarps may be formed (Carter and Stone, 1989).

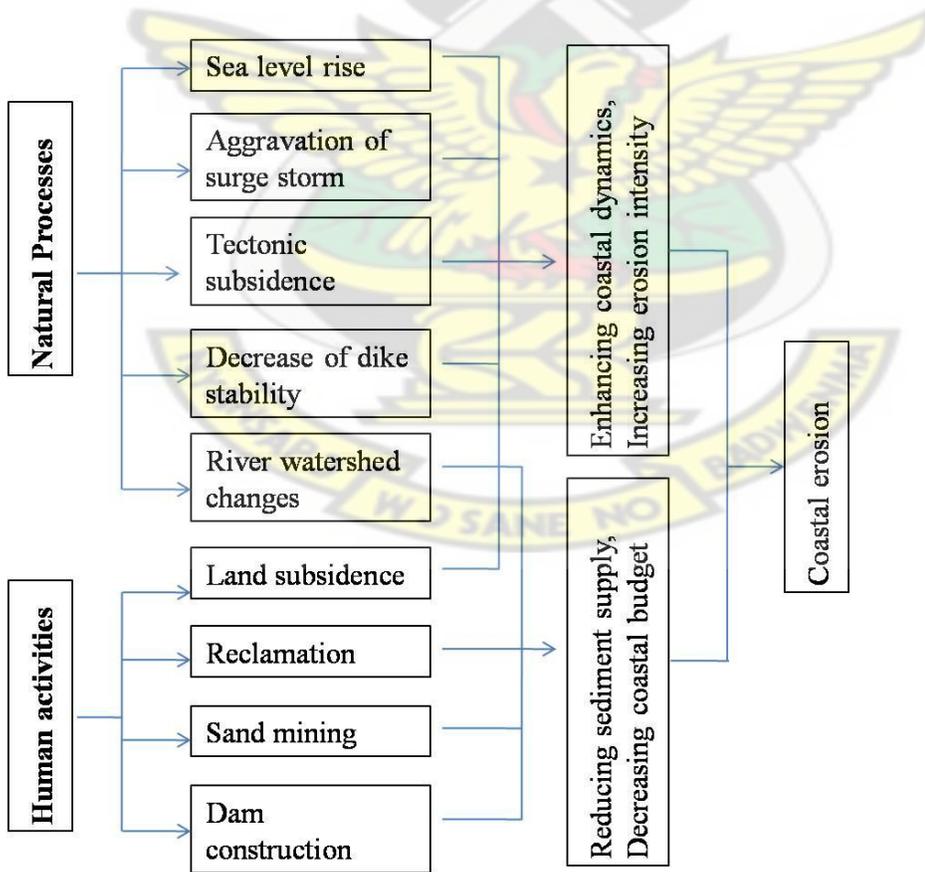
Figure 2.3: Framework of the causes of coastal erosion (source: Cai *et al.*, 2009)

Cai *et al.*, (2009) clearly presents all the major causes of coastal erosion, both natural and human, in figure 2.3.

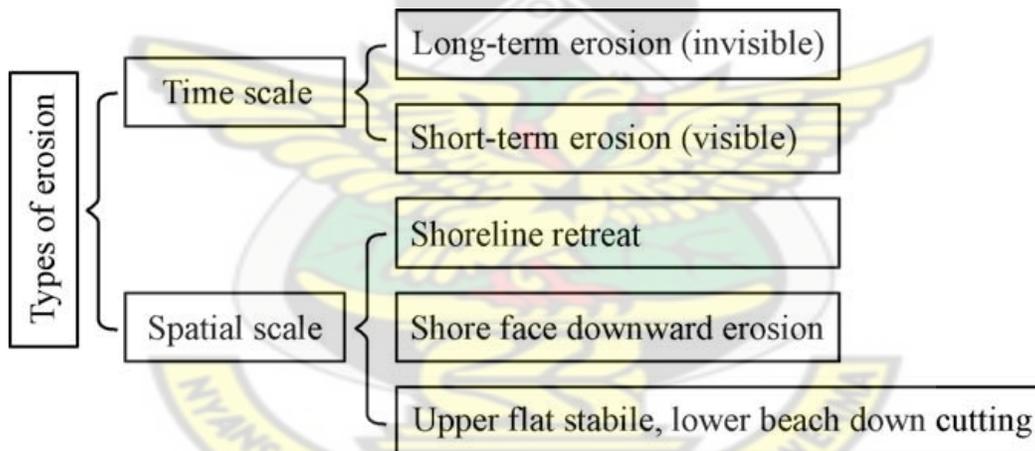
Figure 2.4: Framework of forms of coastal erosion (source: Cai *et al.*, 2009).

1. Coastline retreat - which occurs dominantly for soft coast without protection measures like seawall engineering,
2. Landward movement of the zero meter depth contour - which is caused by beach surface incision, usually occurring on a coast with a seawall, and
3. Downward erosion of the lower beach in the sub-tidal zone by tidal current with the upper flat maintaining its original shape.

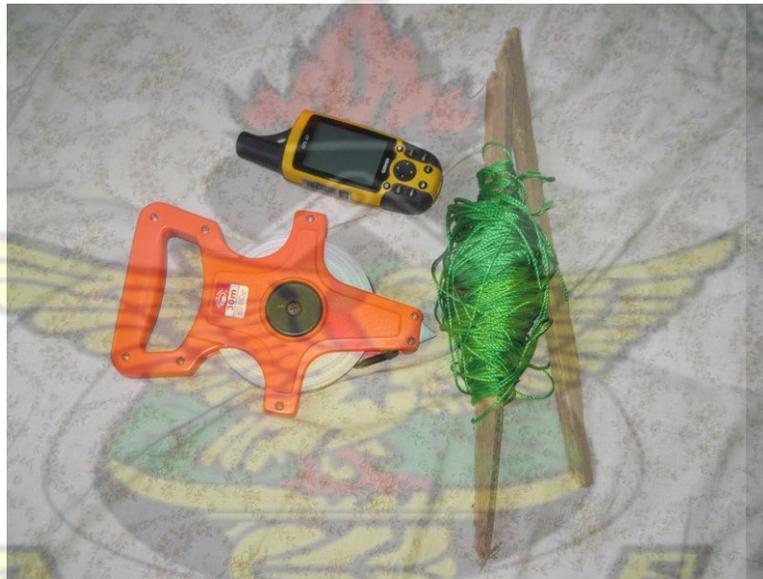
Plate 1: Some equipment used for the field surveys

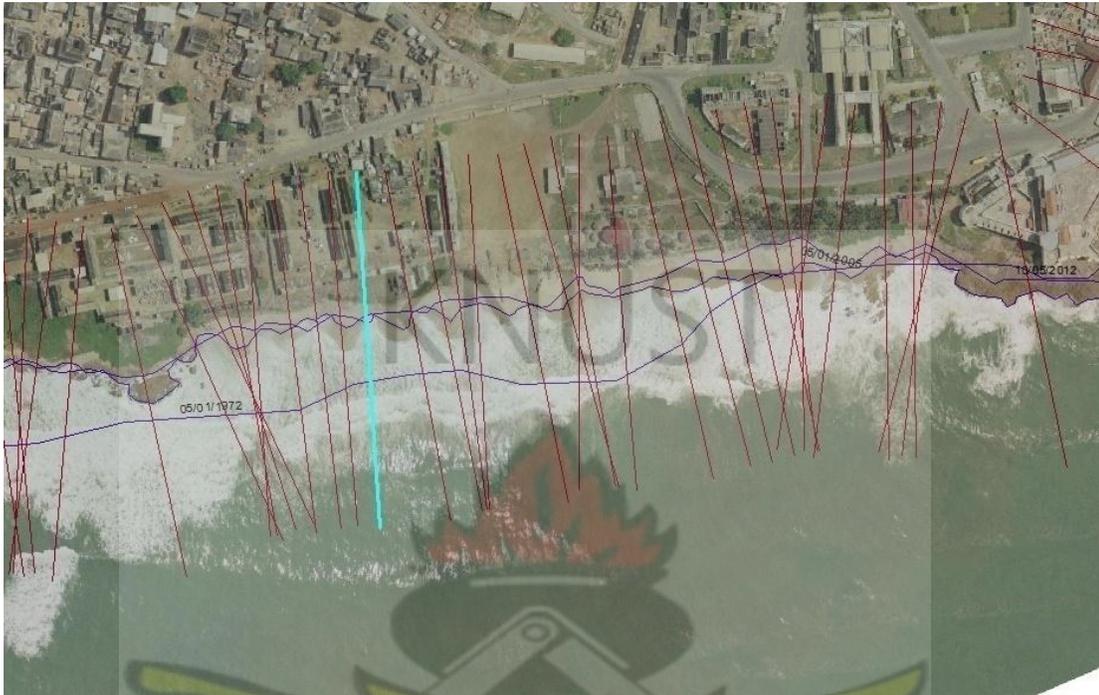
Figure 3.2 A section of the 2005 orthophotograph showing the Cape Coast Castle area with the time series shorelines and cast transects.

from the baseline to each intersection point along each transect were used to compute the selected statistics.

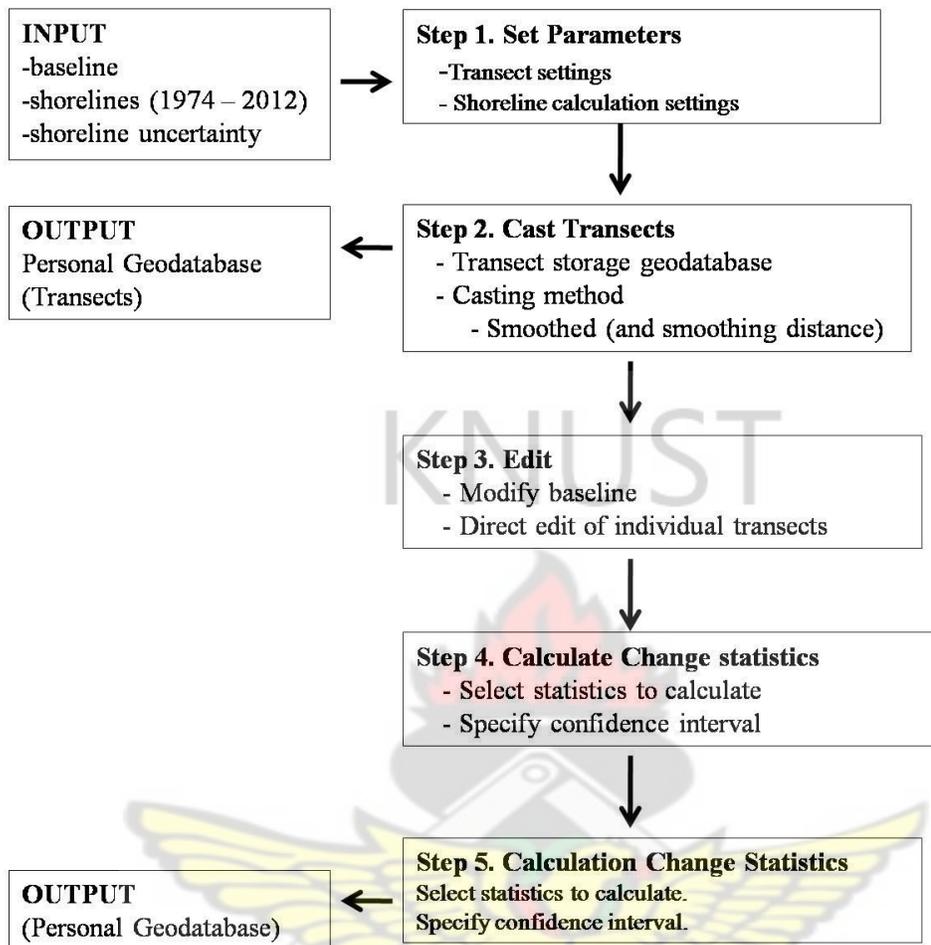
Figure 3.3: Digital Shoreline Analysis System workflow (Himmelstoss, 2009)

On the DSAS settings a default data uncertainty of $\pm 6\text{m}$ was used. This value signifies the minimum source of error within this study. This error margin was used as a result of two factors; a result of a high water line (HWL) positional error of $\pm 6.1\text{m}$, associated with photogrammetric mapping (Crowell *et al.*, 1991; Appeaning Addo *et al.*, 2008; Walkden & Mills, 2008), thus with regards to the 1974 T-sheets and an inaccuracy of $\pm 3\text{m}$ that was associated with the GPS device used to capture the 2012 shoreline. Digital Shoreline Analysis System (DSAS) then generated the shoreline change statistics using the two statistical tools used for the study, thus, net shoreline movement and end point rate (Figure 3.3).

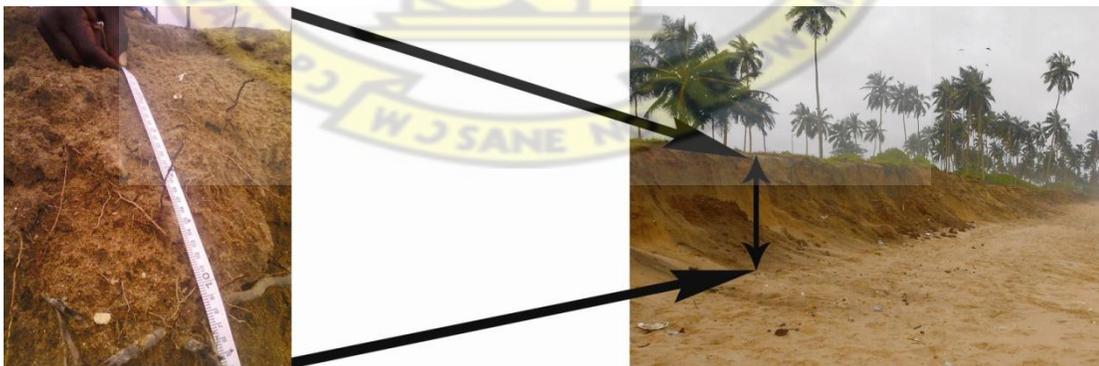
Plate 2 Scarp height measurements along the coastline of Elmina, Cape Coast and Moree.

The heights of erosion scarps on six sandy beaches along the coastline of the study area were taken using a surveyor's tape. The selected beaches were Moree, Amoakofua, Wilson Sey School, Bakaano, Ola and Mbofra Akyinim. Five points were selected randomly along each beach and scarp heights measured. These were then computed to determine the average scarp height at each beach.

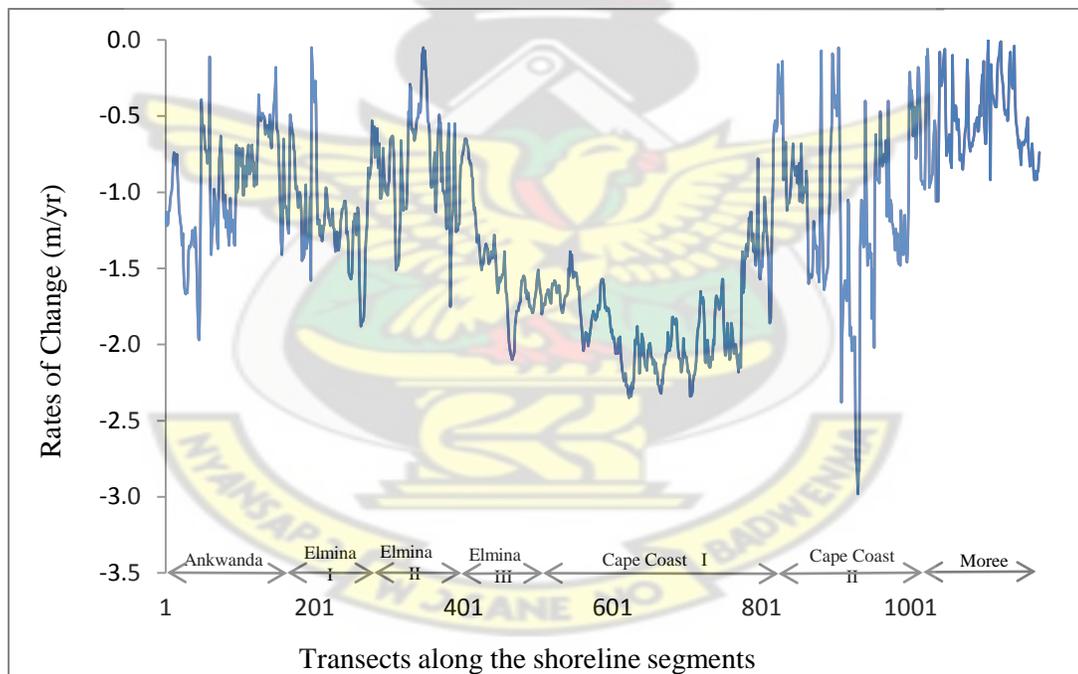
Figure 4.1 Historic end point rate trends in the Elmina-Cape Coast-Moree area from 1974-2012

Figure 4.1 below indicate that the Cape Coast I segment experienced the most consistent shoreline changes with the Ankwanda, Elmina I, Elmina II, Elmina III, Cape Coast II and Moree segments recording fluctuating or more dynamic changes during the period 1972 to 2012.

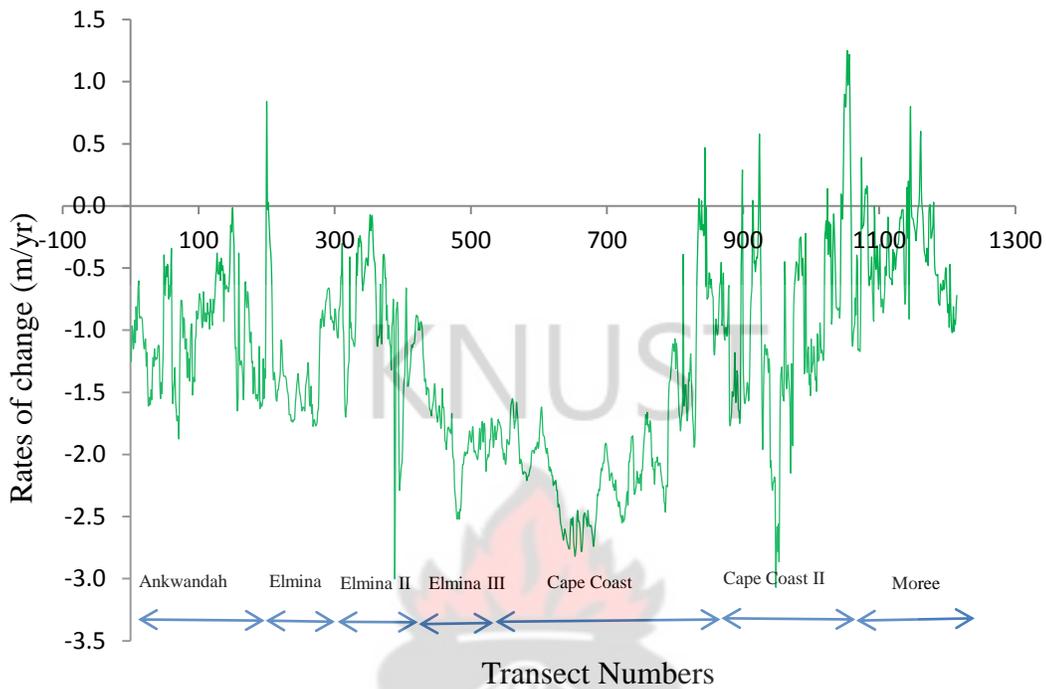
Figure 4.2 End Point Rate trends at the Elmina-Cape Coast-Moree area over the period 1974-2005.

At the Elmina III segment NSM ranged from -21.62 m to -82.02 m with erosion rates (EPR) also ranging from $-0.88 \text{ m/yr} \pm 0.17 \text{ m}$ to $-2.49 \text{ m/yr} \pm 0.17 \text{ m}$ at specific transects. Table 4.2 presents averages of NSM and EPR for the segment within the 1974 -2005 period.

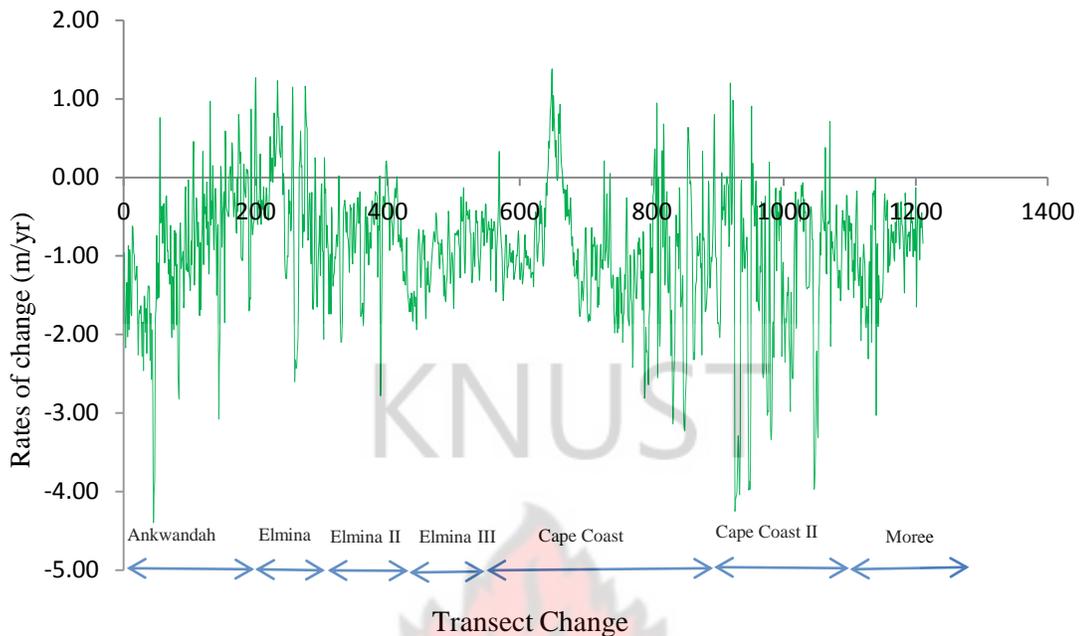
Figure 4.3 End Point Rate trends at the Elmina-Cape Coast-Moree area in the period 2005-2012.

Shoreline change result for the Elmina I segment showed both net accretion and erosion over the period (Figure 4.3). This segment recorded the lowest shoreline changes in the study area within the period (Table 4.3).

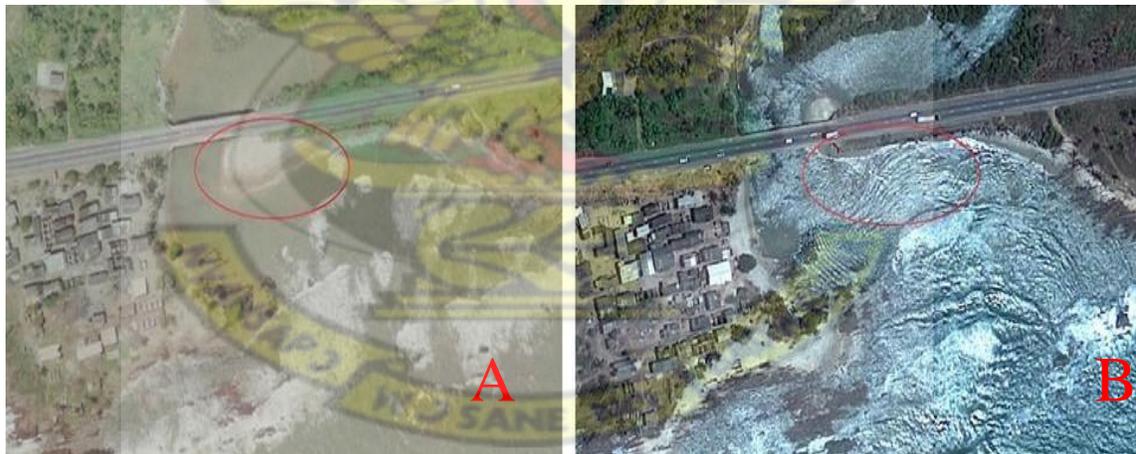
Plate 3 Loss of land at the Elmina Bridge; Plate 3A is a section of the 2005 orthophotograph; Plate 3B is a section of a 2011 satellite image. Source: Department of Geography and Regional Planning, University of Cape Coast

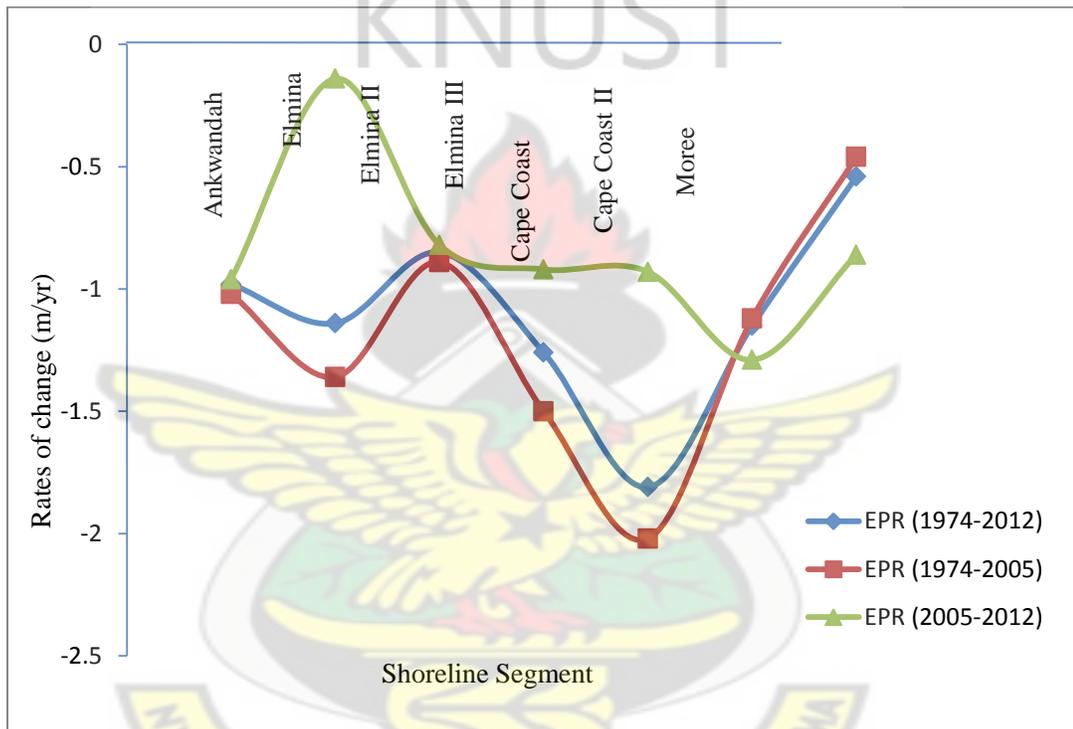
Figure 4.4 End Point Rate trend comparison amongst the three epochs used in the Elmina-Cape Coast-Moree area

A comparison of EPR averages amongst the various shoreline segments during the different epochs indicated that the 1974-2005 epoch recorded higher erosion rates in all the segments, except at the Cape Coast II and Moree segment where the 2005-2012 epoch recorded the highest trends. The 1974 to 2012 epoch recorded EPR trends which were always lower than the 1974-2005 values but higher than values recorded for 2005-2012 period (Figure 4.4).

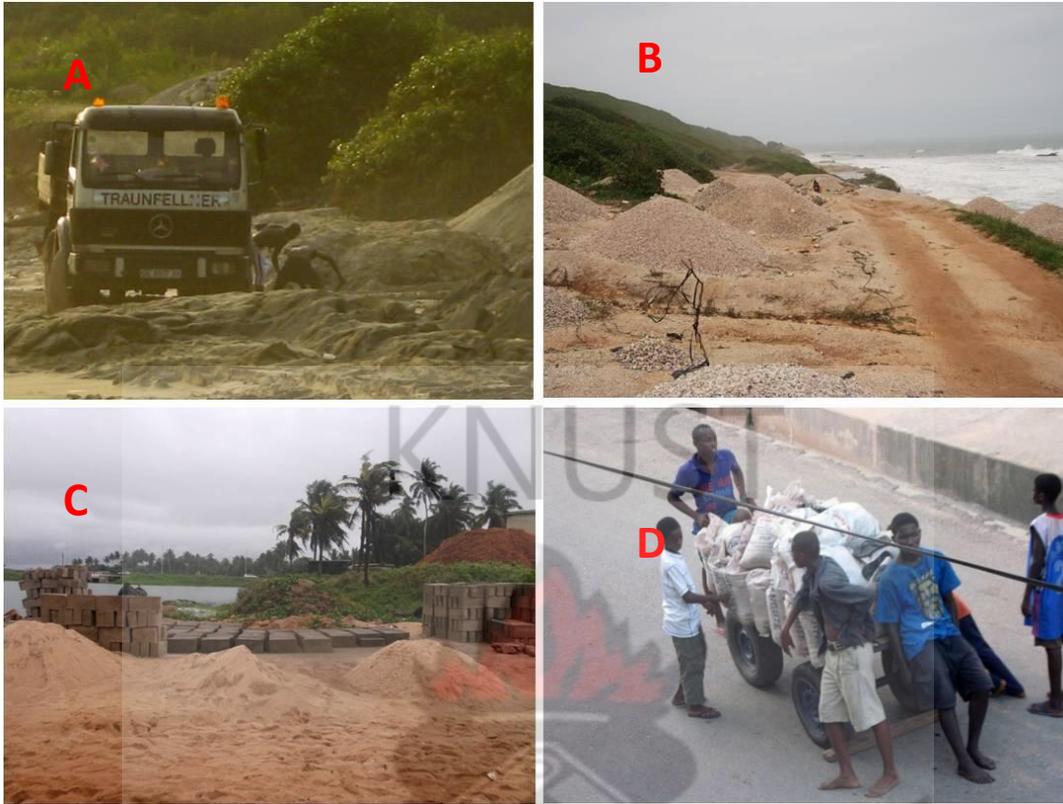
Plate 4 Some types of coastal sand and stone mining identified in the study area. (A) shows tipper-truck based beach sand mining activity at Amoakofua in Cape Coast, (B) peddles awaiting collection by trucks at Amoakofua in Cape Coast, (C) beach sand used to mould cement blocks at Bakaano in Cape Coast and (D) youths transporting beach sand in sacks using a push truck at Gegeano in Cape Coast. Source: Fieldwork

Category	Nature	Sub-category	Description
1. Beach sand mining	Commercial, in small to large scale	Tipper truck-based	This includes sand transported by tipper trucks
		Non-tipper truck-based	This includes those transported by low capacity trucks e.g. pick-ups, Kia trucks, etc.
		Manually transported	This is made up of all the forms of sand mining activities where sand is manually transported without the use of mechanized transport including the use of carts, wheelbarrows, basins, buckets, etc.
2. Beach gravel mining	Commercial, in small to large scale		Sand and pebbles are gathered from the beach or sifted from in-coming waves by using cane baskets, graded to sizes and transported by tipper trucks and other large capacity trucks
3. Coastal stone quarry	Commercial, in small to large scale		Rocks are broken off rocky and cliffed areas and crushed for the construction industry

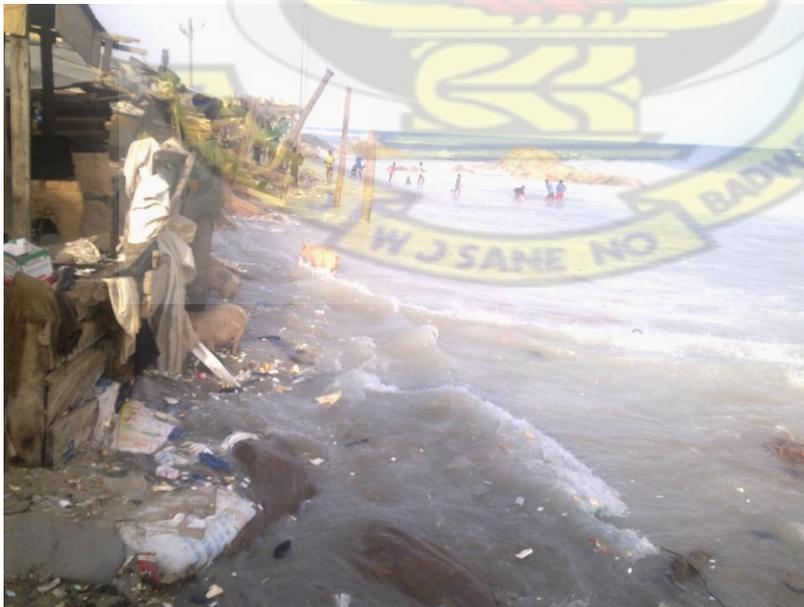
Plate 5: Waves affecting structures at Gegeano in Cape Coast

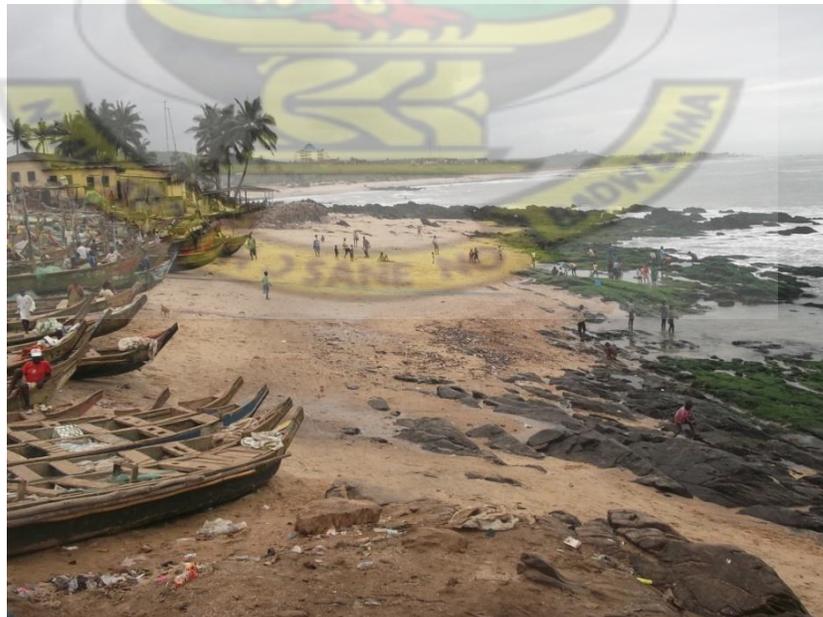
Plate 6: Beach face rock exposure at Moree

During the questionnaire administration, some fishermen stated that they found it difficult launching their canoes onto the sea and to land their canoes after going to sea, since there were rocky exposures on the beach face in some areas. These fears were also reiterated by the participants of the focus group discussion who were in agreement that exposed rocks at fishing landing beaches had made their fishing trade difficult and scary.

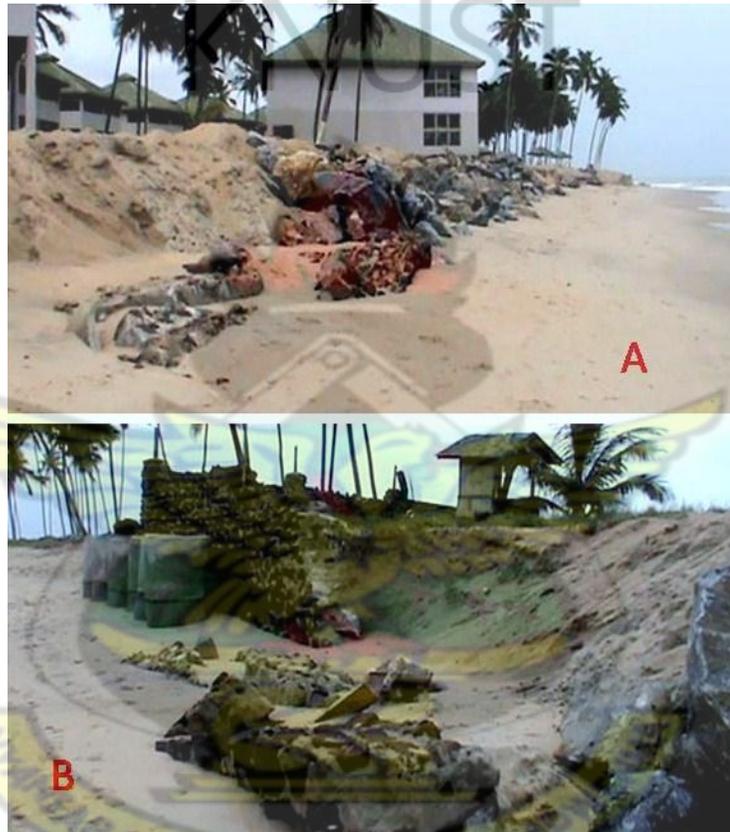
Plate 7 Remnants of various sea defence structures put up to protect the Elmina Bay Resort against sea waves. Source: Fieldwork: June 8, 2012.

The manager of Elmina Bay Resort stated that since 2008 they had constructed 4 sea defence structures, all of which had been ineffective against the waves since parts of the main facility was still battered by the waves during high tides and storms (Plate 7) and at the time of the interview were constructing the fifth sea defence wall. He estimated that they had spent over GH 200,000 cedis (US\$100,000) on these sea defence projects. He mentioned that his business had stalled as a result of these ventures he had had to undertake to protect his facility.

According to the Hotel manager; his observations indicated that sand lifting at Mbofra Akyinim and Ankwanda increased from the 20-30 trucks a day to about 40-50 trucks a day in 2010, a situation he described as traumatic to the beach front environment which eventually led to an escalation in beach erosion and the consequent collapse of sea defence infrastructures (Plate 7).

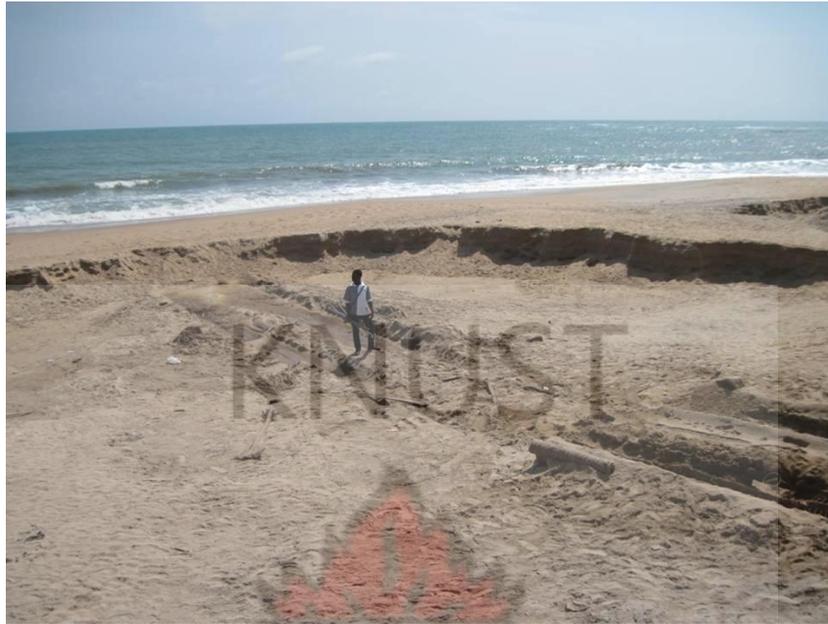
Plate 8 Hollow beach left by sand miners at Mbofra Akyinim after night lifting.

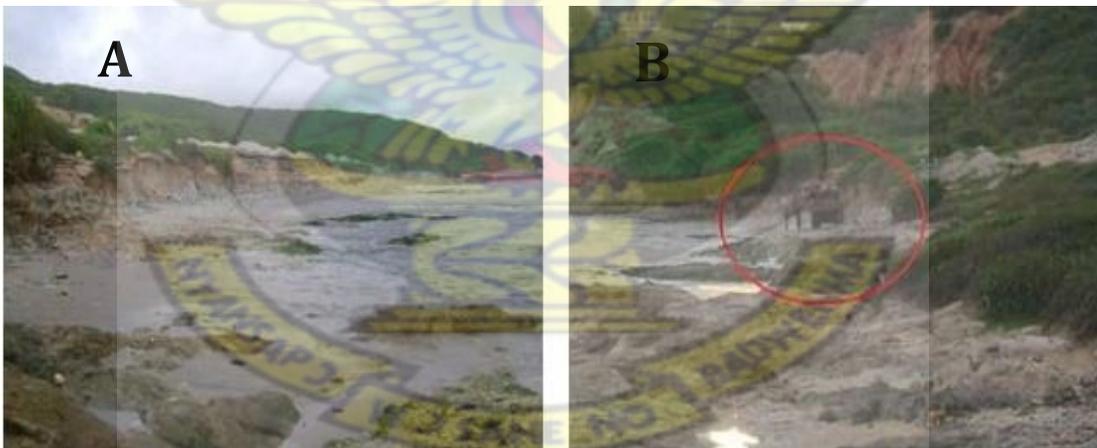
Plate 9 Beach degradation and sand mining at Amoakofua beach. Plate A shows rocky exposure at the beach. Plate B shows a tipper truck lifting sand at the area showed in Plate A (B taken 4 hours after A was taken). Source: Fieldwork November 3, 2010.

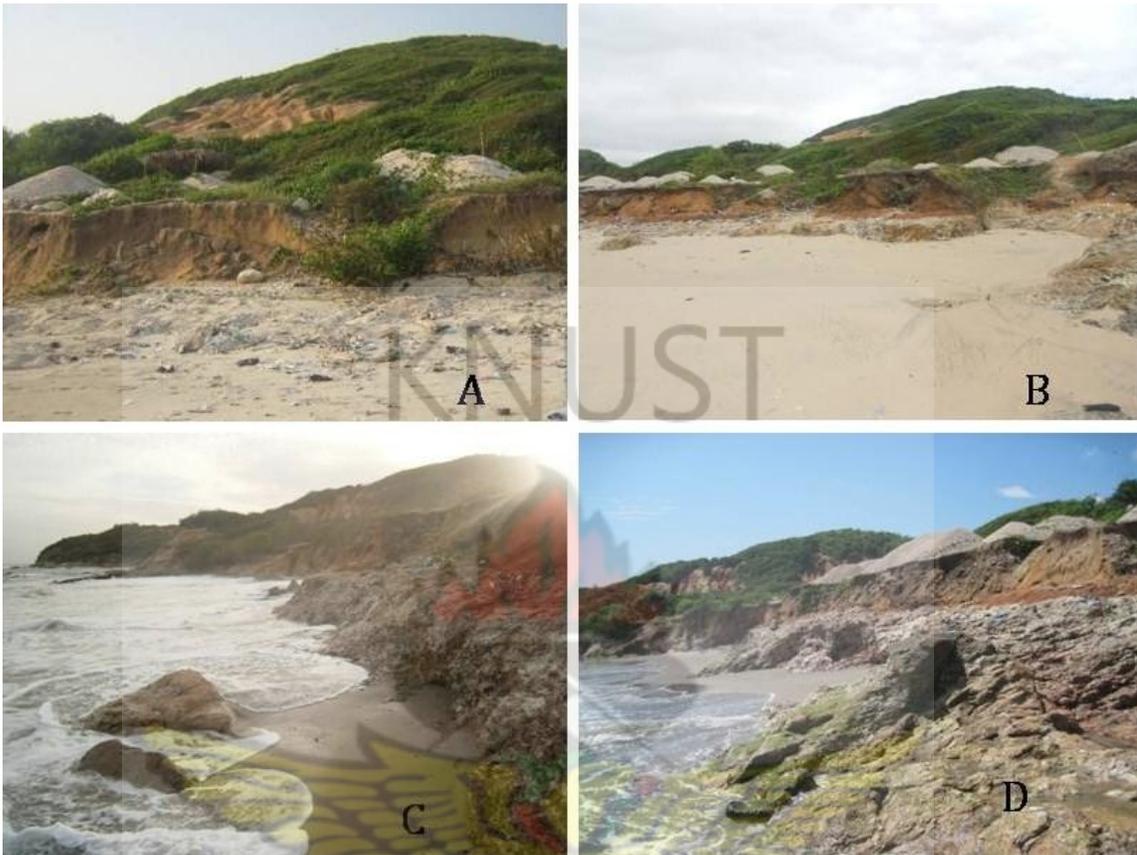
Plate 10: Evolution of physical changes at a section of Amoakofua beach in Cape Coast. *A: January, 2008 photograph showing erosion scarp and early signs of underground rock exposure. B: November 2010 photograph showing exposed upper layers of underground rocks at the beach. C and D: April and November 2012 photographs showing pronounced rock exposures and strong waves hitting the backshore (erosion scarp).* Source: Fieldwork.
