**THE HYDRAULIC PERFORMANCE OF 900MM DIAMETER  
PIPE CULVERT USING WENCHI – SAMPA ROAD AS CASE  
STUDY**

**A Thesis submitted to the Department of Civil Engineering, Kwame  
Nkrumah University of Science and Technology**

**Road and Transportation Engineering**

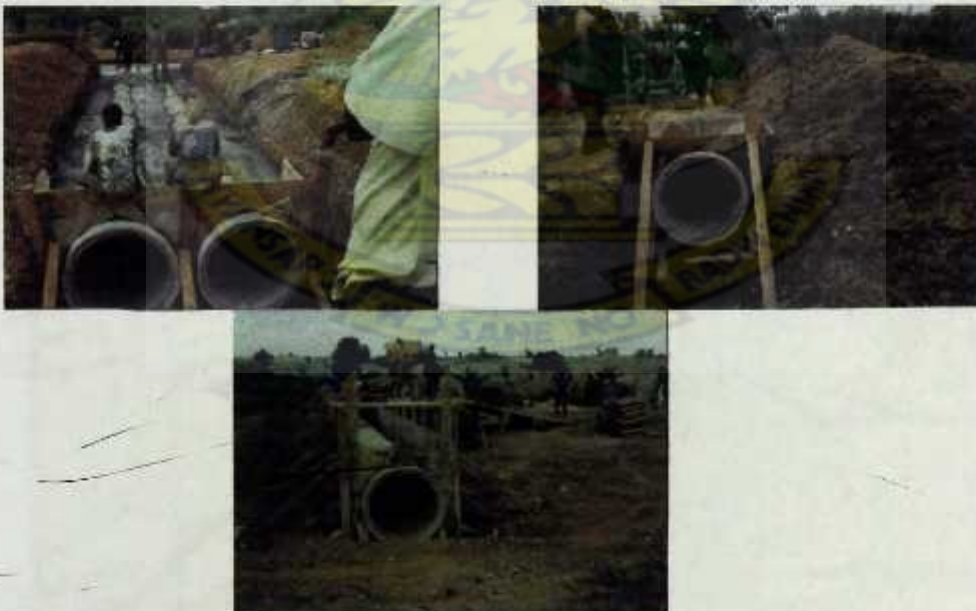
**Figure 2.7 – 900mm diameter pipe culverts under construction**  
**[Wenchi Sampa Road Project (2001)]**

Most of the concrete pipes used in the country are precast, non-reinforced and normally in one-metre spans. The excavation for the culvert is compacted to 93% MDD to a depth of 150mm immediately before concrete is cast (Standard Specifications for Road and Bridge Works, 2006). A concrete surround of 150mm

minimum is placed to protect the pipes from possible damage and to make them water proof. Most of the culverts are fitted at the ends with headwalls, wingwalls, aprons and cut off walls. The angle of flare for the wingwalls is 30 – 75 degrees (Road Design Guide, 1991). The depth of headwalls is 500mm minimum depending on the amount of fill on the culvert. The thickness of the apron is such that it should be flushed with the inverts of the pipes. A cutoff wall of 500mm minimum depth is provided to protect the ends from scouring. The backfill for the culvert is compacted to a dry density of 93% MDD (Standard Specifications for Road and Bridge Works, 2006). The outlet channels are lined with concrete in settlements and they are seldom done in the remote sections of the roads. Flow speed reduction measures are normally incorporated to reduce the flow energy and thereby prevent scouring at the outlets. Figure 2.7 shows some 900mm diameter concrete pipe culverts under construction on the project road.

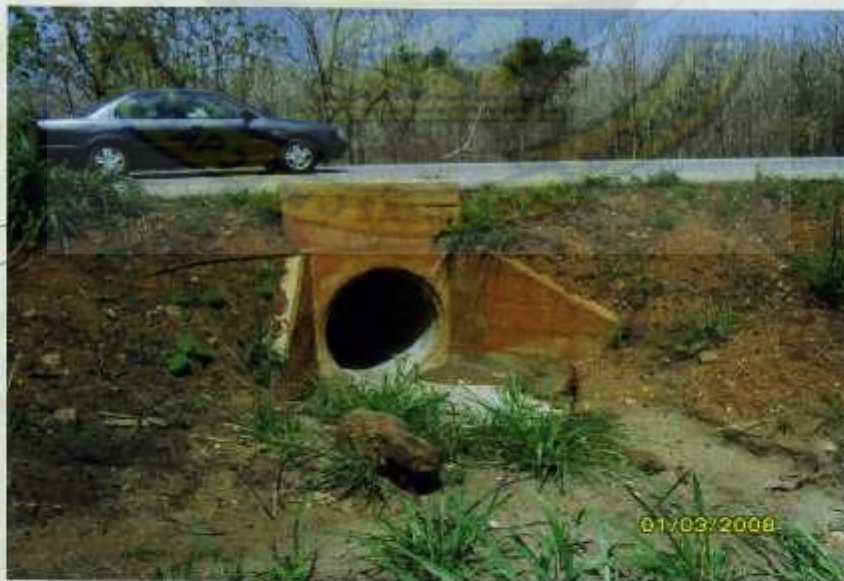
**Figure 4.2 – Pipe culvert in natural channel: Outlet of 1No. 900mm diameter pipe culvert at km 4+425**

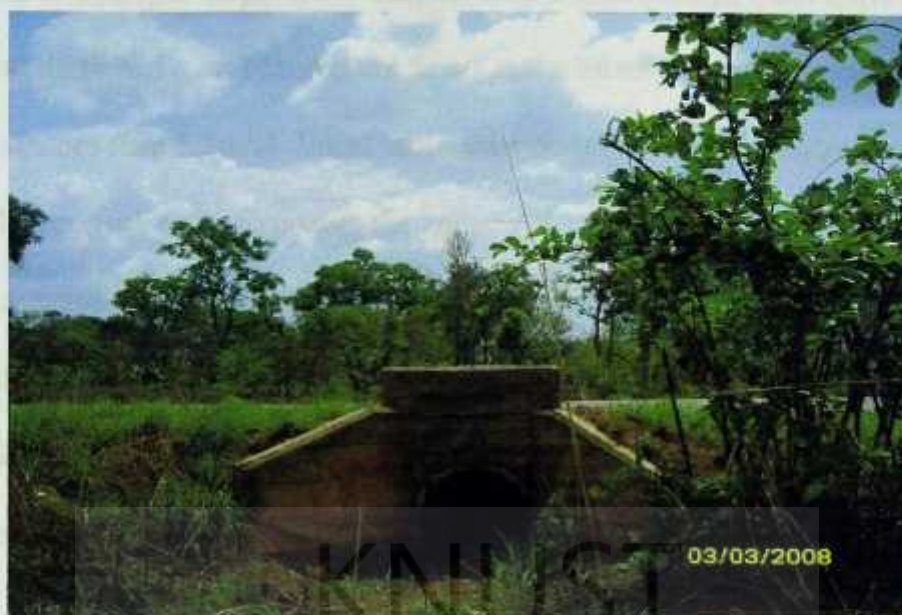
**Figure 4.3 – Pipe culvert in natural channel: Inlet of 1No. 900mm diameter pipe culvert at km 23+450**

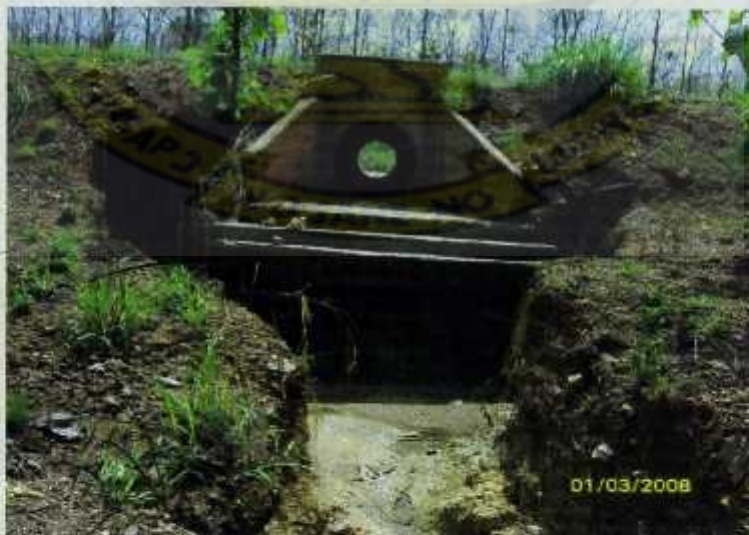
**Figure 4.4 – Scoured outlet of 1No. 900mm diameter pipe culvert at km 4+900 – 2.0 – 4.5% slope area – The result of inadequately sized outlet earth channel**

alignments to a steeper slope of the channel alignments (that is, from 2.0% to 4.5% slope), and these had a lot of turbulent flows at the inlets and high outlet flow velocities (more than 5.2m/s). Local scour thus occurred at the inlets and the outlets of the culverts, with some exposing the apron slab. Seventeen pipe culverts with constant average slope of 3.0% at both ends had no defect because of uniform flow through the channels and the culverts. Twenty-one out of the thirty-eight pipe culverts in the terrain of 0.5 – 1.0% slopes were silted. Figure 4.5 and Figure 4.6 show two of them. This happened because of relatively low velocities of flow.

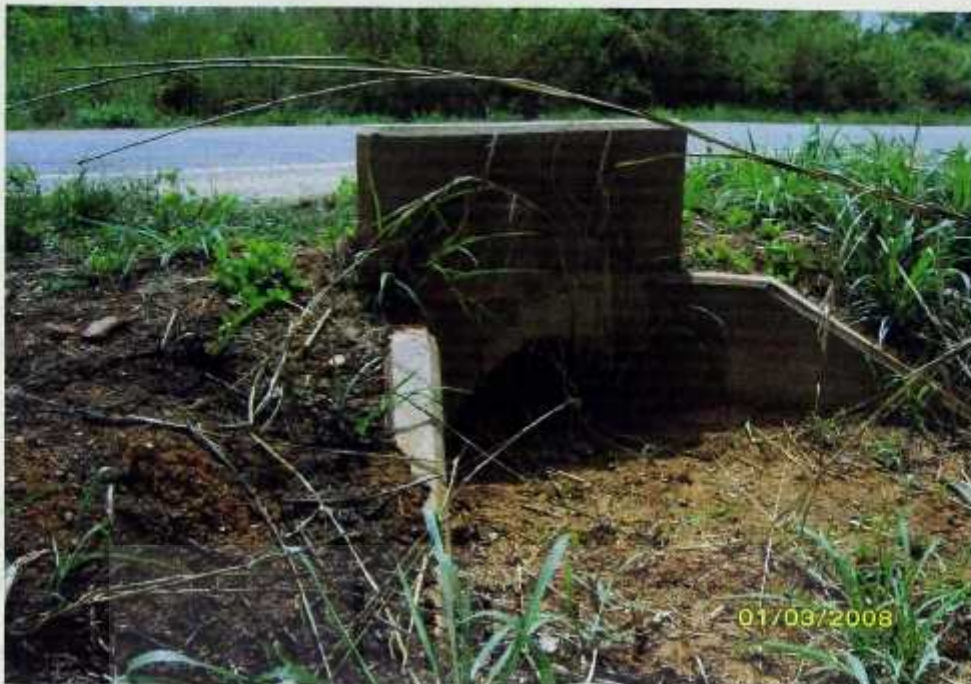
**Figure 4.5 – Silted inlet of 1No. 900mm diameter pipe culvert at km 2+590 – 0.5 – 1.0% slope area – loss of energy to carry sediment through culvert barrel (hence deposition)**

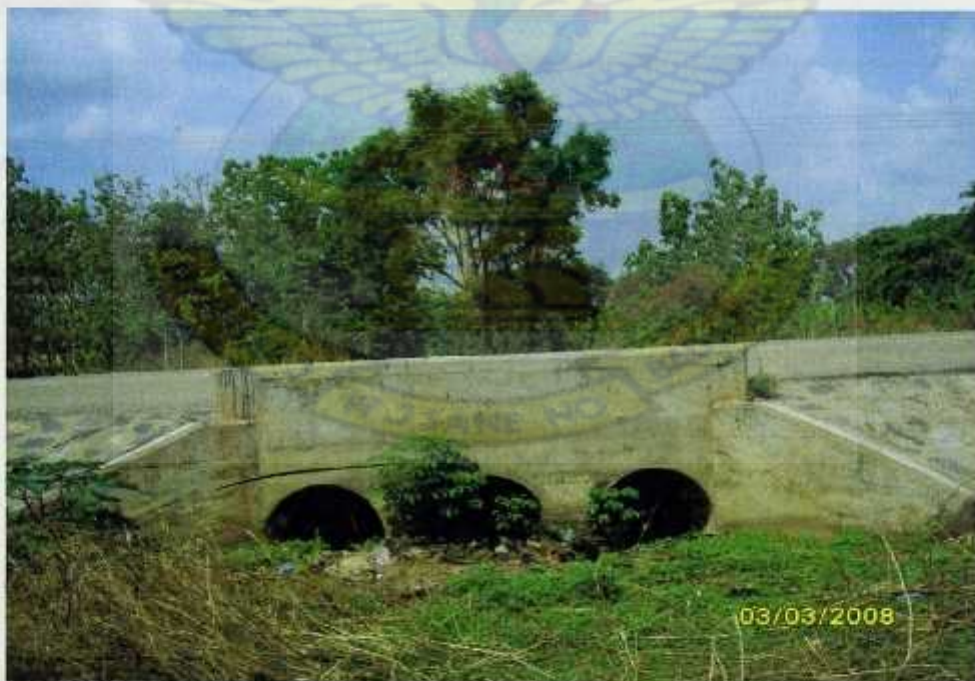
**Figure 4.6 – Silted inlet of 3No. 900mm diameter pipe culvert at km 28+125 – 0.5 – 1.0 % slope area (loss of energy as in Figure 4.5)**

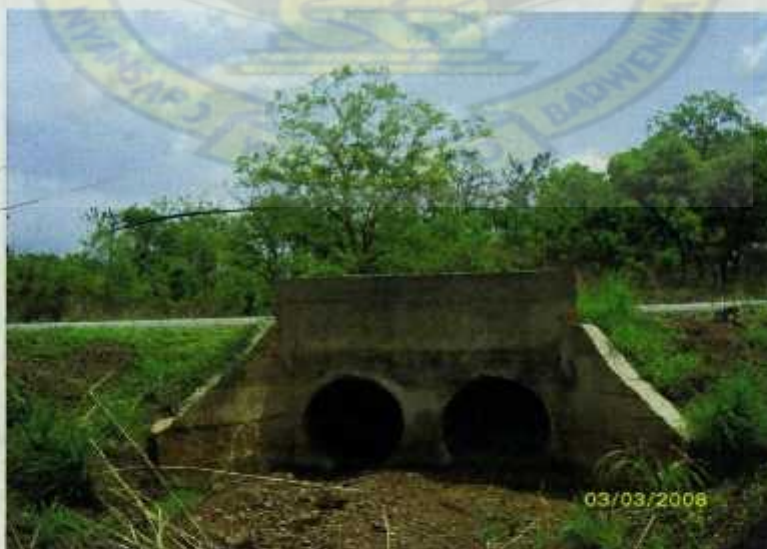
**Figure 4.7 – Silted inner barrel of 2No. 900mm dia. pipe culvert at km 21+800  
(Possible rise in Tailwater Level thus reducing average velocity in barrel)**

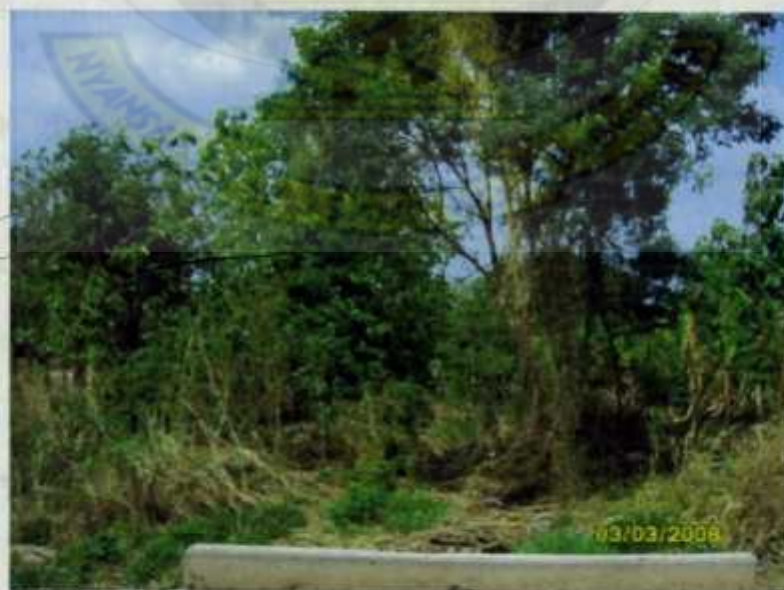
**Figure 4.8 – Braided outlet of 3No. 900mm diameter pipe culvert at km 28+125**

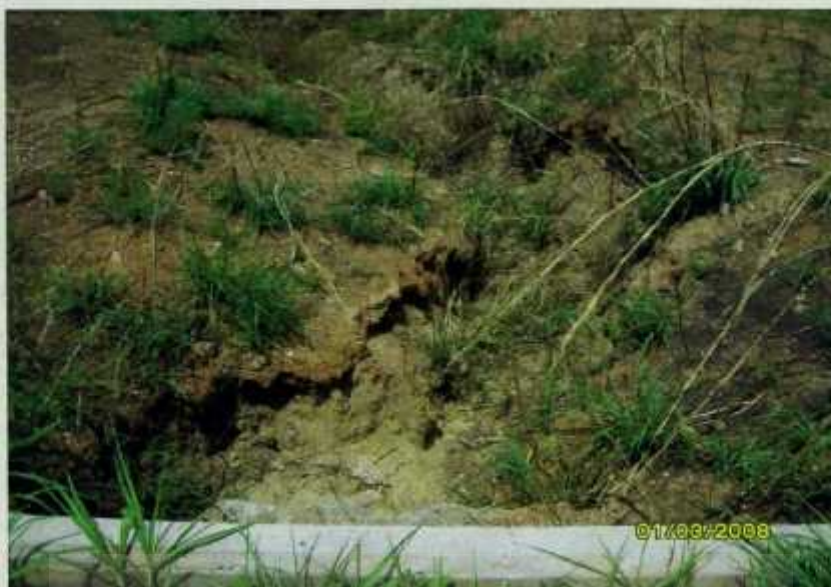
**Figure 4.9 – Meandered outlet of 2No. 900mm diameter pipe culvert at km 3+188**

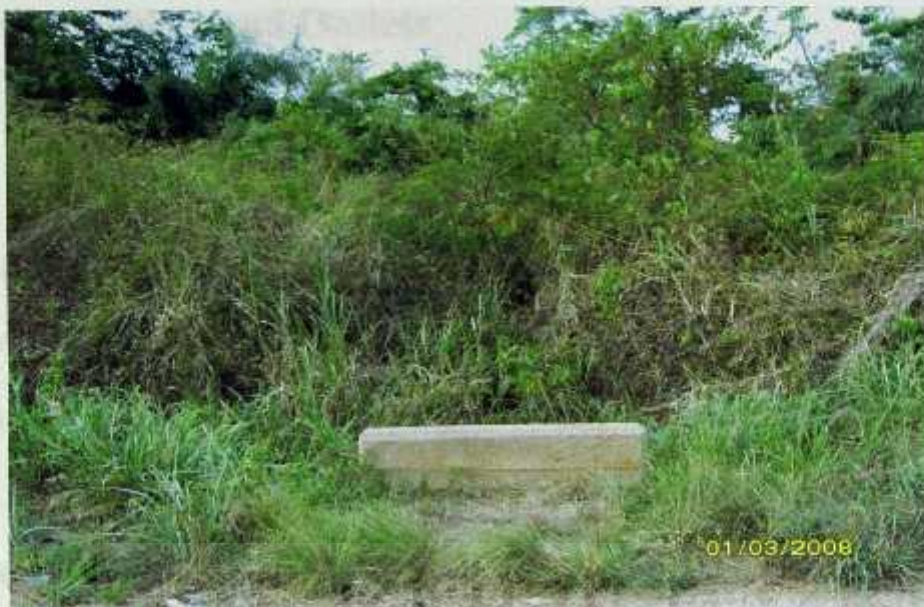
**Figure 4.10 – Weedy outlet of 1No. 900mm diameter pipe culvert at km 3+410**

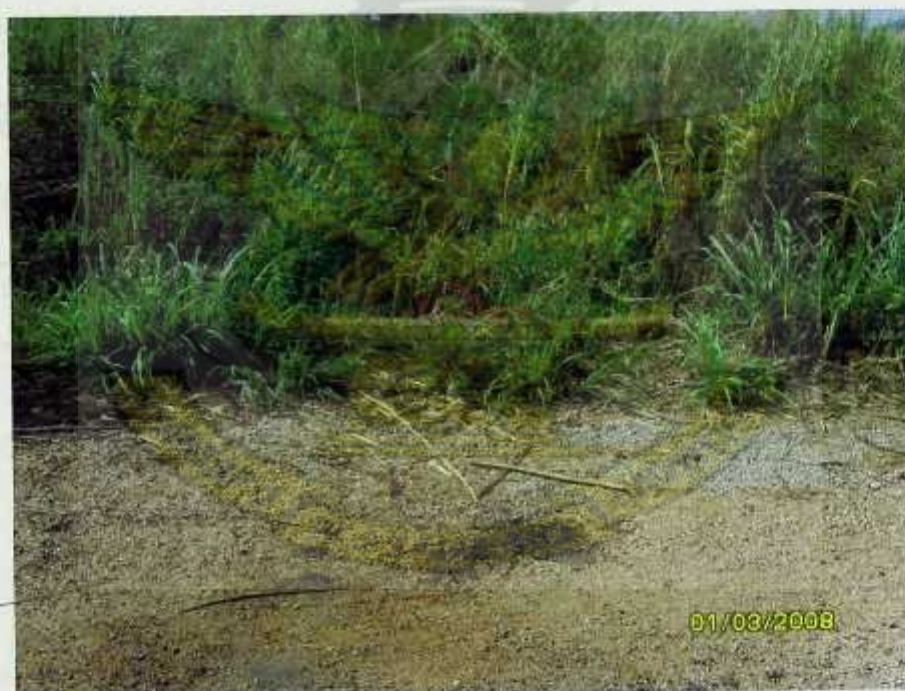
**Figure 4.11 – Weedy outlet of 2No. 900mm diameter pipe culvert at km 9+475**

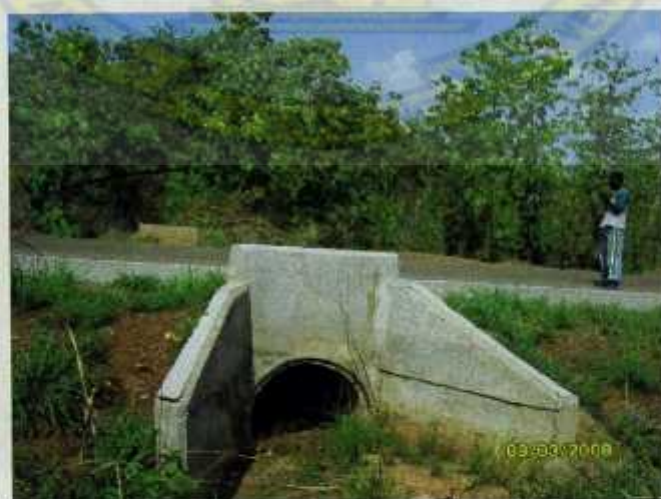
**Figure 4.12 – Silted inlet of 1No. 900mm diameter pipe culvert at km 29+525**

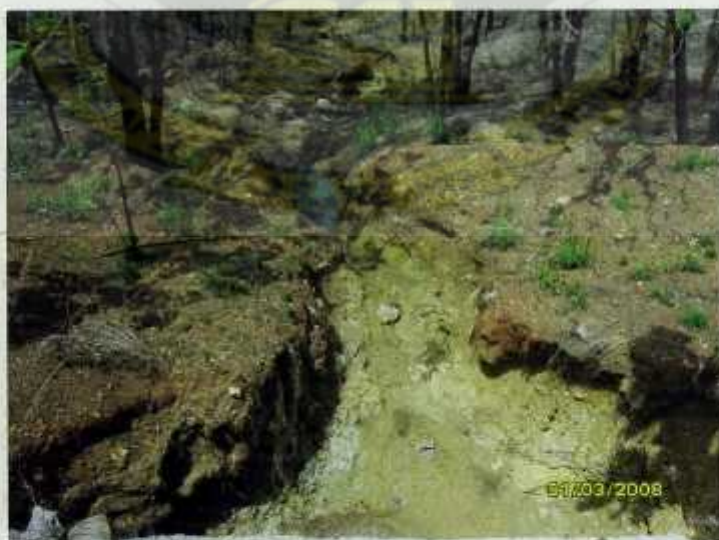
**Figure 4.13 – Degraded outlet of 1No. 900mm dia. pipe culvert at km 4+900**

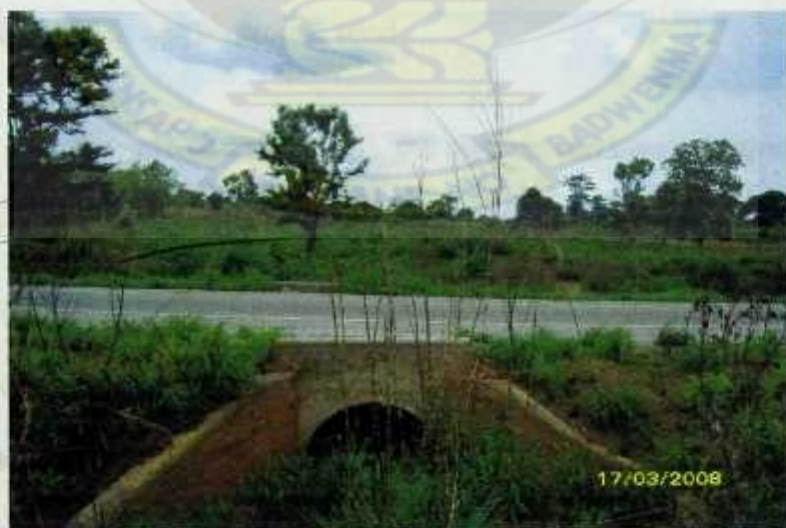
**Figure 4.14 – Weedy and silted inlet of 1No. 1800mm diameter pipe culvert at km 5+075**

All the bigger size culverts with site conditions similar to the affected 900mm diameter pipe culverts performed in the same manner. These are culverts located in areas with streams which flow in well-defined channels during the rainy seasons but dried up during the six to seven months of dry season in the area. Weeds often grow in the channels, thus creating conditions similar to the location of the 900mm diameter pipe culverts. There was one 1800mm diameter pipe culvert at km 5+075 (Fig. 4.14) which had abrupt change in the channel alignment slope from 4.0% to 1.0% at the inlet and had a weedy outlet channel. The resultant effect was that the inlet and outlet were all silted and the outlet channel aggraded. There was another at km 19+500 (Fig. 4.15) with abrupt change in the alignment direction downstream. This was silted up and had both the inlet and outlet ponded. This meant that irrespective of the size of the culverts, the existing site conditions determined the flow rate through them.

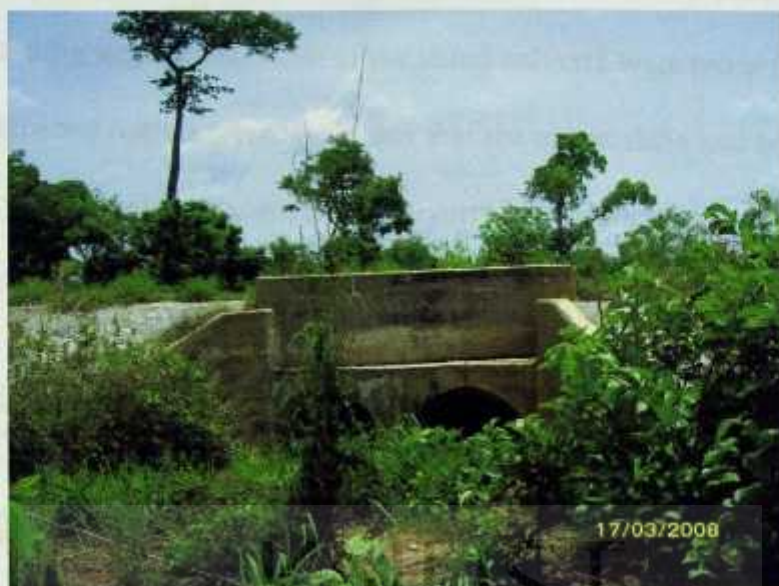
**Figure 4.15 – Weedy and silted outlet of 2No. 1800mm diameter pipe culvert at km 19+500**
