**ANALYSIS OF TECHNICAL AND  
FINANCIAL BENEFITS OF ENERGY  
EFFICIENT PRACTISES IN SELECTED  
ELECTRICITY COMPANY OF GHANA  
(ECG) BUILDINGS IN ACCRA**

A THESIS SUBMITTED IN  
FULFILLMENT OF THE  
REQUIREMENTS FOR THE DEGREE OF

Department of Mechanical Engineering,  
College of Engineering

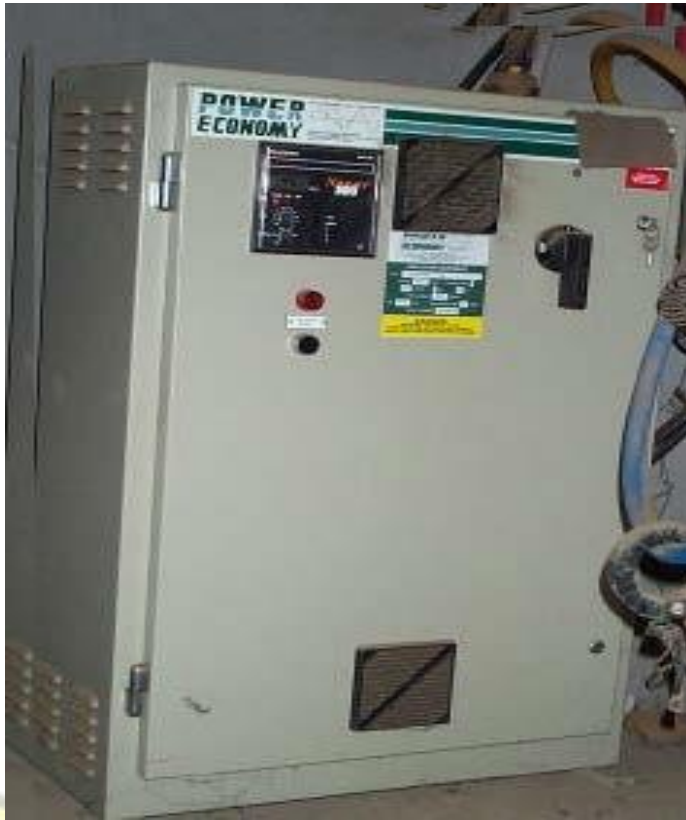
**Figure 2: Power factor improvement by installation of capacitor bank**  
(Source Energy Foundation, 2000)

There are several methods available for improving power factor; two are described here. It has been suggested that for inductive loads, which are much more common, it is feasible to improve power factor by installing capacitors across the input lines feeding the affected equipment. This is done by energy service engineers who use special equipment to determine the size of capacitor necessary (Energy Foundation, 2010). The second method involves the use of synchronous motors. In this instance, an improved power factor may be obtained by adjusting the field excitation of the motors. Synchronous motors used in this way are termed synchronous condensers. The use of this method is however limited to cases where the synchronous motors are in constant use to provide the required field excitation at

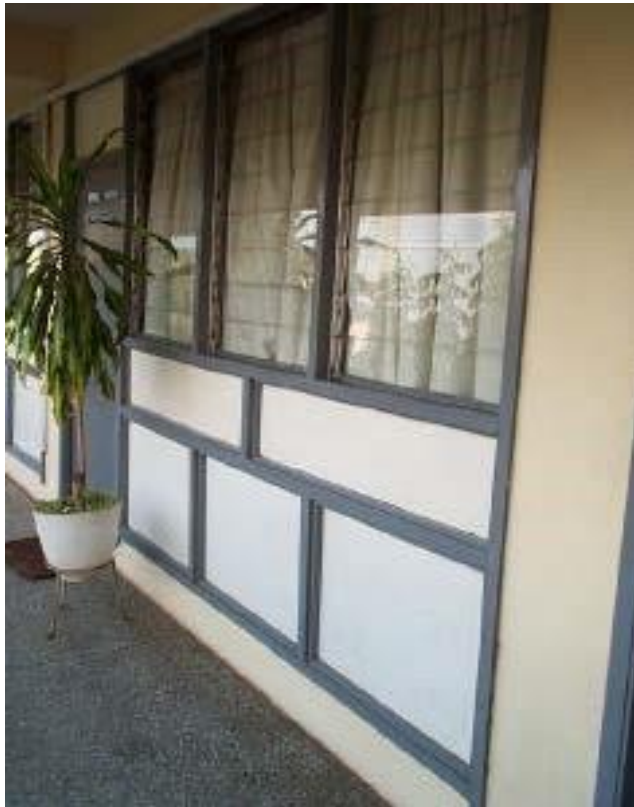
**Figure 3: Front view of the Minister of Energy's office**

Following a successful audit, several energy efficient measures of not were implemented at the Ministry of Energy in Ghana. For instance, in order to reduce the high incidents of ventilation heat gains, all the lower level louvered windows were replaced with solid flush wooden panels, whilst the old louver frames which did not allow for firm closure of windows were either repaired or replaced. The air conditioners were moved from the ground level to heights of 1.5-2meters above the floor level to set up an efficient circulation pattern, borrowing from fundamental knowledge that cool air tends to fall as warm air rises.

Replacing the lower louvered windows with solid flush wooden panels particularly allowed for even and easy circulation of cool air in the offices. It also prevented furniture and other objects from blocking the areas in front of air conditioner units, which could prevent or hamper air circulation. After this exercise it became possible to use one air conditioner instead of two in some of the large offices where two air conditioner units were installed since hot air infiltration was reduced to the minimum (Energy Foundation, 2000).

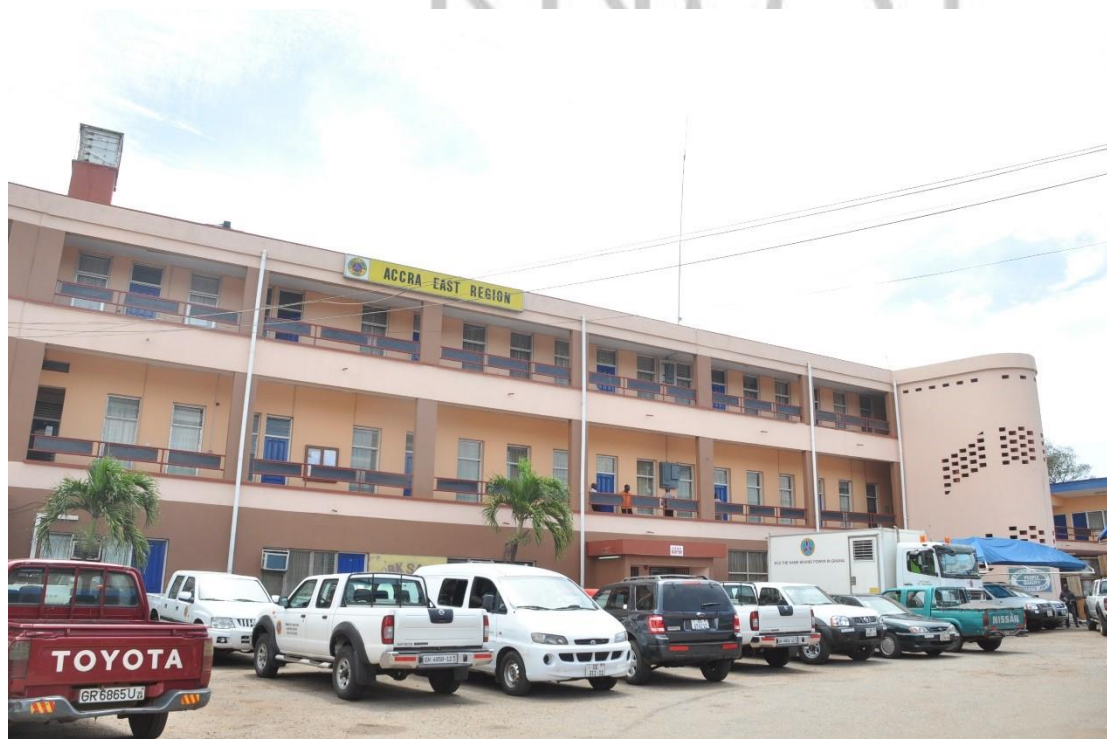
Figure 4: Accra East office building of the ECG

and Transport, Human Resource, Finance and Audit, Engineering, Operations and ICT. This is the older of the two offices. As shown in Figure 4, single glazed louvred windows occupies about 30% of the total surface. This feature permits high rates of air infiltration and ex-filtration, thereby contributing to high heat gains by placing higher demand on the HVAC system.

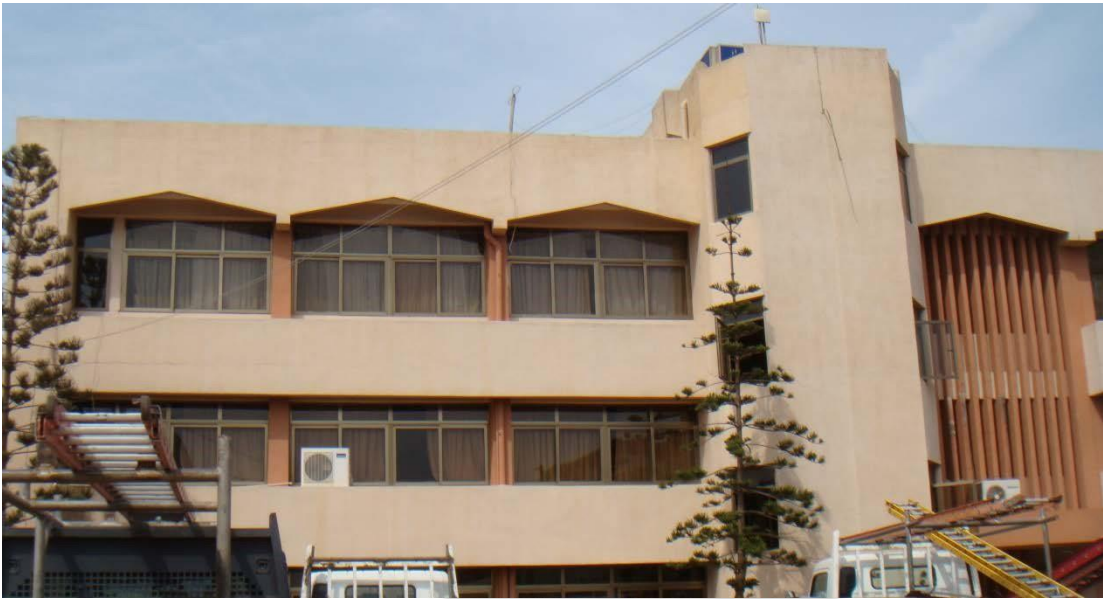
Figure 5: Accra West office building of the ECG (a)

The Accra West Administrative building is a 2-storey building located at Avenor, in the South-Western geographical demarcated area of ECG on the east-west axis on open ground. The building houses seven departments of the ECG, namely: Customer service, Material and Transport, Human Resource, Finance and Audit, Engineering, Operations and ICT. Anecdotal evidence suggests that this building was built to incorporate contemporary energy efficient technology and serves as the reference point in this study. The building was designed with features such as east-west orientation, and

overhangs that reduce the impact of solar gain and therefore improves energy efficiency.

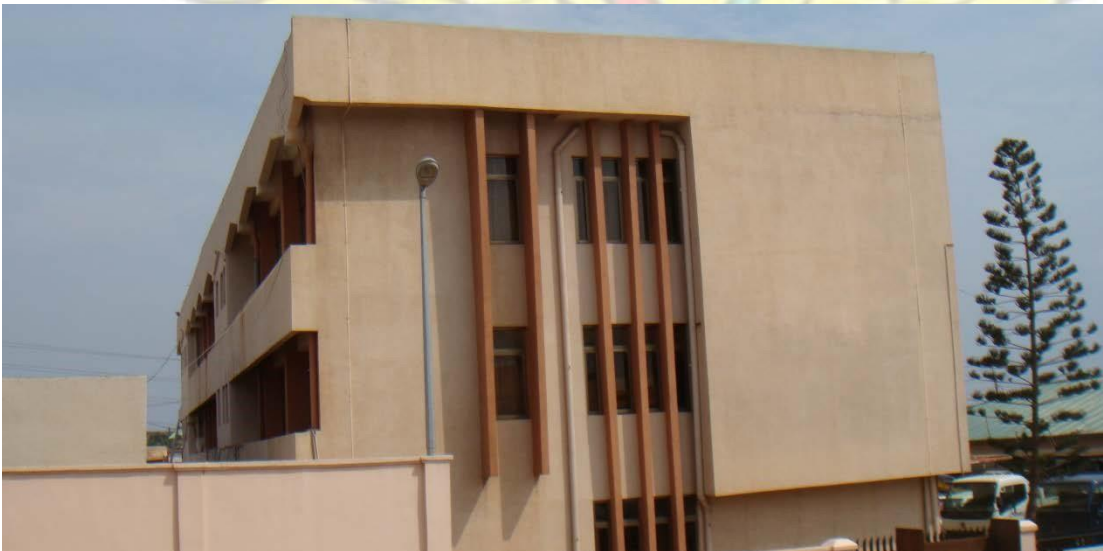
Figure 6: Accra West office building of the ECG (b)

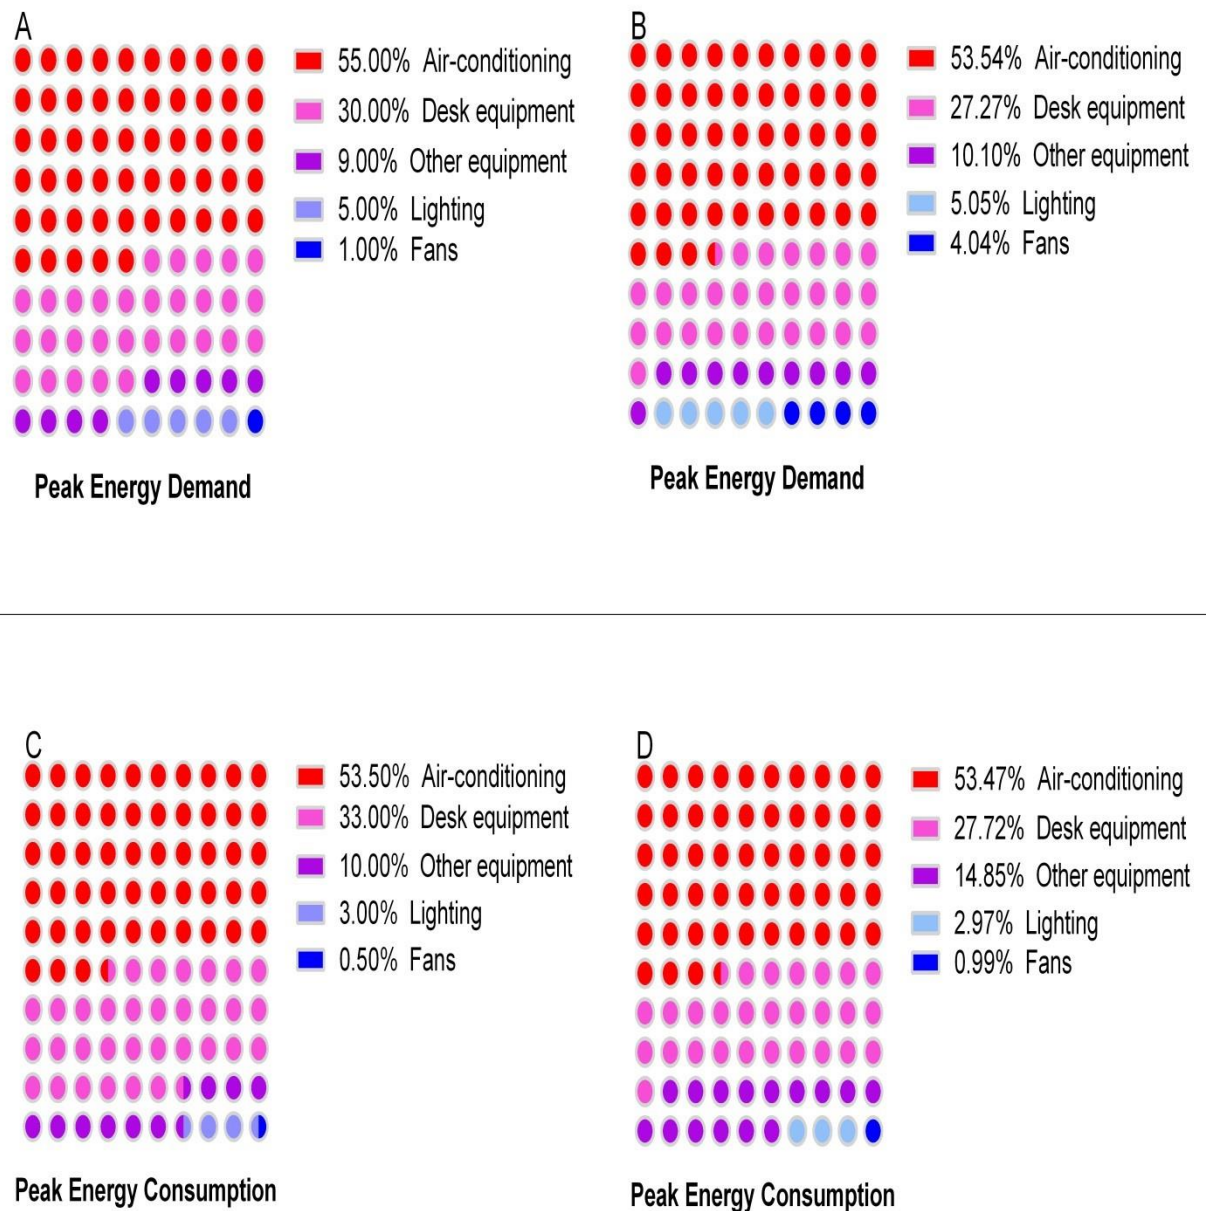
Figure 7: Colour grid showing demand and consumption patterns of energy in ECG buildings in Accra. A & C- Accra East, B & D –Accra West.

Figure 7C and 7D shows the consumption patterns of energy in 2012 stratified by equipment type. At the Accra West facility, air-conditioning equipment recorded the highest (53.5%) fraction of electricity consumption in 2012 followed by Desk equipment (27.7%), followed by other equipment (14.9%). Similarly the largest consumer of electrical energy (kWh) at the Accra East office was air-conditioning (53.5%) followed by Desk equipment (33%), followed by the other equipment category (10%).

Lighting and fans exerted the least influence on the energy-use signature of the two facilities. This suggests that the two buildings have very similar operation. In fact one difference between the two facilities rests with the fact that the Accra West building has many departments on more than one floor.

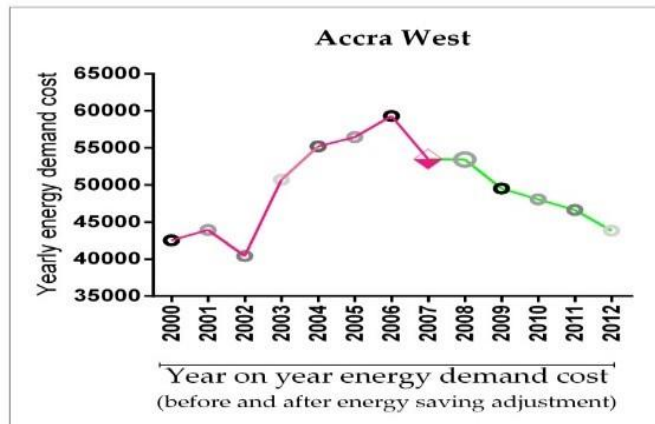
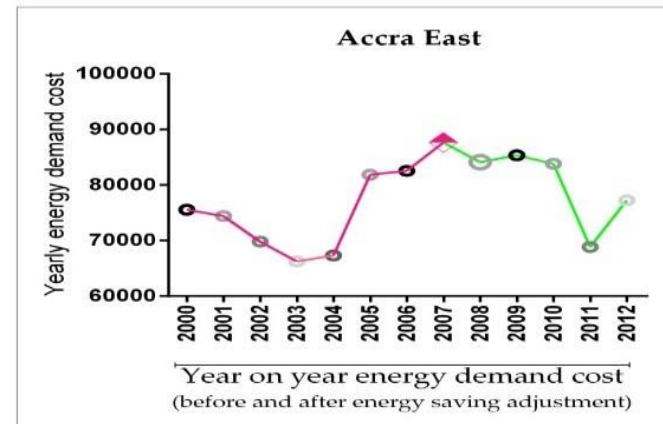
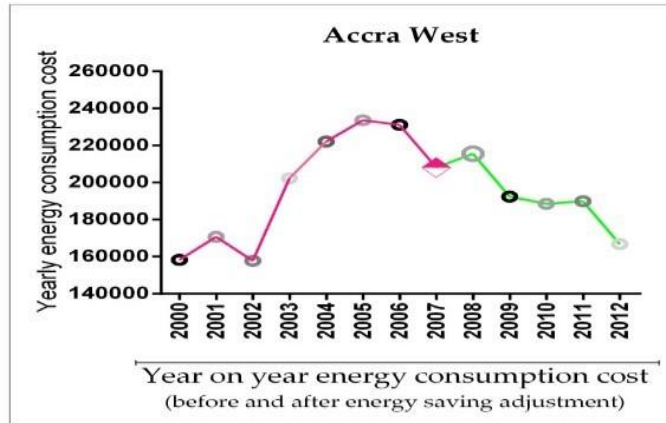
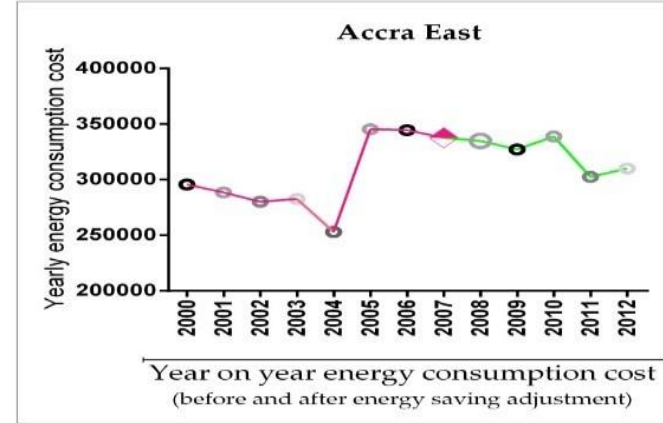
Figure 8: Graphical Presentation of Annual Energy Consumption (kWh) and Demand (kW) cost patterns at AE and AW regional offices of the ECG. Red lines reflect pre-2007 trend and green lines reflect post-2007 trends. Costing is done in Ghana cedis (Gh¢).

has been a steady decline in the annual average peak demand at the AW office. Electrical consumption at AW generally followed a very identical trend throughout the period except for a secondary, less intense peak in 2008. This shows that the Ministry of Energy's directive to replace incandescent light bulbs with compact fluorescent lamps in 2007 had significant effect on consumption patterns.

In the same period from 2000 to 2012, the peak demand at AE followed a U-shaped curve from 2000 to 2007. Within this period, the least demand was recorded in 2003 and the highest in 2007. Unlike at AW, the peak demand began to plummet in 2007 until 2011 when it rose again. Energy consumption was at its lowest in 2004 at AE. By 2007, consumption had hit a plateau but rose slightly in 2010 before declining further to date.

office premises. Data collected in this study suggests that the measure may have had a significant impact in considerably reducing the energy consumption levels of the AW regional office of the ECG. Although other factors may also have a part to play in this effect, the trend as seen from figure 8 is very strong.

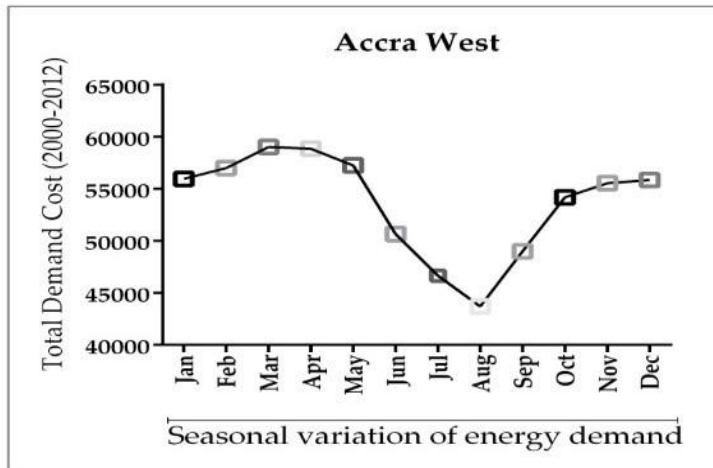
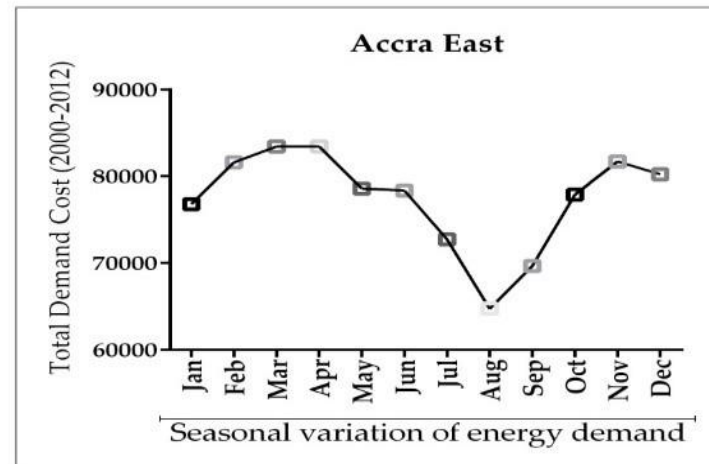
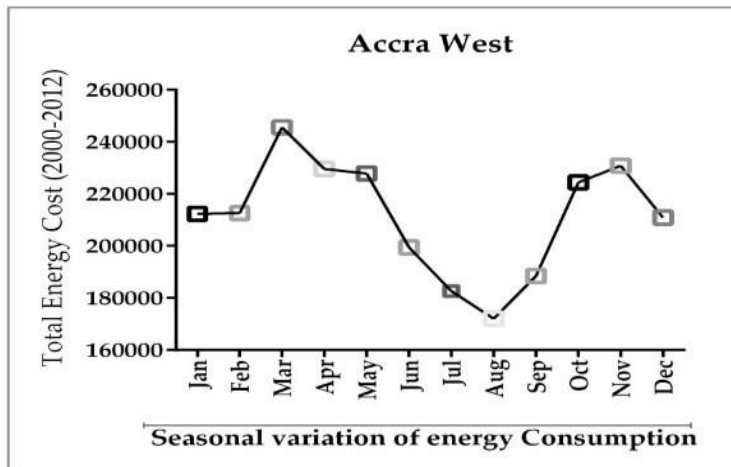
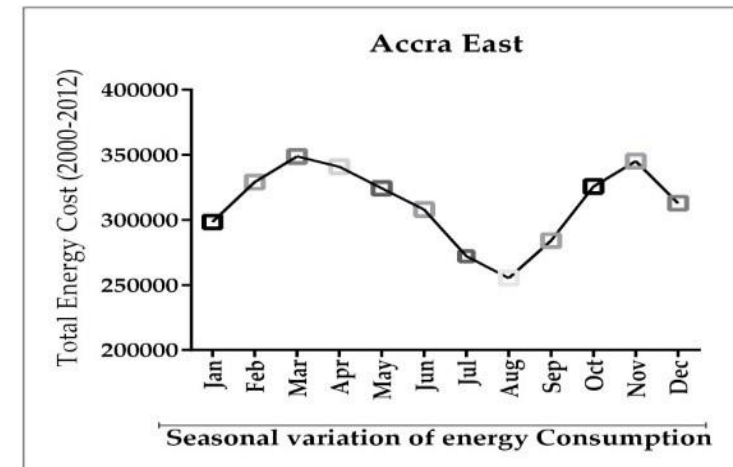
Figure 9: Graphical presentation of monthly energy consumption and demand patterns at AE and AW regional offices of the ECG\*.  
\*Data is presented as monthly averages from year 2000 to 2012.

Figure 9 shows a graphical presentation of monthly energy consumption and demand patterns at AE and AW regional offices of the ECG. Data is presented as monthly averages from year 2000 to 2012. The peak demand rose gently from January to a maximum of 229558.70 kVA in April before it fell off to the minimum of 172060.60 kVA in August before rising steadily to a plateau from November at the AW regional office. A similar trend was also observed at the AE office.

In this survey, The annual pattern of energy use that was found at both facilities is typical and well documented for buildings with a heavy reliance on air-conditioning and other temperature controlling appliances (CIPEC, 2010). Such characteristic patterns are expected for light process outfits such as office buildings, and go to confirm that there are a number of drivers of energy use in a facility. The available data shows that most significant of all these drivers is perhaps, the weather. At both the AW and AE buildings, a seasonal trend in electrical consumption and demand patterns was observed. Both AW and AE regional offices recorded the least demand (kVA) figures in the month of August which, incidentally, is the coolest month of the year.

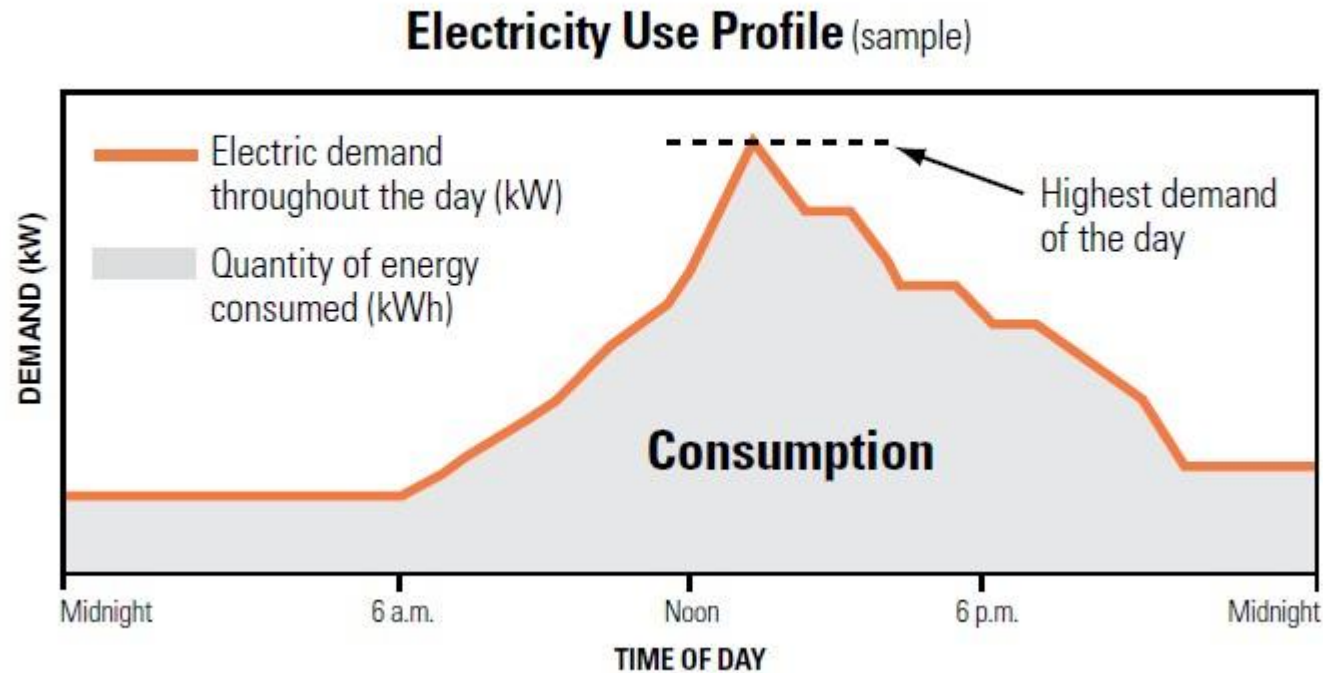
The electricity use diagram below shows the difference between **energy (kWh)** and **demand (kW)**:

**Figure 11: Difference Between Energy Consumption and Demand.**
