**A GIS – BASED FLOOD RISK MAPPING: A CASE STUDY OF PRU  
DISTRICT IN THE BRONG AHAFO REGION OF GHANA**

A Thesis Submitted to the Department of Environmental Science of the Kwame  
Nkrumah University of Science and Technology in Partial Fulfillment of the  
Requirements of  
Master of Science Degree in Environmental Science

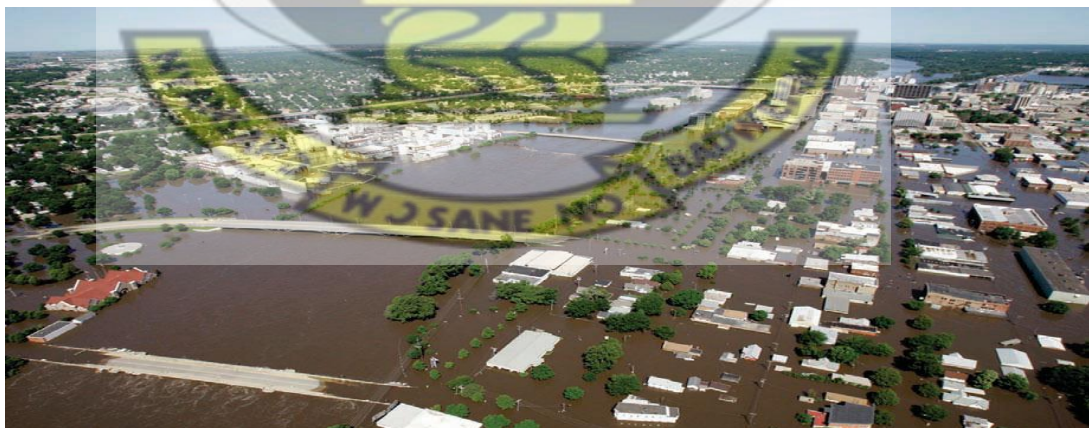
**Figure 2-1:** The flooding Cedar River; covers a large portion of Cedar Rapids, Iowa, on June 14, 2008. Source: (Cunningham and Cunningham, 2011).

According to Cunningham and Cunningham (2011) floods occur when the flow of a stream becomes so great that it exceeds the capacity of its channel and overflows its banks. They further indicated situation where torrential rains in June 2008 caused massive flooding across the American Midwest, where many cities in Iowa, Wisconsin, Illinois and Indiana experienced their highest water levels in more than a century. In Cedar Rapids, Iowa, for example, almost the entire downtown was inundated by the overflowing Cedar River (Figure 2-1).

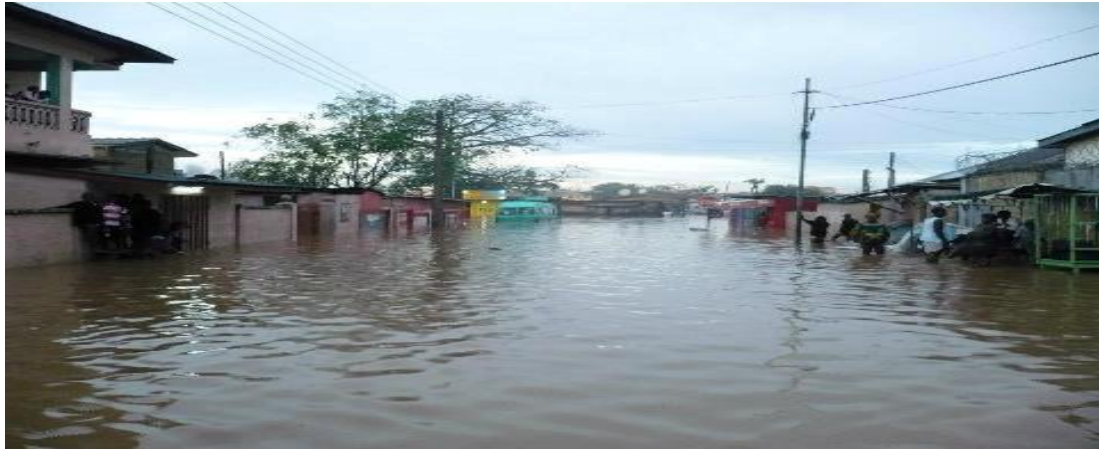
**Figure 2-2:** Flooding in central Accra after a heavy rain. Source: (NADMO, 2011).

The heavy rains recorded in Ghana in June 2010 caused severe flooding, especially for many communities in the south (IFRC, 2011). The floods caused varying degrees of destruction leading to the displacement of thousands of people including children while property like houses, bridges and shops were washed away. Among the most affected areas was Ashaiman in the Greater Accra Region where 11 persons died (GNA, 2010). Residents living close to the river that runs through the town were particularly affected. Also in central Accra, heavy rain and the local rapid runoff of the Odaw River rose above its riverbanks and flooded the nearby areas (Figure 2-2).

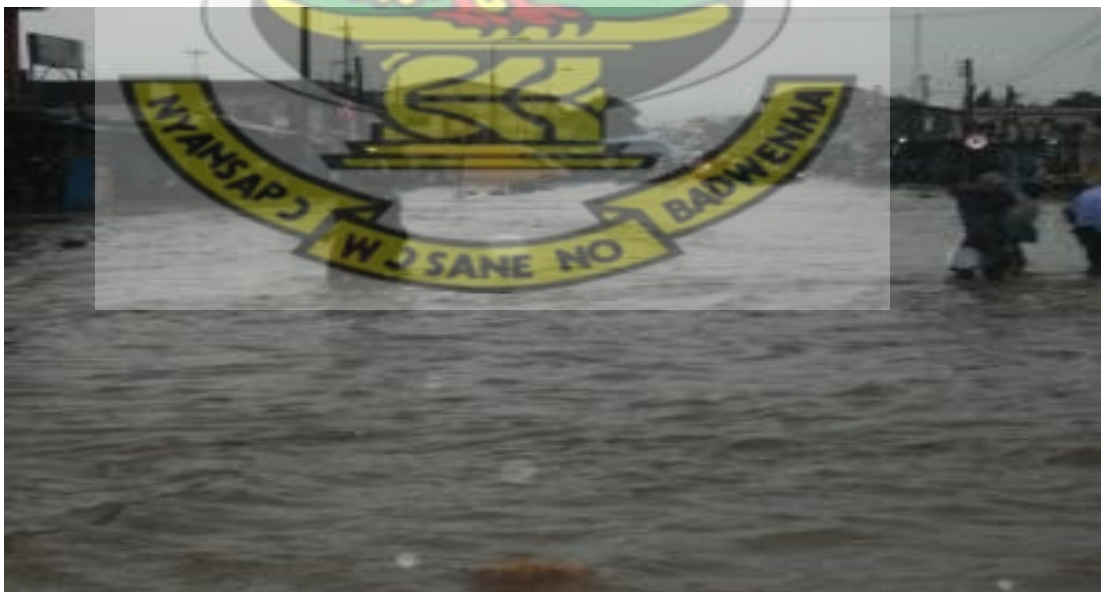
**Figure 2-4:** Floods in Yeji town, 2010. Source: (GNA, 2010).

In 2008 and 2010 certain portions of the settlements in Pru District were flooded after torrential rains causing much difficulty to its affected victims (Figure 2-4).

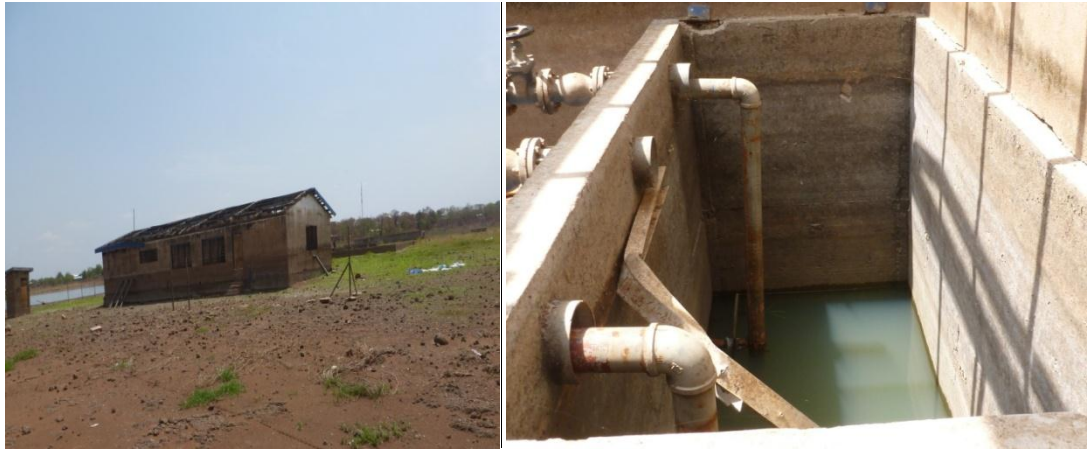
**Figure 2-6:** Abandoned STWSS Facility due to the 2010 Floods.

Even the difficulties encountered with movement cannot be wholly quantified in monetary terms. Some victims have to seek shelter in some of the school buildings causing delays in schools' academic works which certainly affect the performance of school children, a situation which is irreversible in the lives of affected pupils (NADMO, 2010). The Small Town Water Supply System (STWSS) facilities in Yeji and Parambo/Sawaba got inundated by the overflowing Volta Lake which compelled people living in these towns to depend on the polluted lake (GNA, 2010) which could potentially affect the health of the people (Figure 2-6).

This Sustainable Rural Water Supply Project (SRWSP) was a World Bank (WB) and the International Development Agency (IDA) funded project for selected districts, in six regions of the country, including the Brong-Ahafo, which has 11 out of its 22 districts and municipalities benefiting with Pru District being a beneficiary but unfortunately losing this project to floods which was worth millions of dollars (GNA, 2010). The National Disaster Management Organization in the Pru district was able to identify few of the flood affected areas in 2010, the number of people affected, their sexes, the type of damages and the estimated amount needed to provide relief items for the affected victims (Table 2-1). It can be deduced that over 261 houses were affected with over 2,172 people affected at an estimated cost of GH¢ 122,233.36. The destructions caused by floods are so alarming that some have relocated far from the district due to the psychological, financial and emotional stresses they went through (NADMO, 2010).

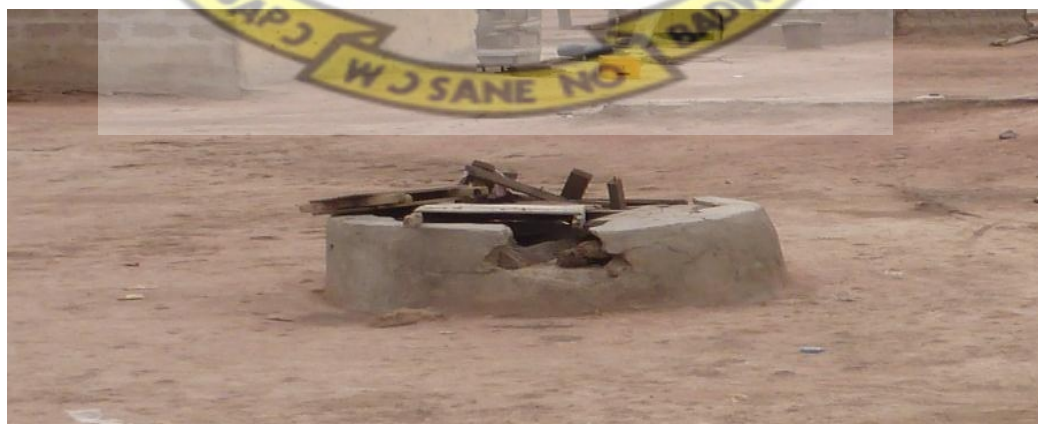
**Figure 4-17:** Sample of unprotected wells at Kobre in Pru district.

But the major sources of water in the district are unprotected wells, boreholes and rivers. One hundred and twenty - eight respondents, who live in communities within the reach of a river, mostly depend on the river for their sources of water. These communities include; Banyawaya, Fante Akura, Jaklai, Parambo / Sawaba, Labun Quarters, Kadua, Vutideke, Adjantrewa and Accra town. Figure 4-17 shows a sample of an unprotected well at Kobre which 156 respondents rely on for water, while 108 of the respondents rely on boreholes (Figure 4-18).

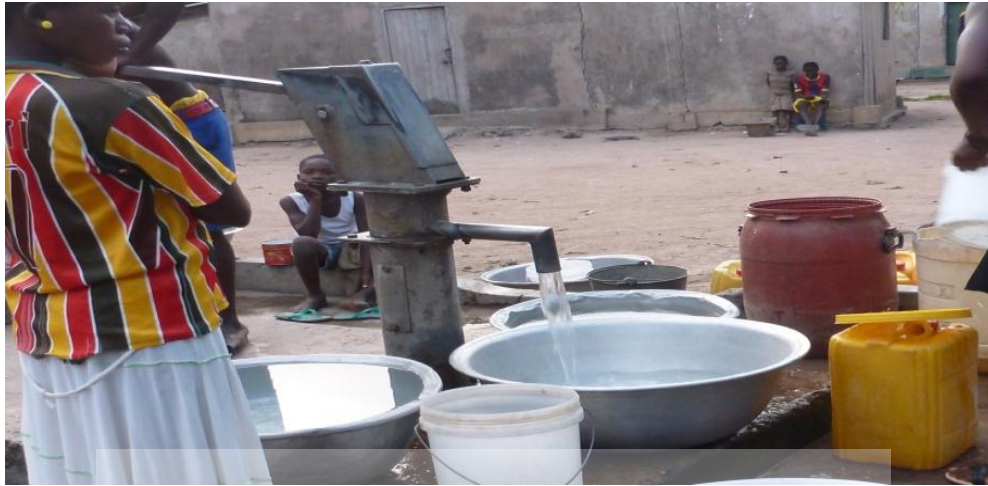
**Figure 4-18:** One of the only two boreholes at Cherepo in Pru District.

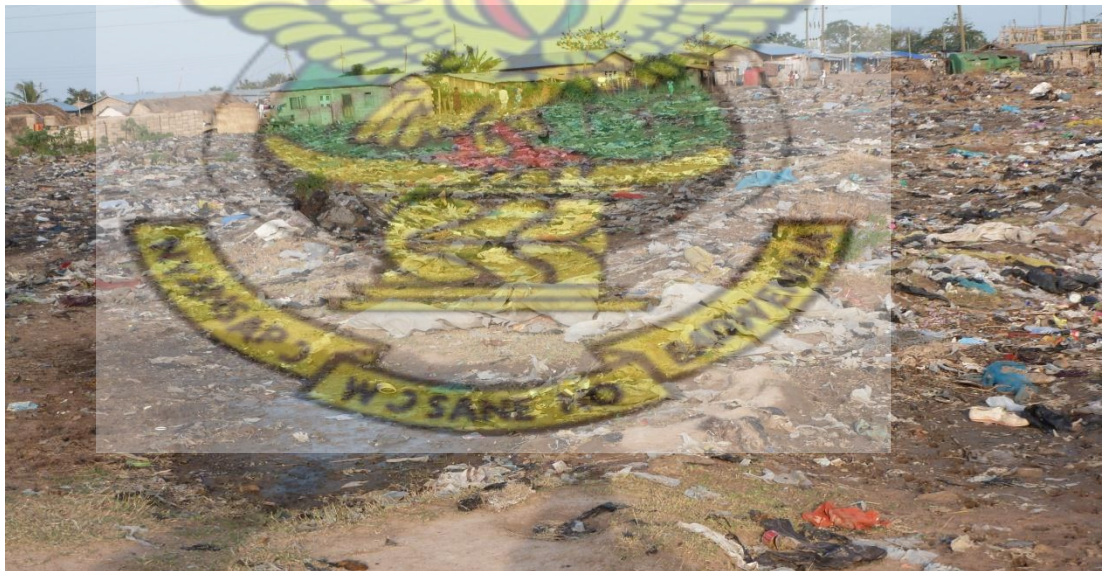
**Figure 4-19:** Open - place waste disposal at Banyawaya in Pru district.

All the 226 respondents representing 100% response indicated that they dispose of waste in open places and on near-by public refuse dumps (Figure 4-19).

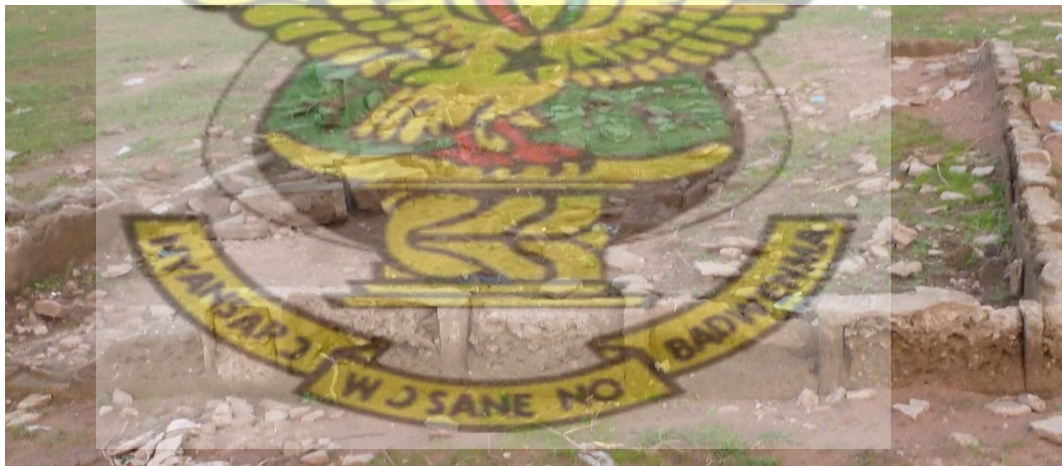
Through field survey, about 283 homes built of clay and cement blocks totally collapsed within Banyawaya, Fante Akura and Yeji Nsuano with another 69 collapsed at Kobre (Figure 4-23).

**Figure 4-23:** Sample of collapsed buildings after the 2010 floods in Fante Akura.

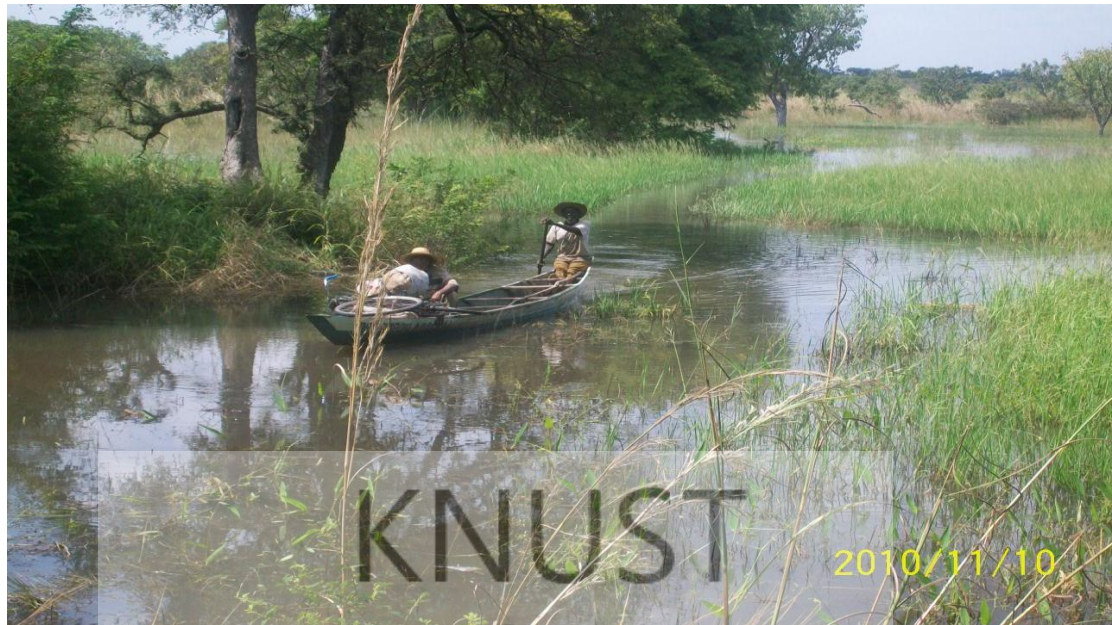
**Figure 4-27:** Canoe used as means of transport during floods at Kade in Pru district.

Movement from one place to another during floods is a major problem in flood affected communities. It was revealed by 74.34% of the respondents that, their means of movement from home to other places within the flood affected boundary was walking through flood water. Another 34.96% are able to secure canoes which they use as means of transport to other places, and others have to pay for the service of being transported from their locality to other places (Figure 4-27). They were totally separated from the reach of other localities. Most could not send their produce to the Yeji market which starts on every Sunday and ends on Tuesday evening which normally affected the business of trading in the District contributing to low revenue generation for the District Assembly.
