**TRUCK USE OF NEWLY-INSTALLED  
ROUNDBOUTS ON THE KUMASI-EJISU SECTION  
OF THE ACCRA-KUMASI-GONOKROM ROAD  
(ROUTE N6)**

A Thesis Submitted to the Department of Civil Engineering,  
Kwame Nkrumah University of Science and Technology  
in Partial Fulfilment of the Requirement for the Award of the Degree  
of

**MASTER OF SCIENCE**

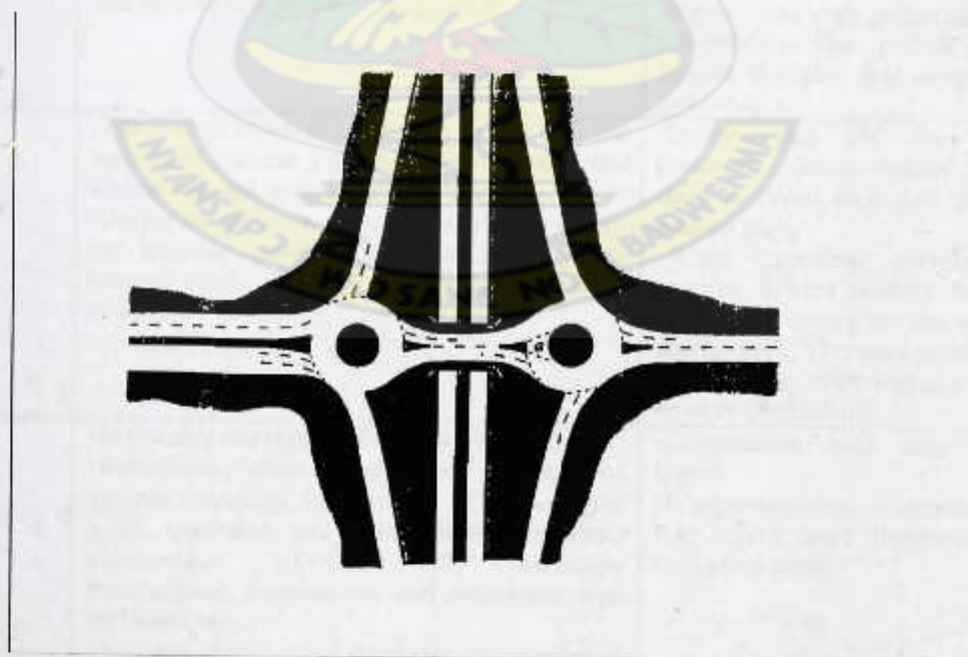
Figure 2.7. Roundabout interchange (Taekratok, 1998)

The roundabout interchange is an interchange with one or more roundabouts.

The most common types are a freeway passing over or under one large roundabout which is joined by ramps and the cross street, and a roundabout at the ramps intersection with the cross street (see Figure 2.7).

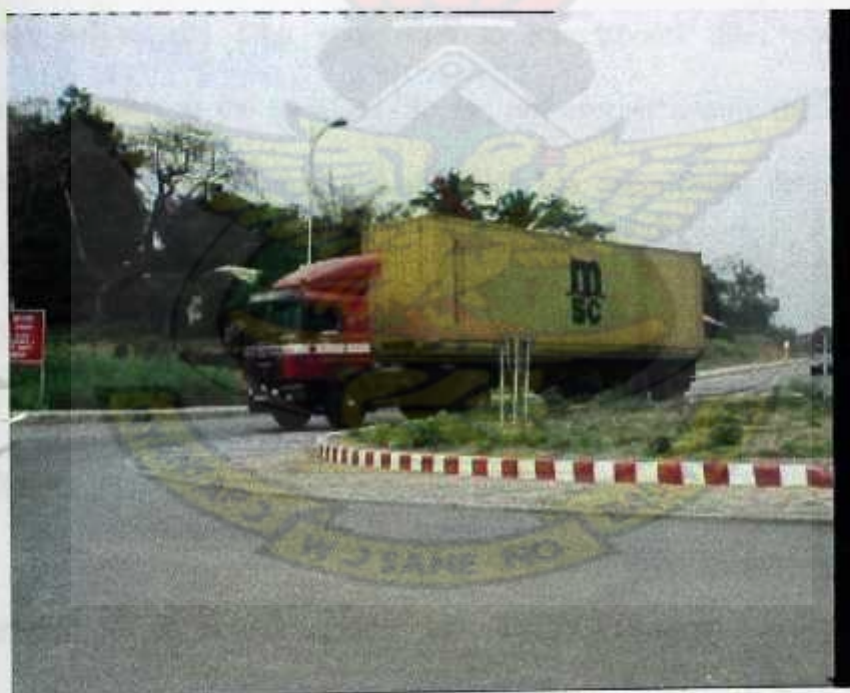
**Figure 4.5: A truck-trailer manoeuvring a roundabout**

A total of 187 trucks were captured on video whilst manoeuvring the University Police Station Roundabout. Of this number, 150 (80.2%) did not use the truck apron on the central island though an insignificant number (6, i.e., 3.2%) began their manoeuvres using the apron (flared cobbled-island) that reduces the entry to the roundabout to a single lane. Figure 4.5 shows a truck-trailer captured manoeuvring the University Police Station Roundabout.

Quite clearly the results of the manoeuvre studies corroborate well with the truck driver interview in which, as already mentioned, 77.1% of the drivers admitted to not using the truck apron at all.
