**DESIGNING FOR PHYSICAL ACCESSIBILITY IN MODEL VOCATIONAL
TECHNICAL SCHOOL FOR THE VISUALLY IMPAIRED**

A Thesis submitted to the Department of Architecture,

MASTER OF ARCHITECTURE (M.ARCH)

September, 2008

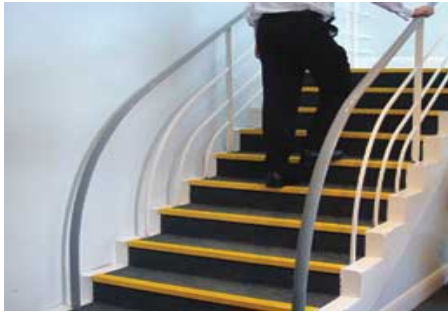
Fig. 1-Highlighted stair nosings

[Http://www.tiresias.org](http://www.tiresias.org) writes that 'nosings should be highlighted to indicate the location of the nosing or leading edge of tread to provide safe usage up and down the stair and that open risers should be avoided'. The feet of such persons can enter openings in such risers and can cause them to fall down or trip. Accessibility for the Disabled –A Design Manual for a Barrier Free Environment (United Nations, 2003-2004) recommends that a 'textural marking strip (of different color from surrounding environment) should be placed at the top and bottom of the stairs and the intermediate landings to alert sightless persons as to the location of the stairs'. This strip when used will serve as a good guide for visually impaired students.

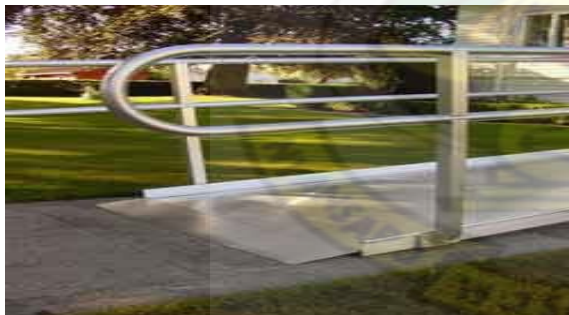
Fig.7-Handrails on the sides of an access ramp

[Http://www.tiresias.org](http://www.tiresias.org) recommends that two handrails should be installed on both sides of a ramp at least 0.40m high and its design should be ergonomic (can be used by all). This is

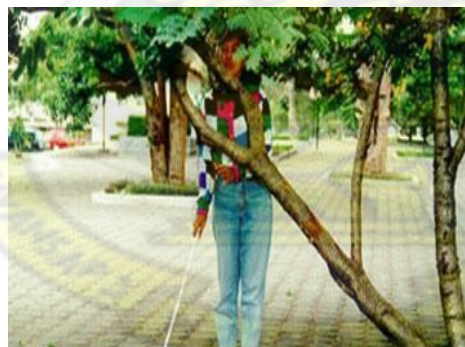
Fig.15-Planting obstacle in a walkway

The obstacles may include potted plant, rubbish bins, fire hydrants, etc. These obstacles pose lots of danger to visually impaired persons. There should be clues to warn against potential harm such as the use of textural markings. Poles and freestanding columns can also be designed such that they are not in the direct line of pathways or walkways. It is essential that architects and other designers consider this so persons can move about without injuring themselves.

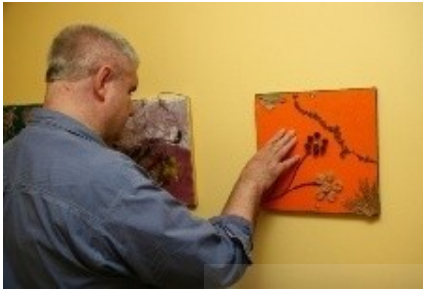
Fig.16-Textural clues on walls

With regard to the design of walls, <http://www.rnib.org.uk> recommends that textural clues can be incorporated into the design of it so that they can assist visually impaired persons.

This recommendation is in the right direction, as persons can comfortably trail their fingers on the walls to know where they are or going. However, the finishes of the walls should not be injurious to them. For example, a rough terrazzo finish can be potentially dangerous. For

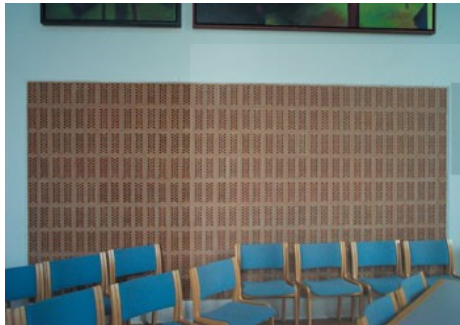
Fig.20-Brick facing at back wall for good acoustics in a classroom

[Http://www.tilgaengelighed.emu.dk/tilgaengelighed/fy...](http://www.tilgaengelighed.emu.dk/tilgaengelighed/fy...) makes further recommendations for the use of materials such as brick, fabrics, and acoustic tiles among others to encourage good acoustics.

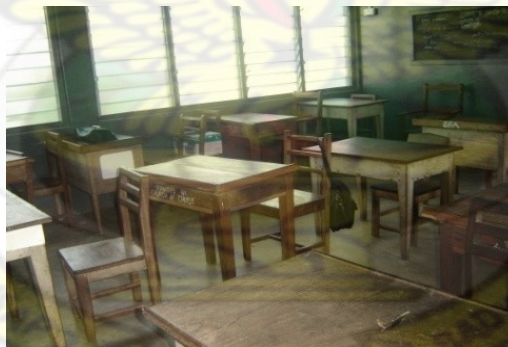
Fig.33- Furniture layout in a classroom

Generally, the louvered windows on the north and south elevations of the dining hall, classroom block, administration bring in good natural light. Students are also able to open and close windows; however there were some barriers that the students talked about. In the classrooms and dormitories, however, furniture is too close to the windows and they impede mobility.

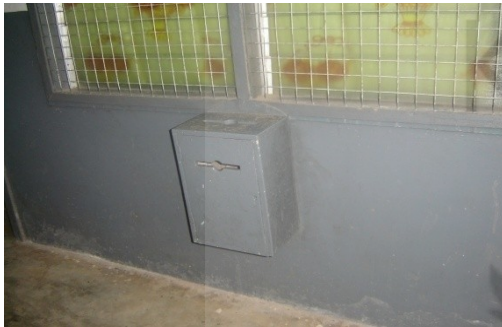
Fig.40-Wooden post box on the corridor of classroom block

First, a wooden post box hanging from the corridor wall of the main classroom block sometimes impede student mobility. A piano placed against a wall in a circulation area in the dining hall also impede mobility. There are no textural clues on the corridors to guide students as to the location of doors and staircases. Students have a hard time moving about quickly. Another barrier on the corridor is the exposed end of the metal tube of the railing. Students sometimes hit against them as they move about.

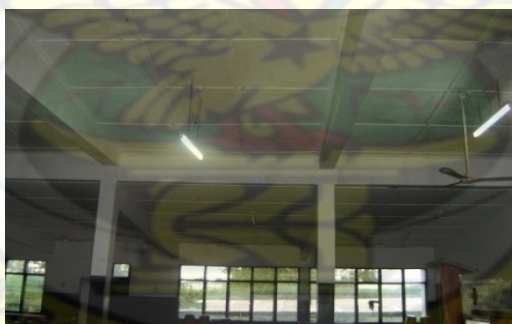
Fig.45- Structural columns in dining hall

The dining hall is able to seat close to 300 (three) hundred students. There are aisles for good movement however the first barrier mentioned and observed is the lack of tactile clues on the ground to warn students of the many exposed structural columns in the dining hall space. Students could miss their way and hit their heads against these. Also there are no textural clues on the walls of the dining hall for enhanced movement of students.

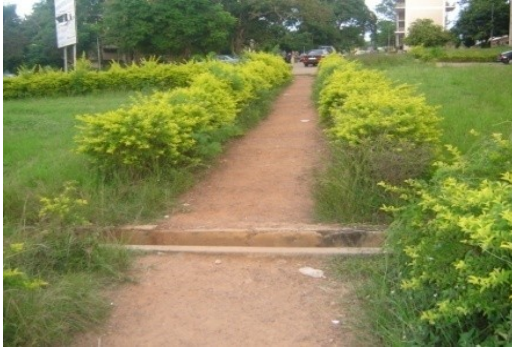
Fig.57-Gutter cutting through
walkway to College of Pharmacy

One big architectural barrier that would inhibit the easy physical accessibility of visually impaired students on campus is the issue of uncovered drains (gutters). The drains on the shoulders of almost all roads in the staff residential area of the university are not covered. Visually impaired students can fall into such openings. The drains on the shoulders of the road leading from the College of Agriculture Junction to the Central Classroom Block (C.C.B) are not covered. It is the same, along the road from Queens Hall to Independence Hall. Some drains are covered fully while others are broken. The drains along the road from the main administration block to the teaching area also present the same problem. For the proposed school all drains will be covered.

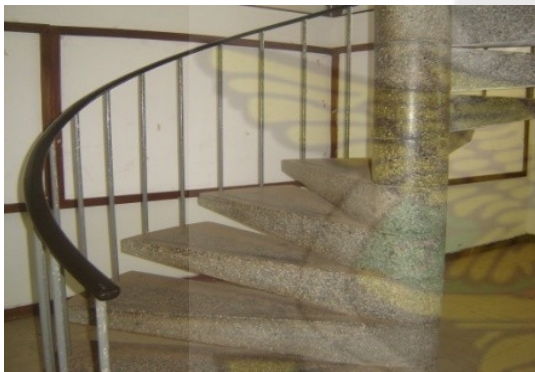
Fig.59-Spiral stair at Studio block
(College of Architecture)

The spiral staircase in the exhibition hall of the College of Architecture main studio block and the Great hall would pose difficulties in safe accessibility for sight impaired students.

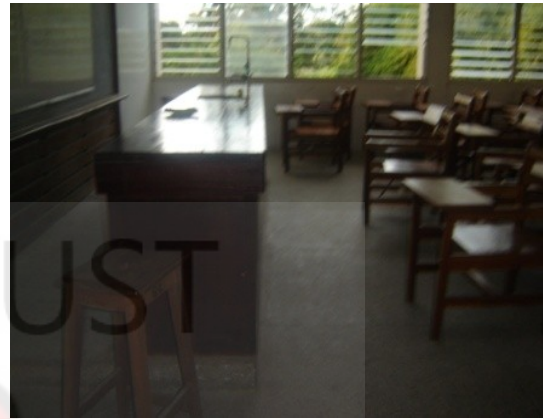
Fig.64-Raised floor at front of classroom (College of Science)

surrounding wall. Some classrooms had the blackboard area on a raised floor. Visually impaired students could hit their feet against this as they move in front of the classroom to find a seat.

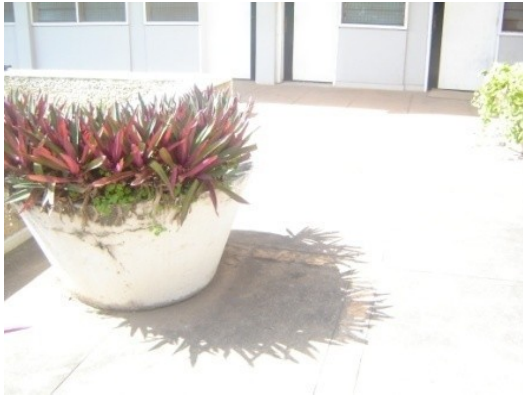
Fig.65-Potted plant in circulation area
(Faculty of Architecture)

In some instances, dustbins have been placed along corridors in the line of movement. This was the case at the College of Science block. Also in some cases, free standing structural columns were in the line of movement of circulation areas. There were no tactile warning clues either on the wall or elsewhere. In other instances, potted plants were also not placed well in circulation areas. This barrier was present at the main Library foyer, Great hall and the College of Architecture.

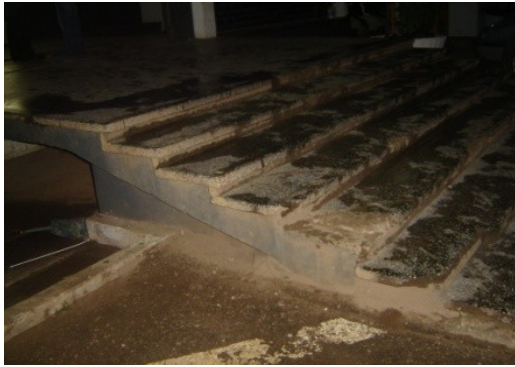
Fig.67-Entrance steps without tactile warnings (Republic Hall)

One architectural barrier associated with the halls of residences is the lack of tactile clues on staircases. The halls include the Independence, Africa, Republic, Unity and Queens. Also connecting walkways are generally without guard rails. This was the case at Queens hall, Africa hall, Republic hall, Unity hall among others.

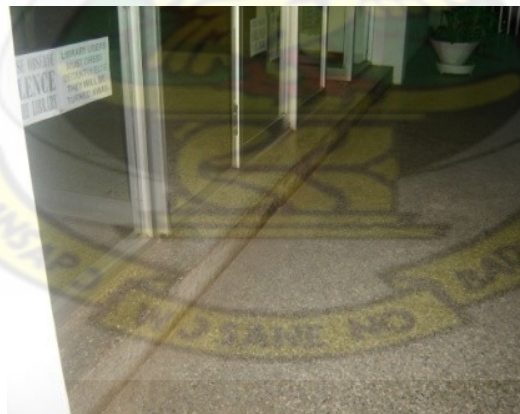
Fig.69-Raised floor level of main entrance

The library foyer with its free standing structural columns in the line of movement of persons presents the first obstacle. There are no tactile warnings to prompt a visually impaired person. The mushroom columns at the old library block. The main entrance door into the library is not on the same level with the foyer. There is no entrance ramp either. Students with visual impairments would find the 200mm door threshold a barrier.

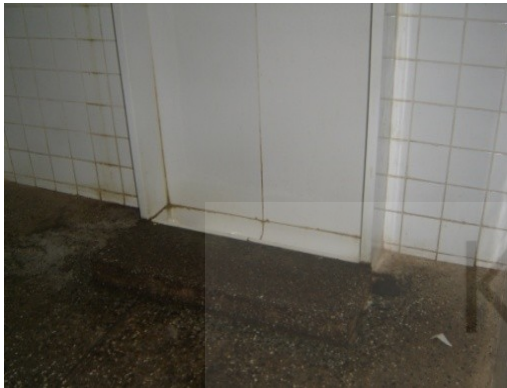
Fig.70-Raised floor level of urinal

Another obstacle is the raised standing concrete platform (200mm) for the urinal.

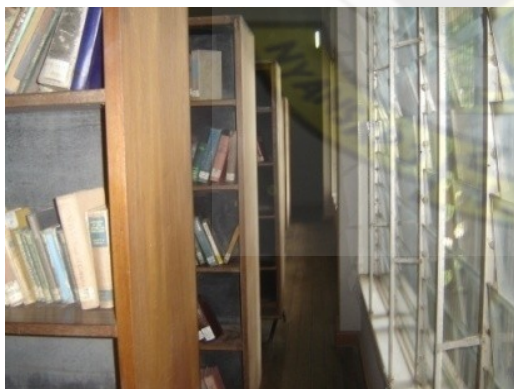
Fig.72-Aisles between wall and bookshelves

The layout of the book shelves and the small aisles between them and the external wall will present obstacles. Sight impaired students would find it difficult to orient themselves between the shelves and the narrow aisles (less than 500mm). Aisles between bookshelves are not big enough (less than 1500mm). There are also no tactile clues on the ground to know the location of the shelves from the reading areas.

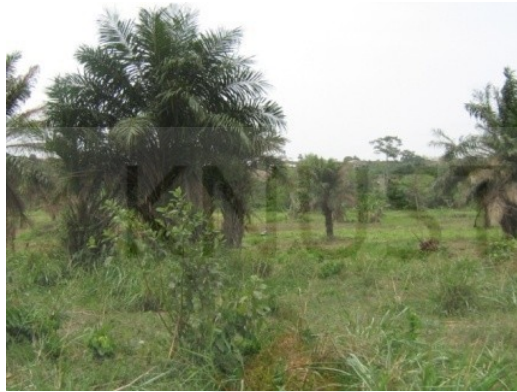
Fig.78-Site is gently undulating

The macro climate of the proposed site is tropical in nature (hot and humid). The green nature of vegetation (shrubs, grasses, trees) suggests a rainy terrain. The site slopes generally from the north to the south. However, from east to west, the land is slightly undulating.

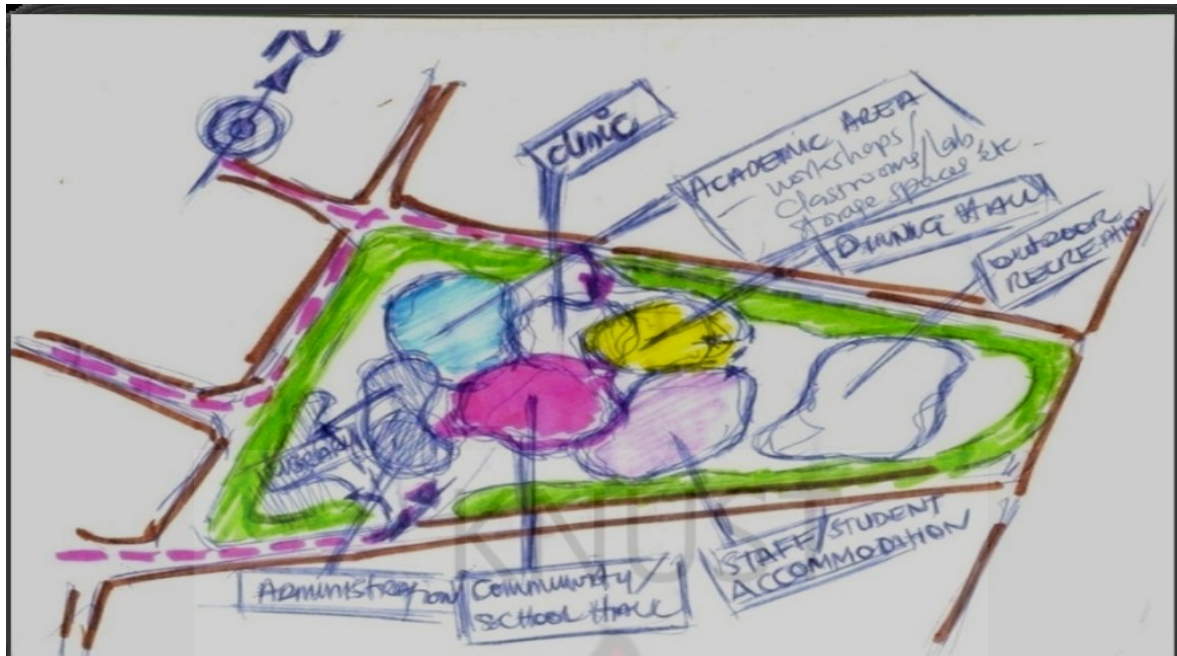
Fig.82-Conceptual site planning 1 (option 1, selected)

Some of the merits of conceptual site Planning 1 is that it reinforces philosophy, main access is at a good location, service access is at a good location and it reinforces the concept of proximity. Its demerits were minimal.

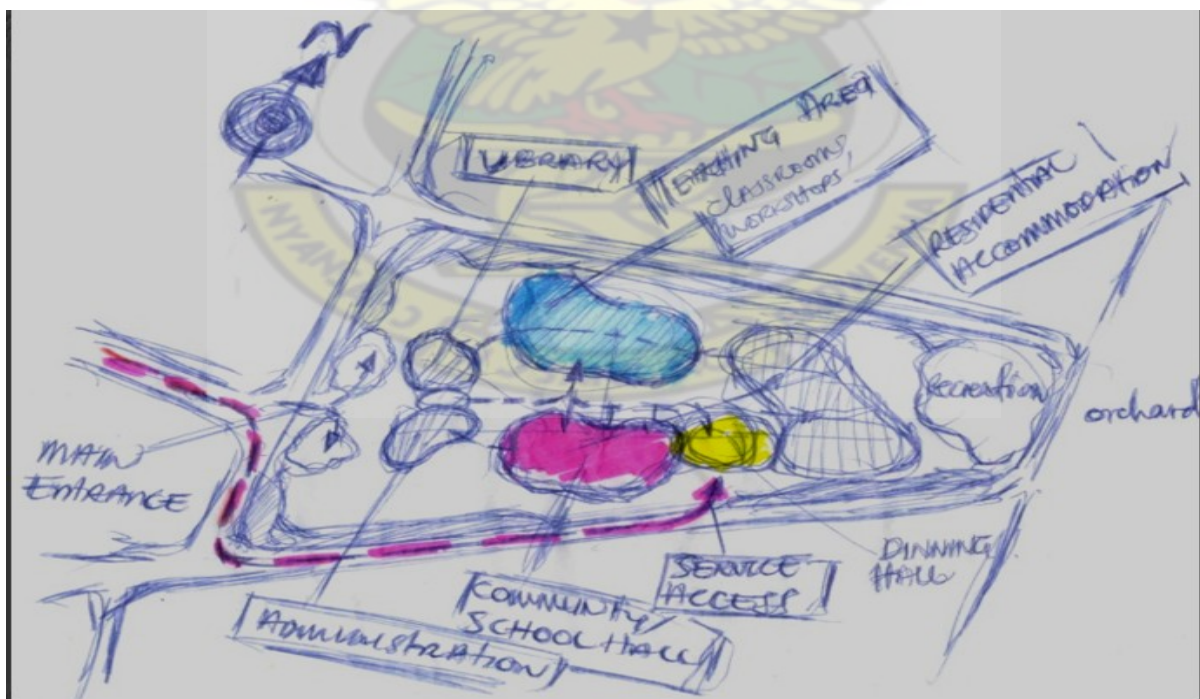
Fig. 83- Conceptual site planning II

With option 2, the demerits were found to be more than the merits. Some of the demerits included; main access road is too busy for a main entrance and the layout doesn't reinforce the philosophy where the community and school hall has to be in the centre.
