ASSESSMENT OF RISK PRIORITY NUMBER OF 2.5 MW POLYCRYSTALLINE SILICON PHOTOVOLTAIC POWER PLANT AT NAVRONGO, GHANA IN SUB-SAHARA AFRICA.

A Thesis Submitted to the Department of Mechanical Engineering, Kwame Nkrumah University of Science and Technology, Kumasi in partial fulfilment of the requirement for the award degree of

MASTER OF PHILOSOPHY IN MECHANICAL ENGINEERING

April 2019

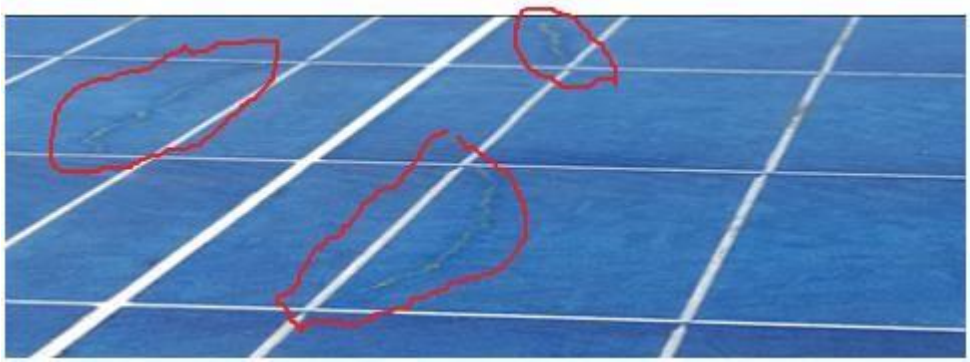
Plate 4- 2: cell cracks/ cell snail tracks

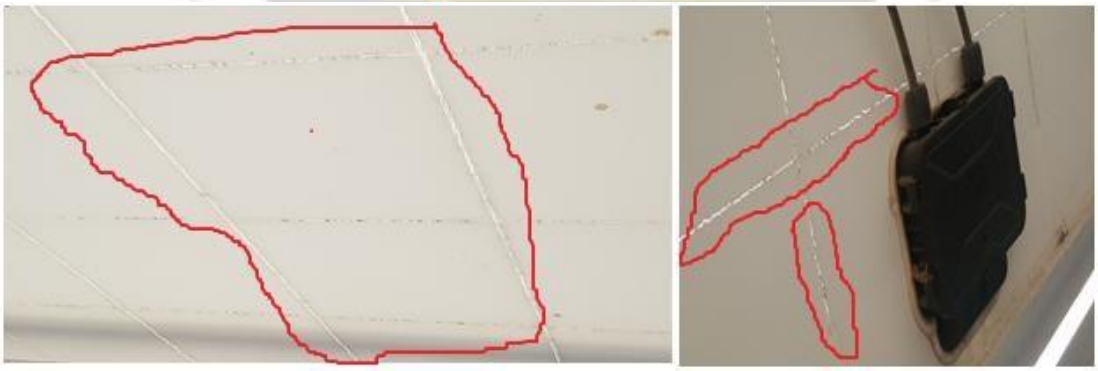
Plate 4- 3: back sheet cracks between cells

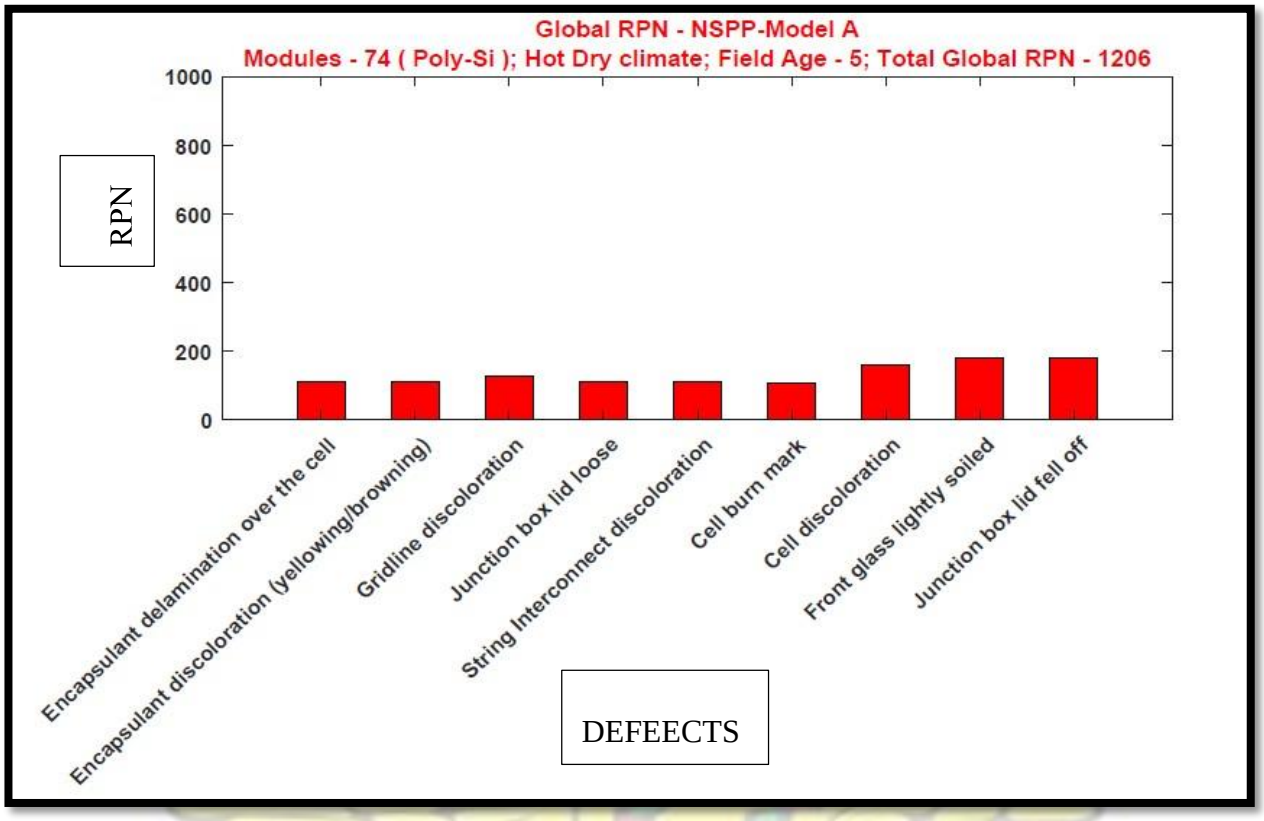
Figure 5- 1: Global RPN Plot for Model- A using occurrence, detection and severity

The defects that are present on the 74 observed modules of model A is presented in figure 5-1. It was realized that;

iv. The global RPN for this model A was determined automatically with the software as 1206 as shown in **figure 5-1**. This value represents the addition of all the RPN of failures observed on the field for the Model. This information can lead to grading of the PV plant and the financial risk computations of the modules for decision making for future products.

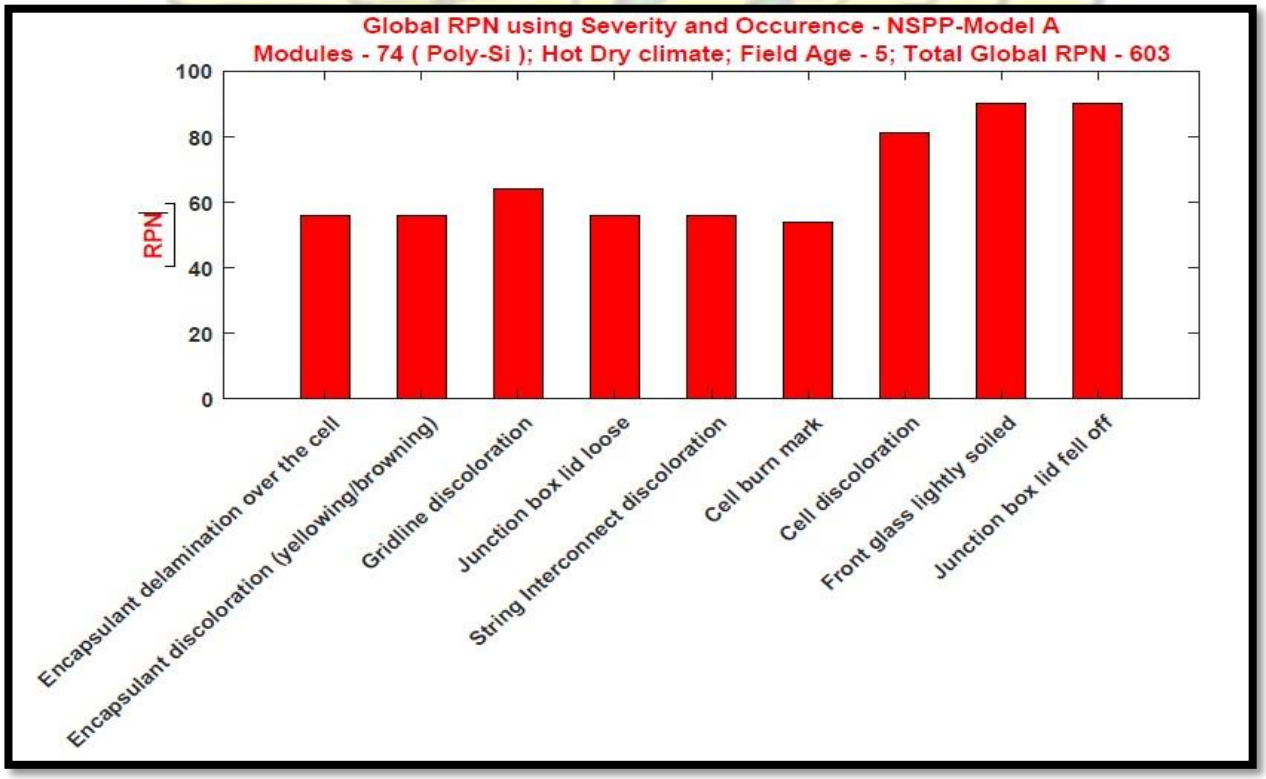
Figure 5- 2: Global RPN plot using Severity and Occurrence for Model- A.

Moreover, considering all the failures can easily be detected by physical observation, the Global RPN was again computed using the occurrence and severity neglecting detection as indicated in figure 5-2. The following observations were made from the plot;

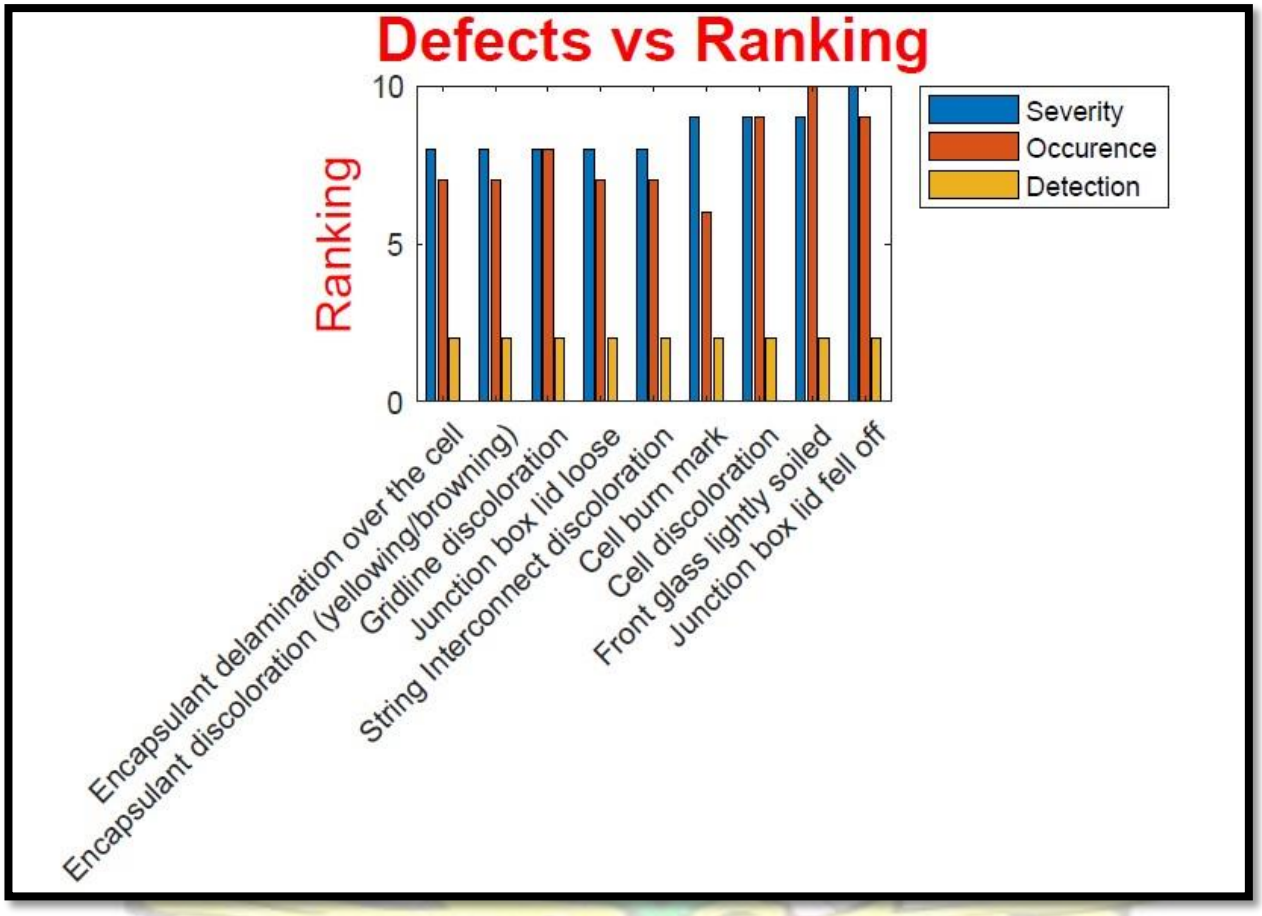
i. All the failures present have detection rank of two as explained earlier.

ii. Front glass slightly soiled can be seen to occur more frequently among the modules since it has the highest occurrence value. This can be associated with the fact that the site is located in an environment with relatively dusty particles in the atmosphere.

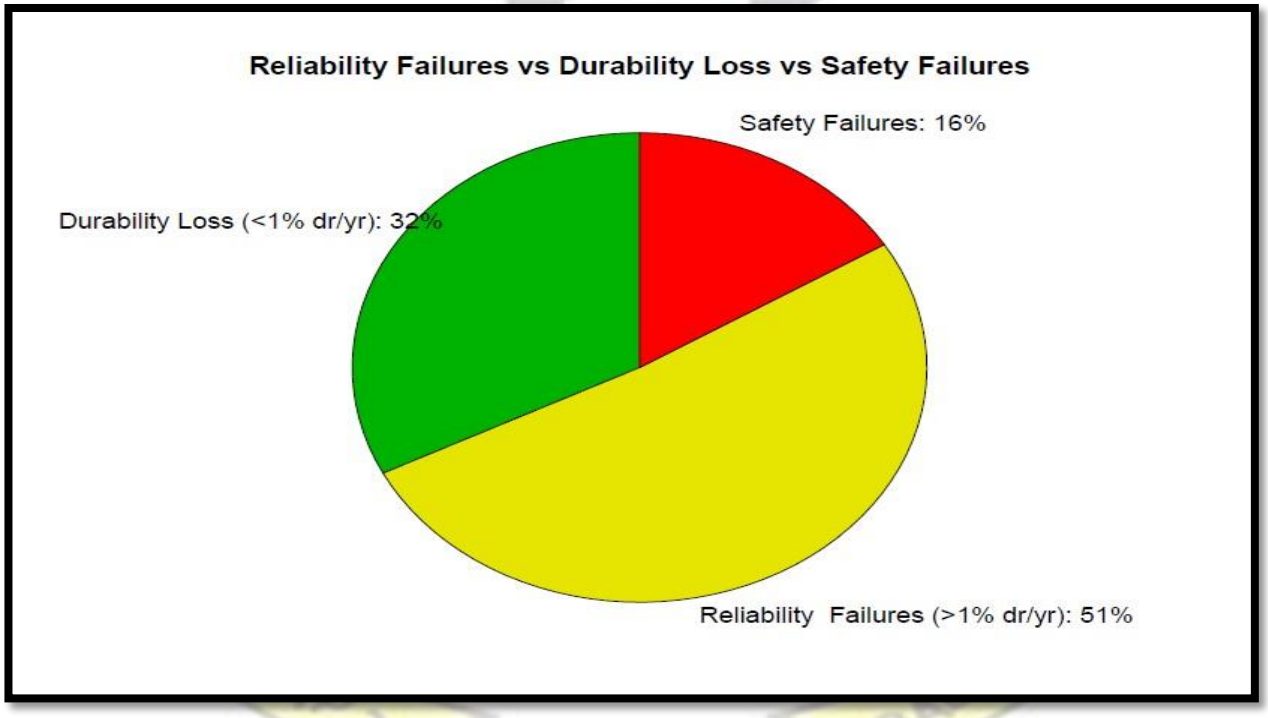
Figure 5- 4: Pie Chart of Reliability, Durability and Safety Issues for Model- A

The proportion occupied by Durability loss, Reliability failures and safety failures is represented graphically using the pie chart shown in figure 5-4. This helps to quantify the percentage of modules that need urgent replacement to avert property loss and personnel threat or loss in the PV plant. Also, percentage of modules which are still functioning well with power degradation rates less than 1%/ year (Durability loss) are established whilst those which can qualify for warranty for losing power at a rate of more than 1%/ year (Reliability failures) are known.

iii. Fifty-one percent (51%) of modules have degradation rates higher than the manufacturer's usual warranty of 1%/ year as indicated in figure 5-4 and needs to be replaced to maximize the performance of the plant.

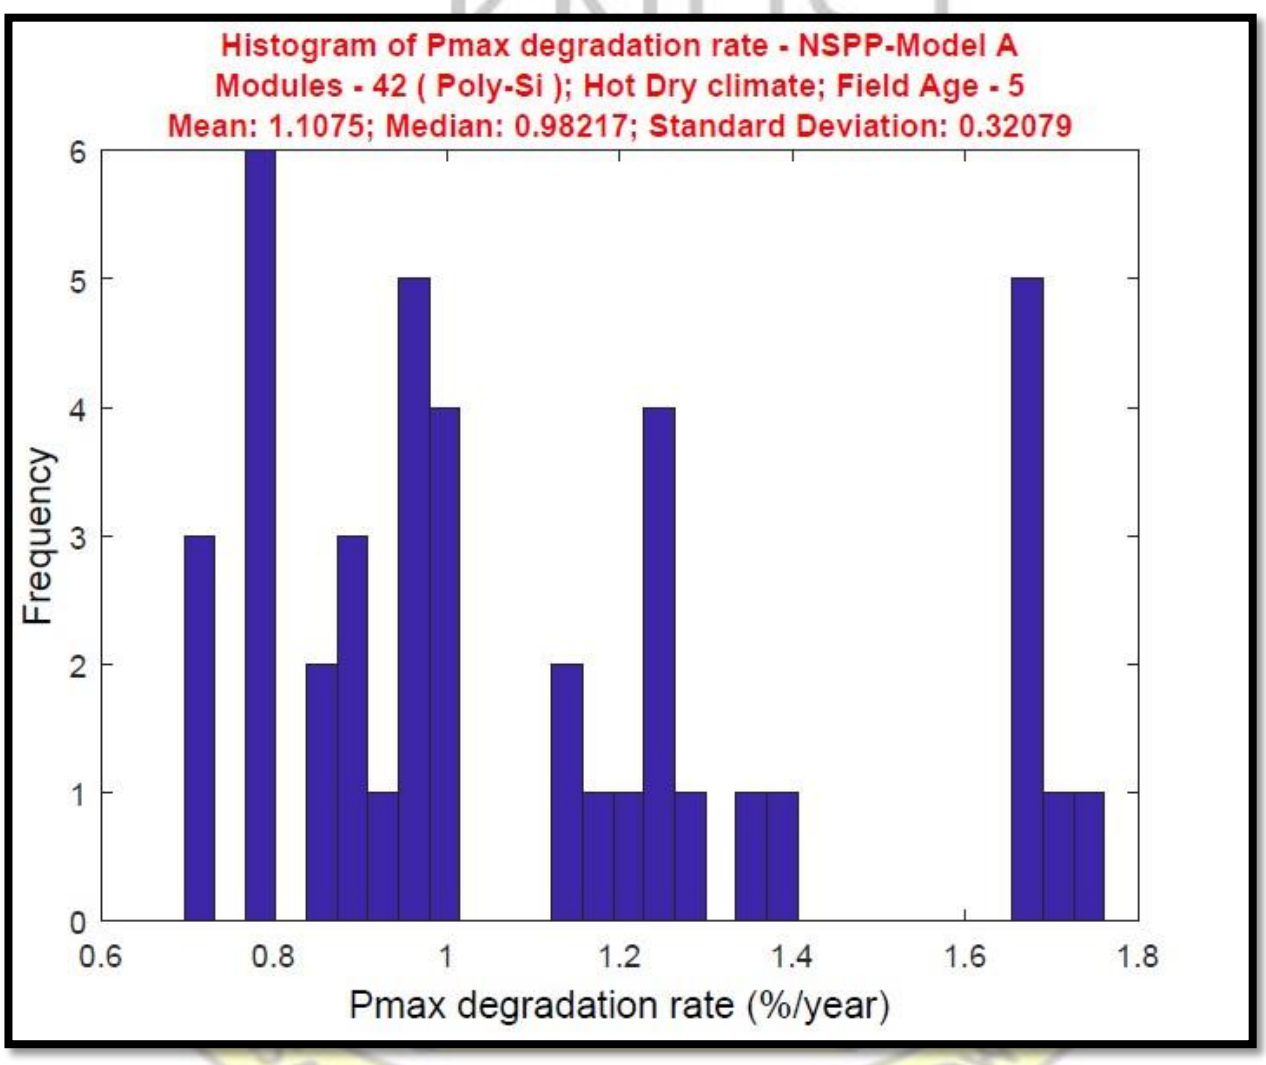
Figure 5- 5: Histogram of Pmax degradation rate for Model- A

The histogram shown in Figure 5-5 provides the average and median degradation rate of power for Model-A. The following inferences could be deduced from the plot;

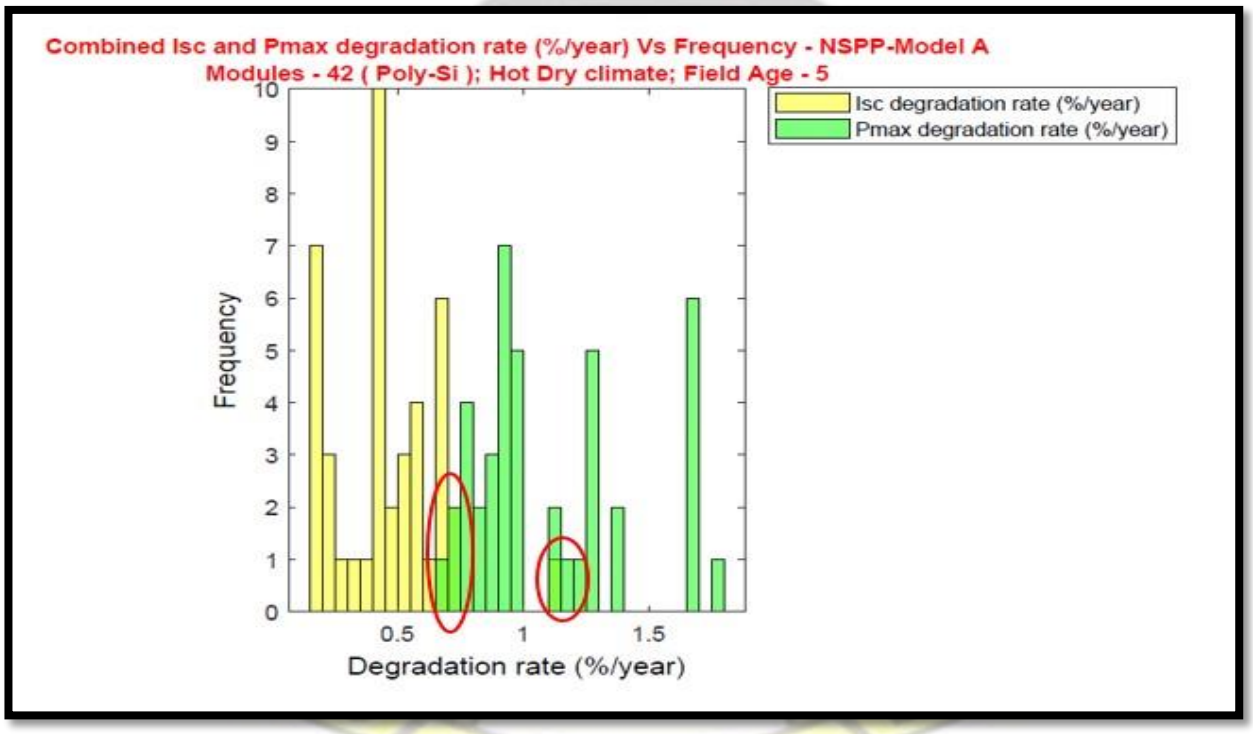
Figure 5- 8: Combined Histogram of Isc and Pmax degradation rate for ModelA.

i. It is evident from **figure 5-8** that, there is an overlap between Isc and Pmax degradation rates around 0.6%/year to 0.7%/year and around 1.2%/year to 1.25%/year, which suggests that degradation of Isc is affecting Pmax.

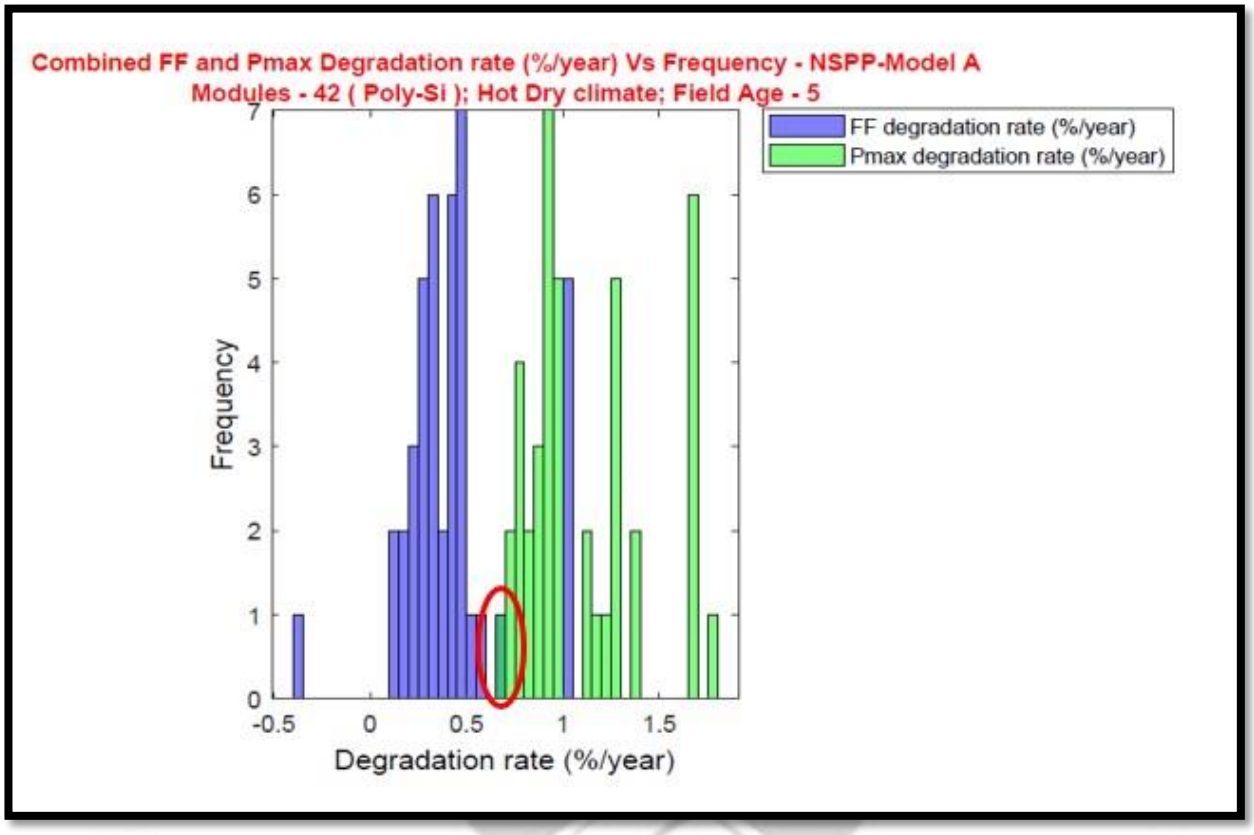
Figure 5- 9: Combined Histogram of FF and Pmax degradation rate for Model-A

ii. Again, it can be noticed that there is an overlap between FF degradation rates and Pmax degradation rates in **figure 5-9** around 0.6%/year, which also denotes even FF degradation has an influence on Pmax degradation but not in the same scale as Isc degradation, which can be identified from the frequency or count of modules, affected.

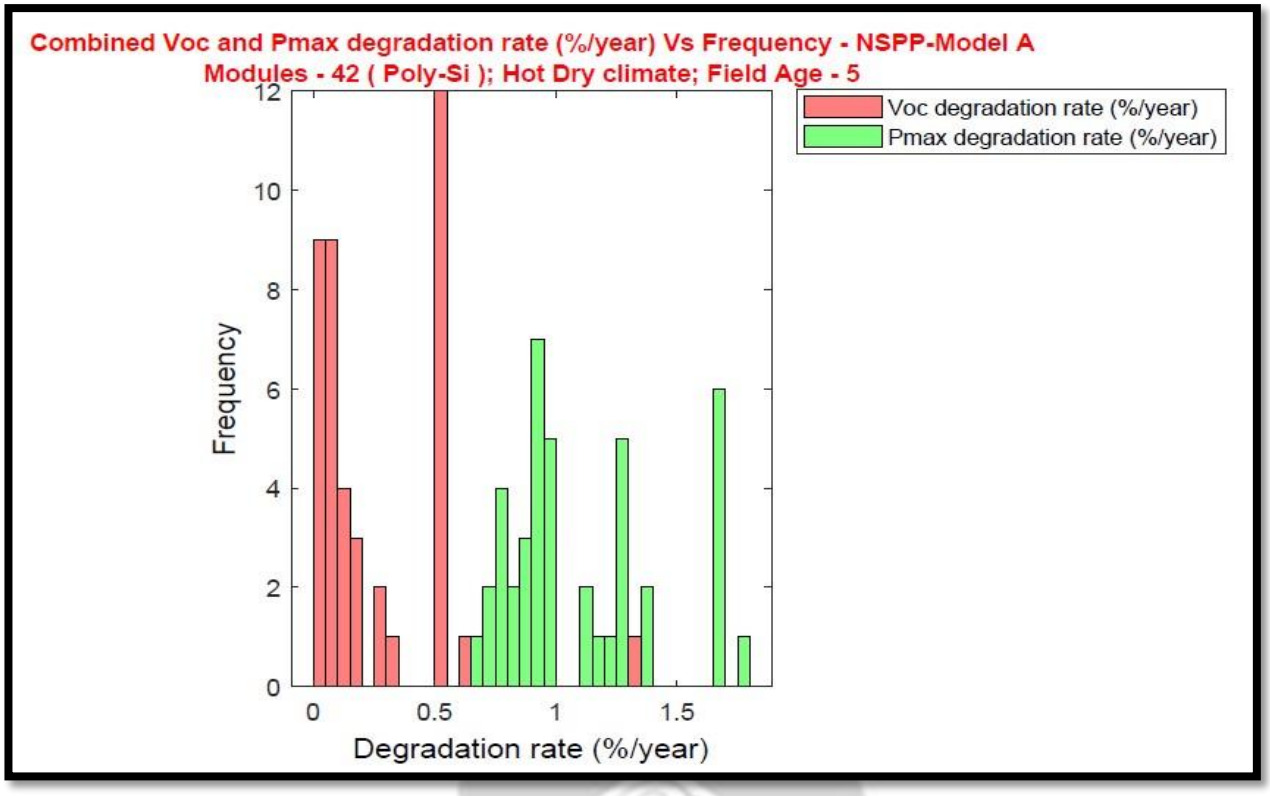
Figure 5- 10: Combined Histogram of Voc and Pmax degradation rate for Model-A

iii. In contrast, there is no overlap between V_{oc} and Pmax degradation rates as shown in **figure 5-10**. This suggests that degradation of Voc is not affecting degradation of Pmax.

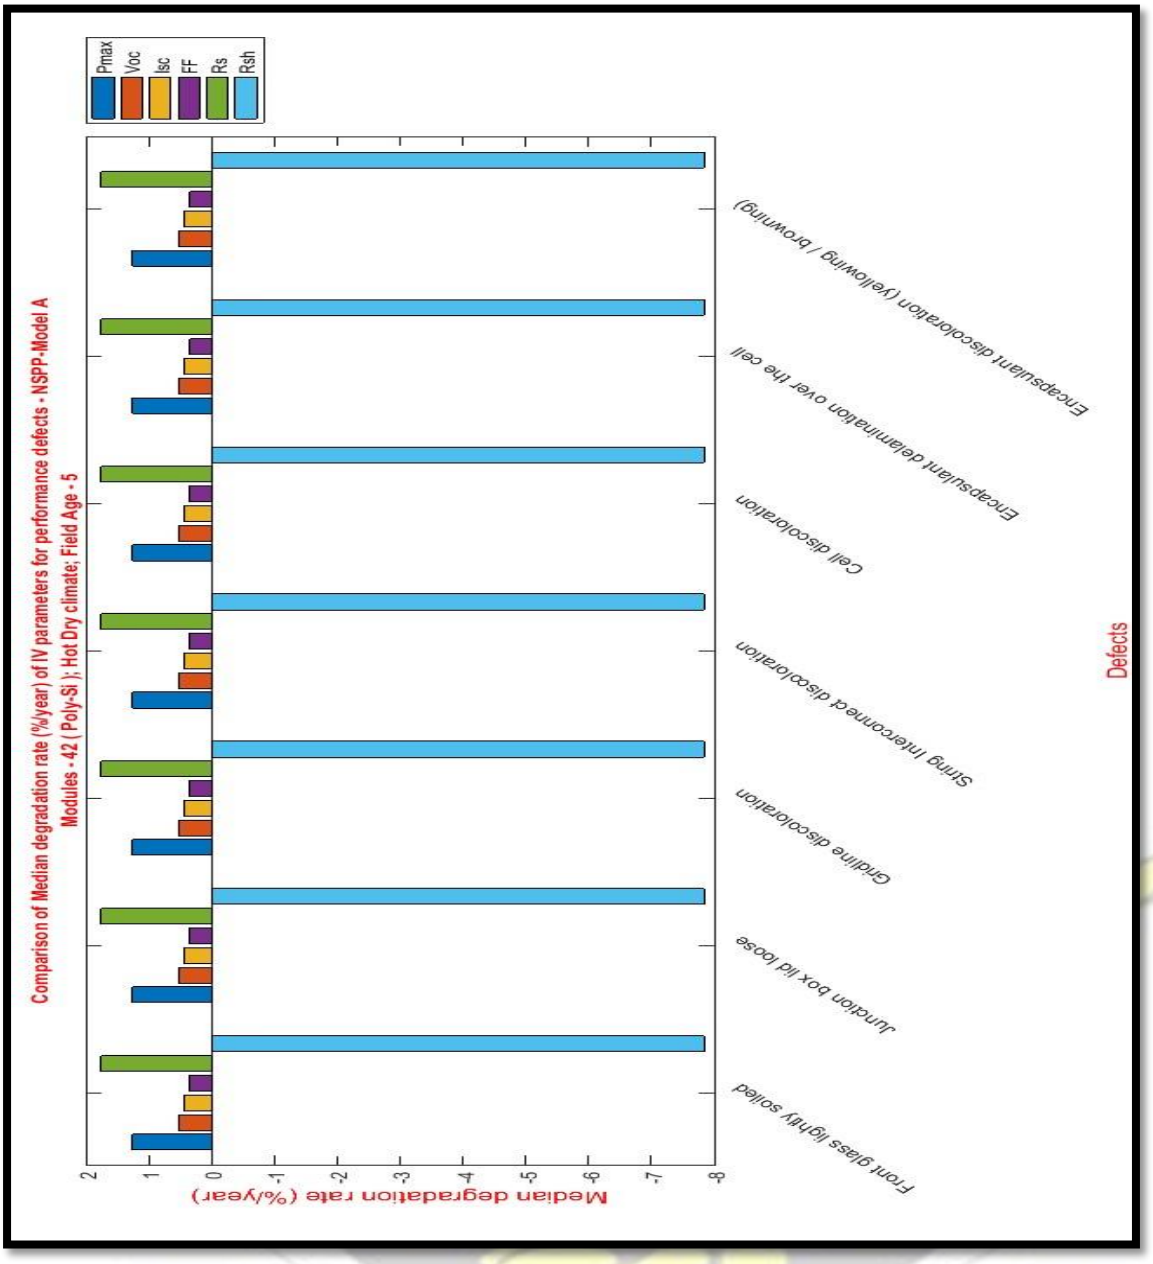
Figure 5- 11: Comparison Plot of Median degradation rates of I-V Parameters for Model-A Discussions

i. It is evident in figure 5-11, that for Gridline discoloration and string interconnect discoloration, the order of parameters affecting Pmax degradation will be as follows; Rs > Voc=Isc> FF >> Rsh. ii. In addition, Rs has higher values for all the defects, which suggests that it affects degradation of Pmax using the defects.

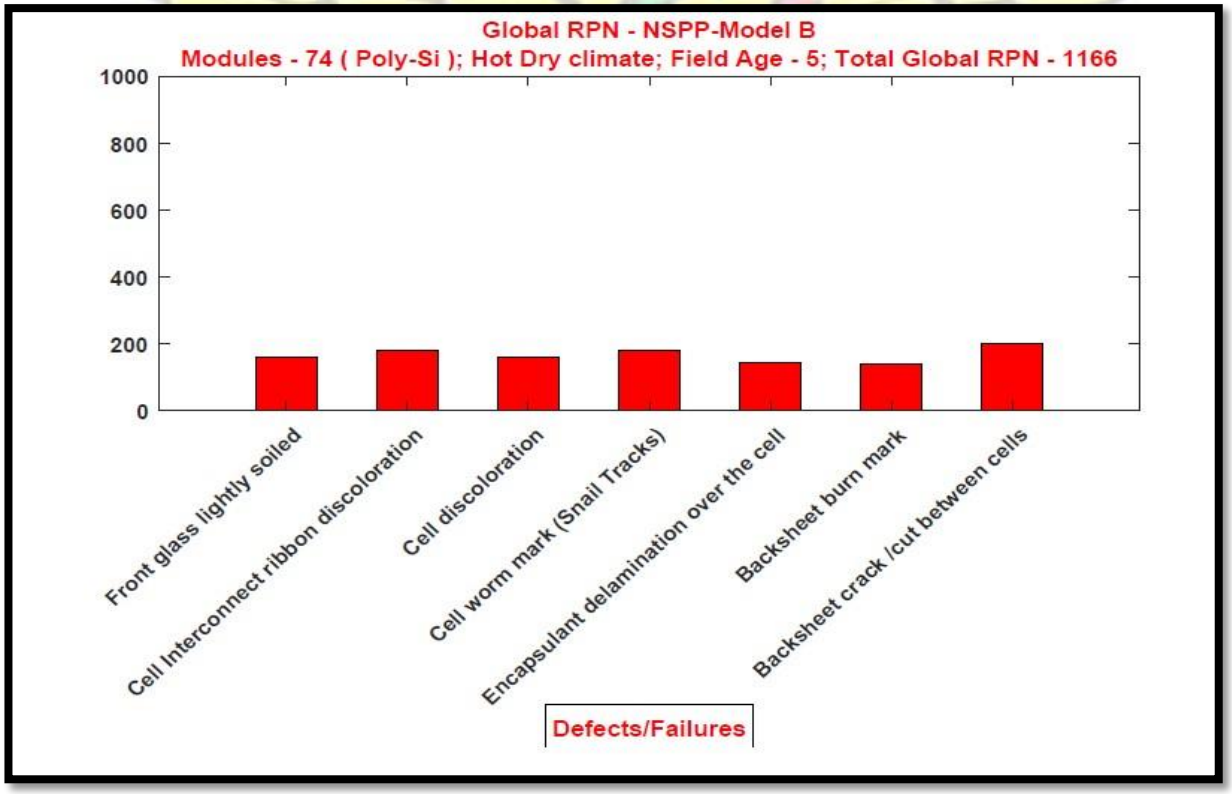
Figure 5- 12: Global RPN Plot for Model- B

The defects that are present in 74 modules of model B is shown in figure 5-12 above.

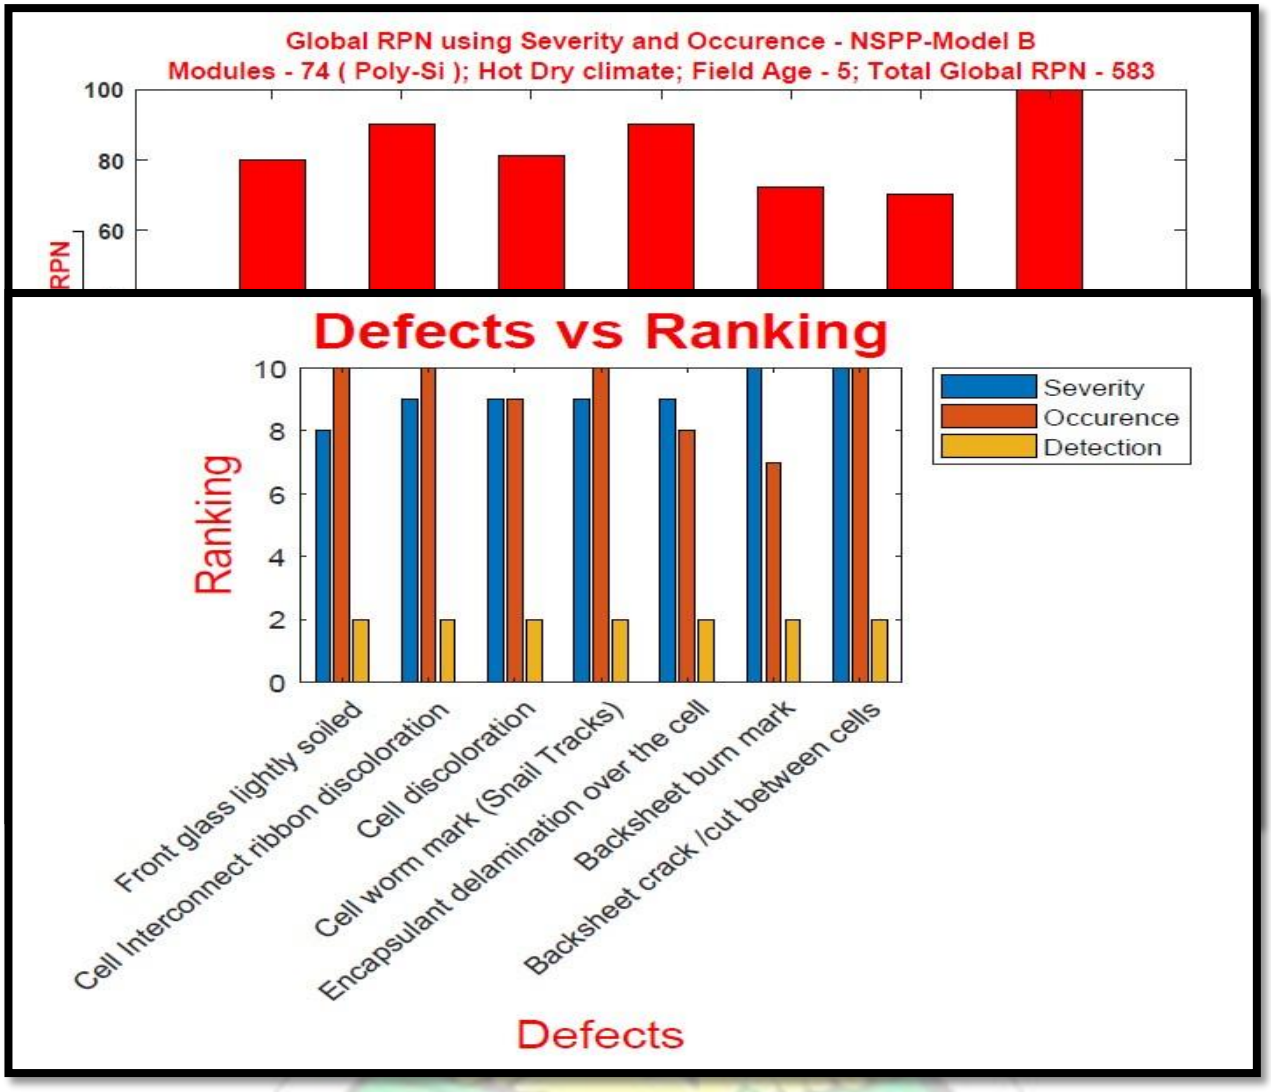
Figure 5- 13: Global RPN Plot Using Severity and Occurrence for Model- B Discussions

i. It can be deduced from **figure 5-13** that the RPN values of the defects were halved.

ii. This could be due to the visual inspection that was used in the collection of the data and was assigned a detection value of two (**see Appendix D for Detection ranking)**. For instance, the RPN value of backsheet crack/ cut between cells is 100. This provides a better view on the RPN value instead of 200 as depicted in figure 5-12.

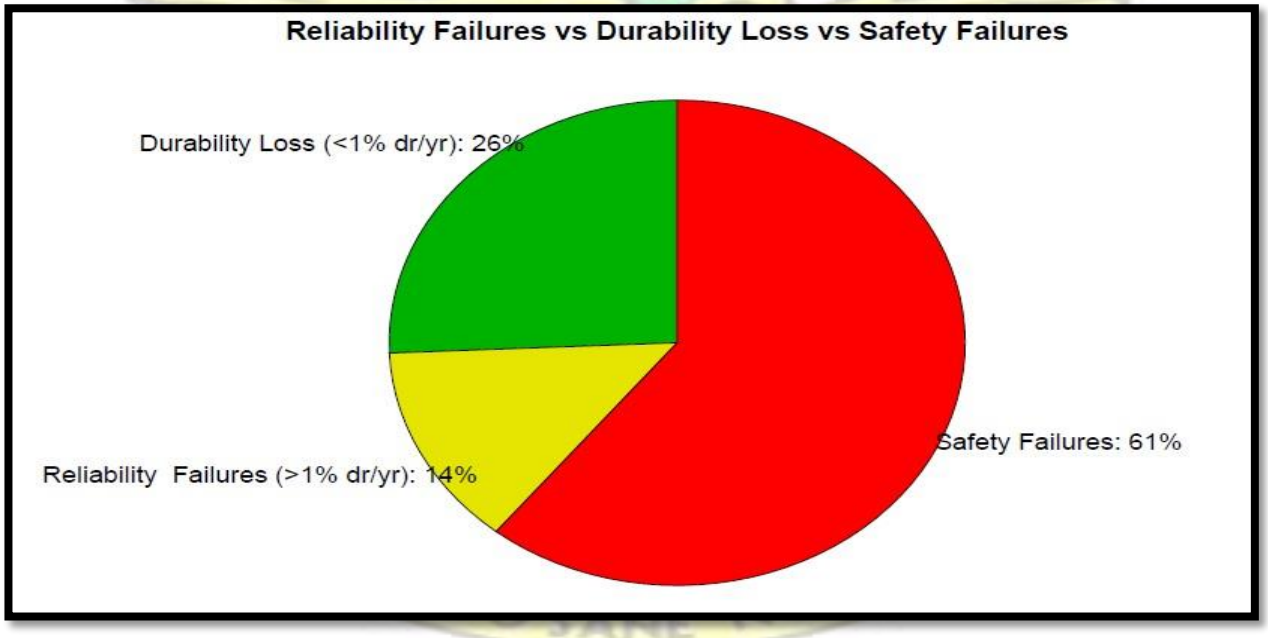
i. Twenty-six percent (26%) of the modules meet the manufacturer's warranty and are safe to give adequate power output. ii. Sixty-one percent (61%) of modules posing safety issues to users and need urgent maintenance attention to avert the threat.

iii. Fourteen percent (14%) of modules are beyond the manufacturer's usual warranty of 1%/ year degradation rate as indicated in figure 5-15 and needs to be replaced for optimum performance from the modules.

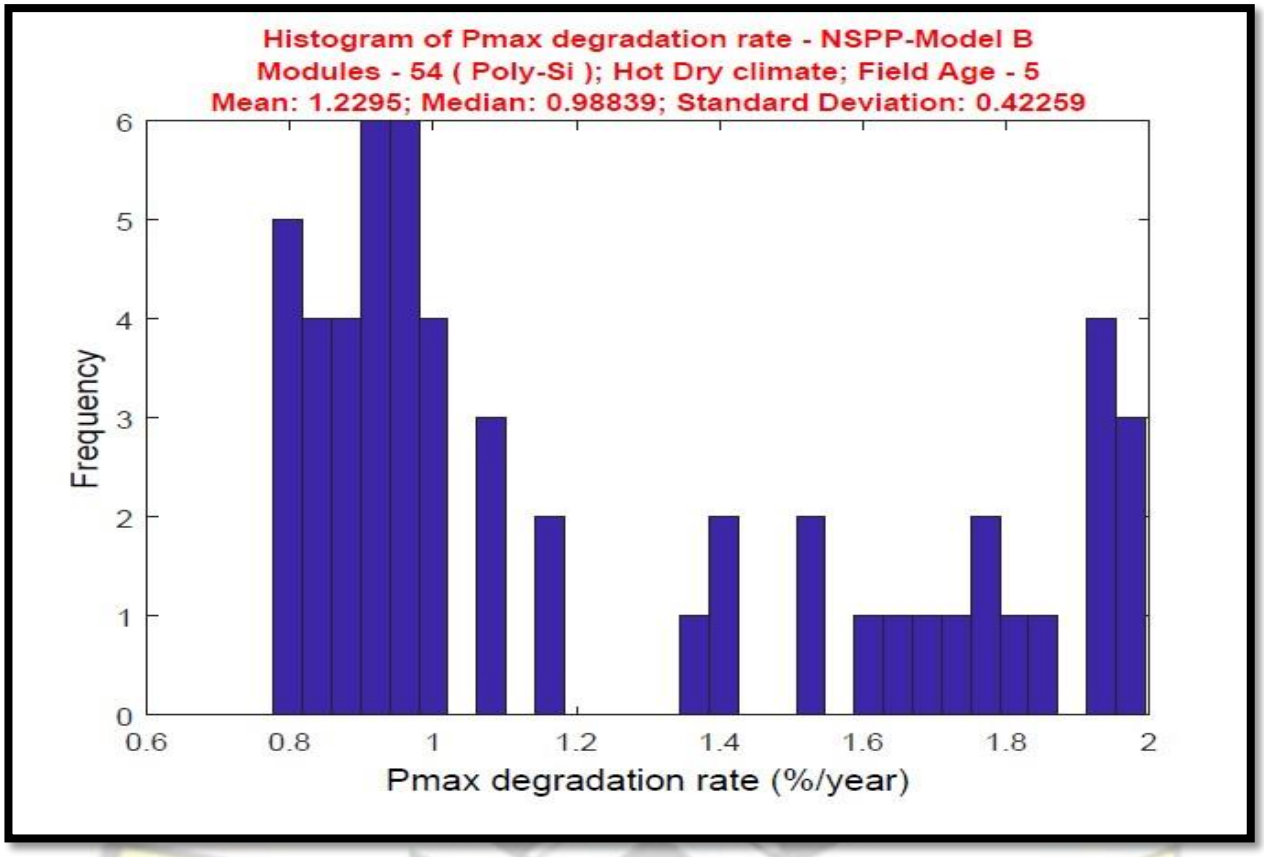
The histogram presented in figure 5-16 shows the average and median degradation rate of power for Model-B.

i. The average power degradation rate for Model B is calculated as 1.23%/year. ii. Out of the 54 modules considered, 29 modules (approximately 54%) meet the maximum degradation rate of 1.0%/year typically provided by the module manufactures.

iii. The median and average degradations rates are quite close (that is, 1.23%/year vs. 0.99%/year), indicating a tight quality management system during production.

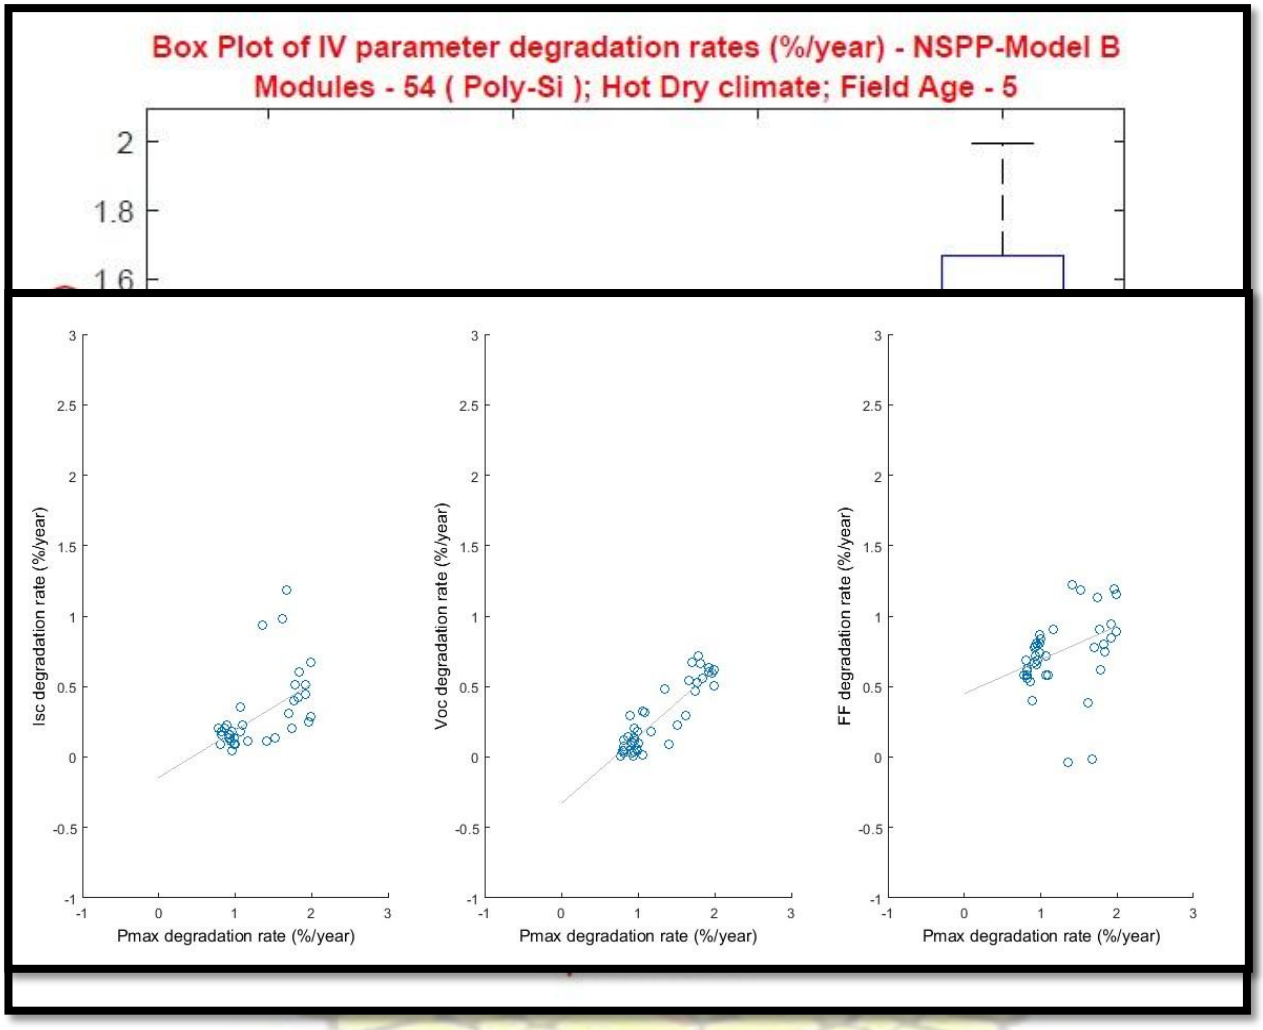
Figure 5- 17: Box Plot of I-V Parameters degradation rates for Model- B

i. It is apparent from figure 5-17 that, FF degradation rate is affecting Pmax degradation rate (%/year). ii. The order of IV parameters affecting Pmax degradation rate (%/year) is as follows: FF > Isc > Voc.

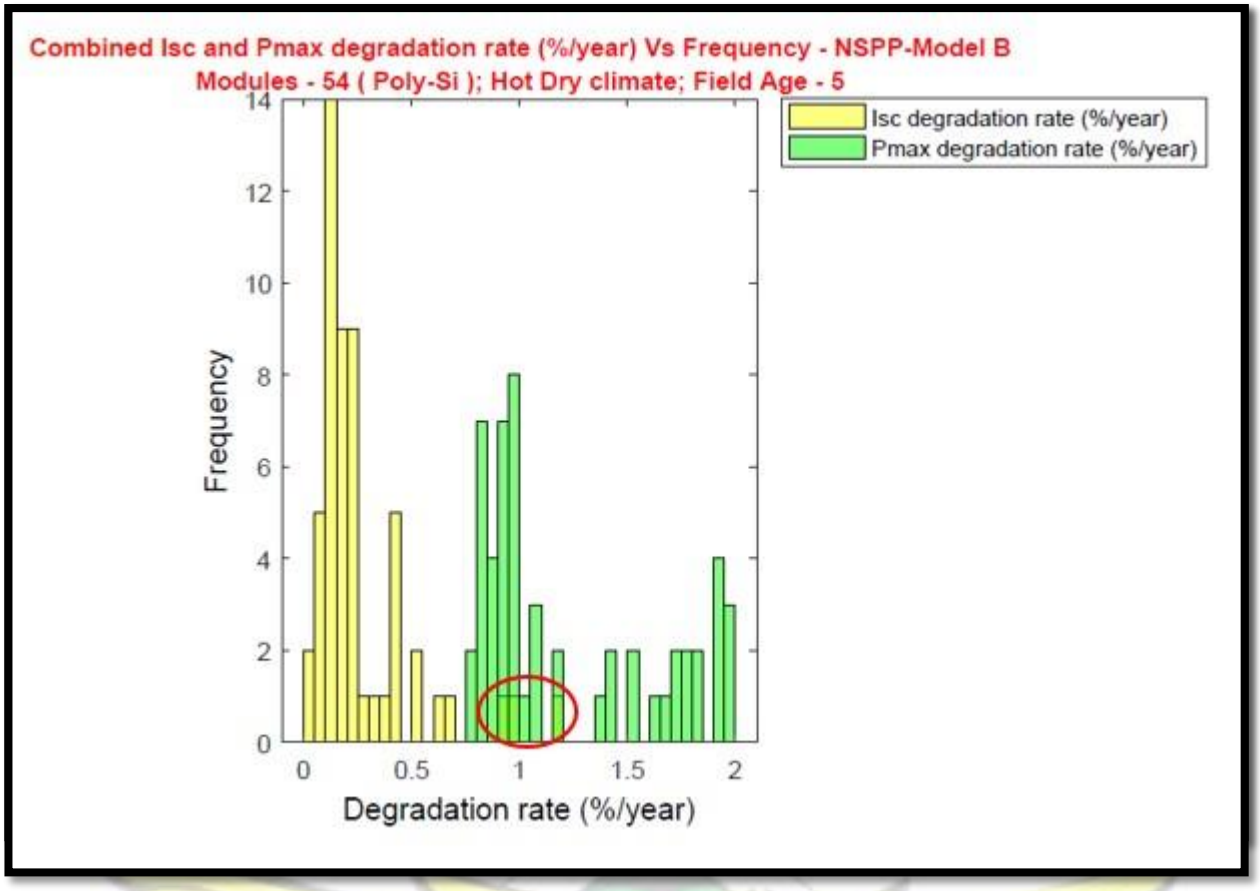
Figure 5- 20: Combined Histogram of FF and Pmax degradation rate for Model- B

i. It is evident from **figure 5-20** that, there is an overlap between FF and Pmax degradation rates around 0.8%/year to 1.2%/year, which suggests that degradation of Isc is affecting Pmax.

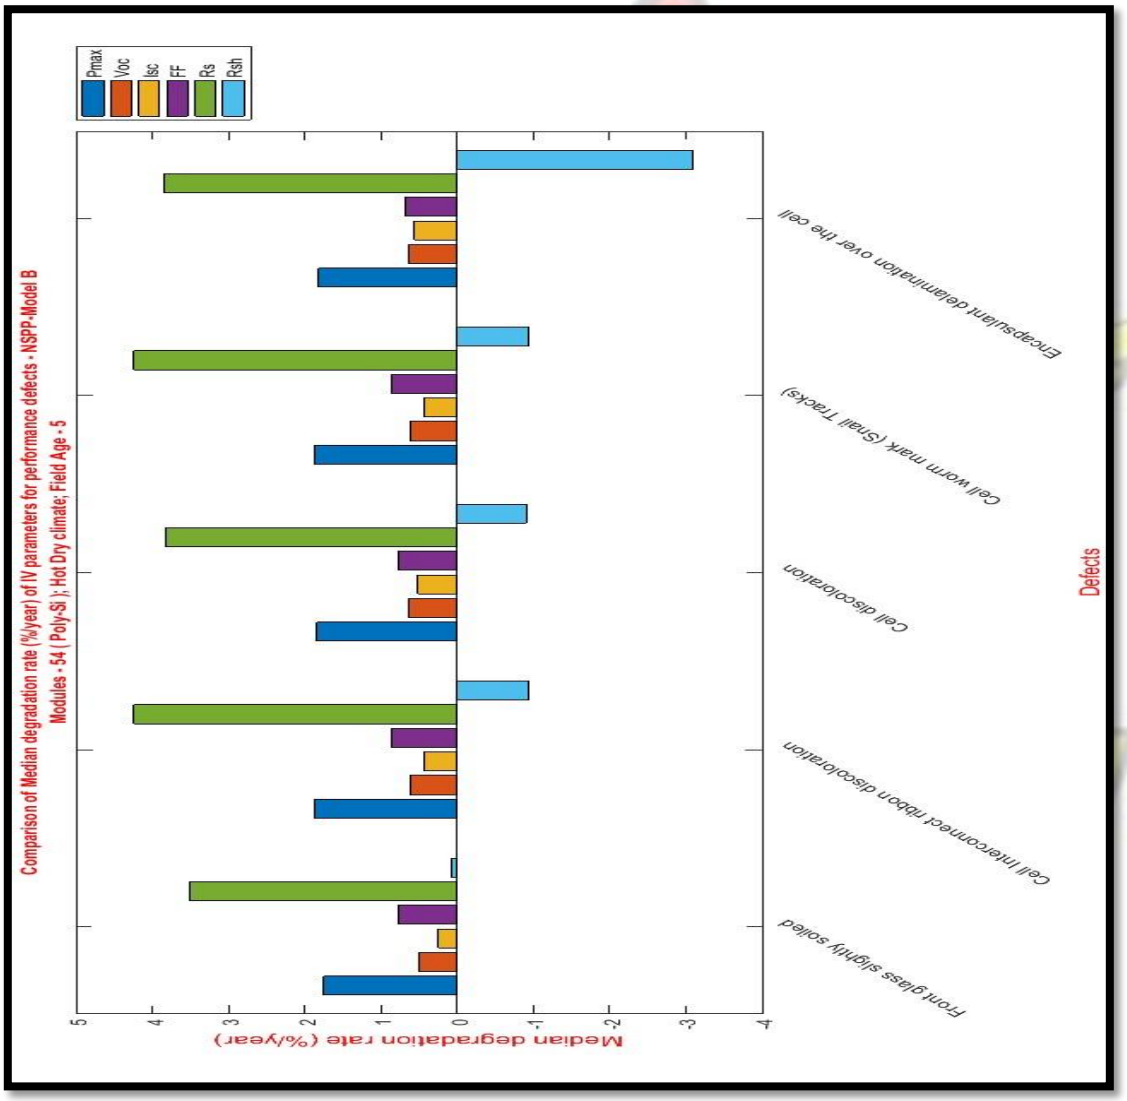
Figure 5- 22: Comparison Plot of Median degradation rates of I-V Parameters for Model-B

i. It can be deduced from figure 5-22 that, median FF degradation ratse has the highest values for all the defects excluding the Rs and Rsh values. This shows that FF degradation rate influences the degradation of Pmax for the defects shown.

ii. In addition, the order of IV parameters for each defect can be determined from the plot. For instance, cell discoloration, has the order of parameters affecting Pmax degradation as follows; Rs >>FF>Voc >Isc > Rsh.

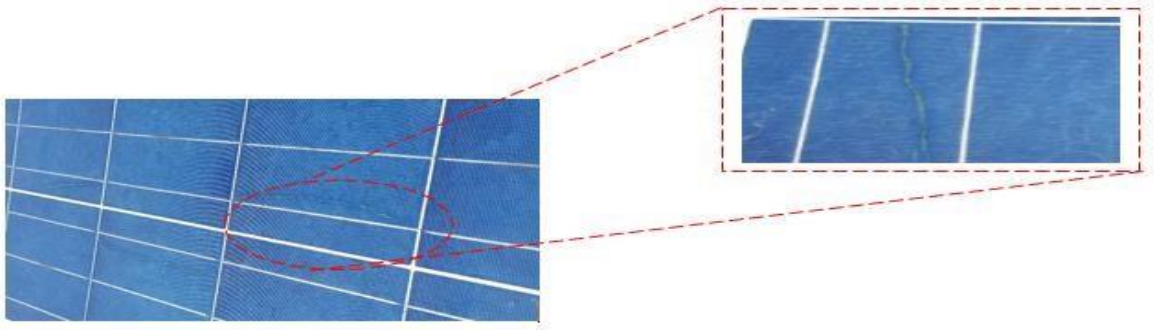
Cell crack/ cell snail tracks

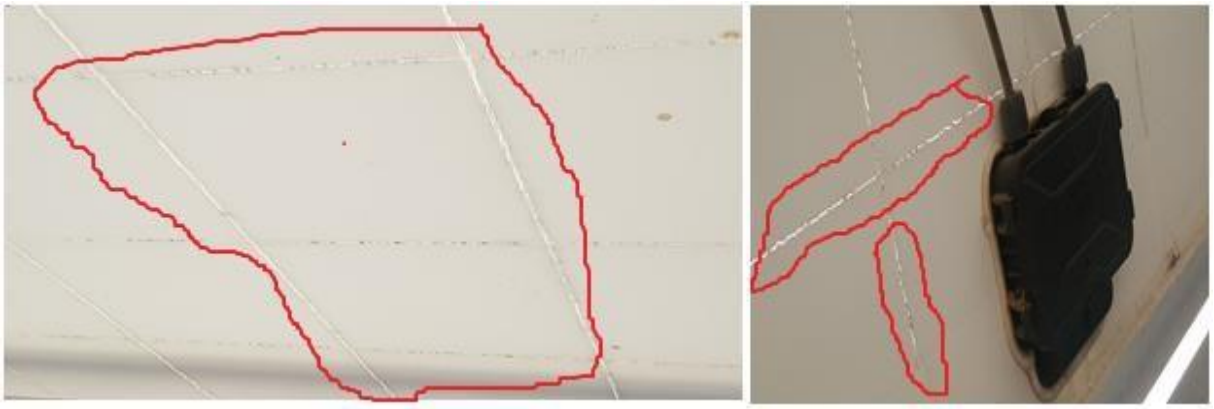
Back sheet cracks between cells

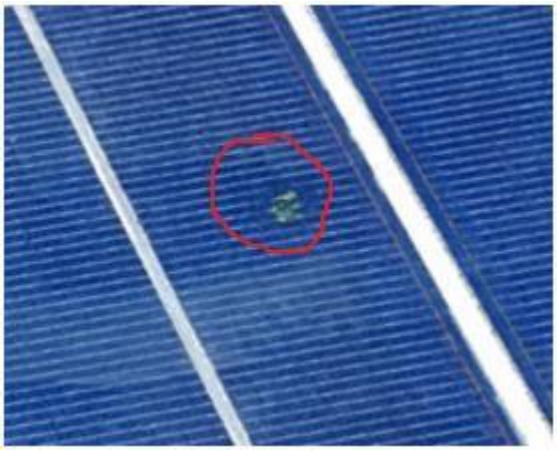
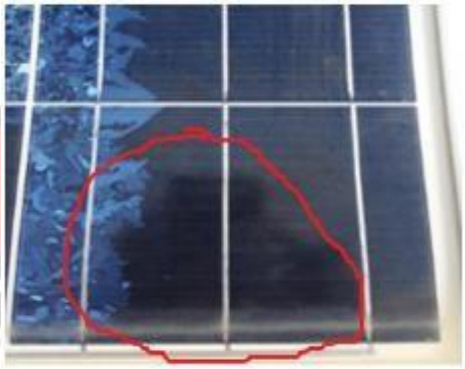
Dent/ shattered glass spot cell discoloration and browning that can lead to hotspot

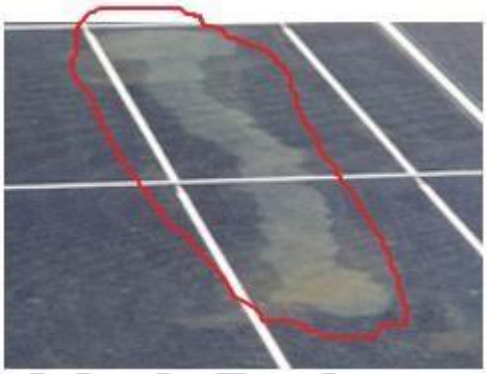
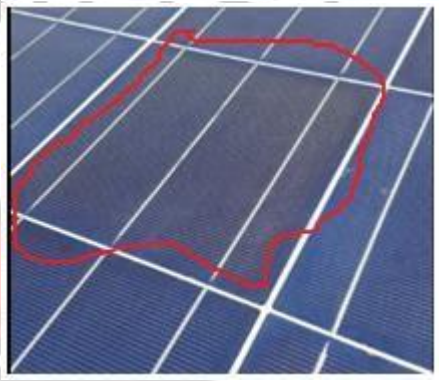
Moisture intuition leading to delamination Cell browning/ discoloration

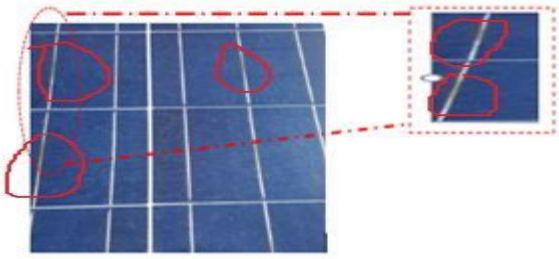
Back sheet delamination leading to cracks cell interconnect discoloration

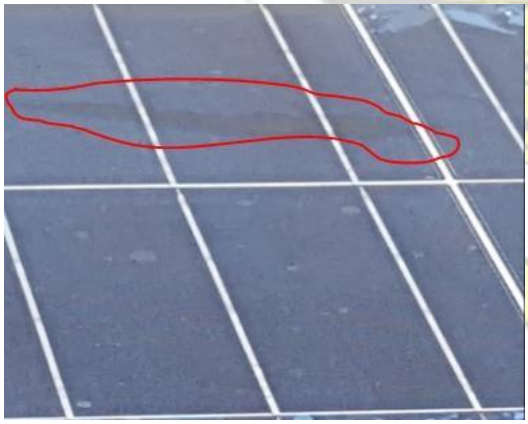
Cell burn marks

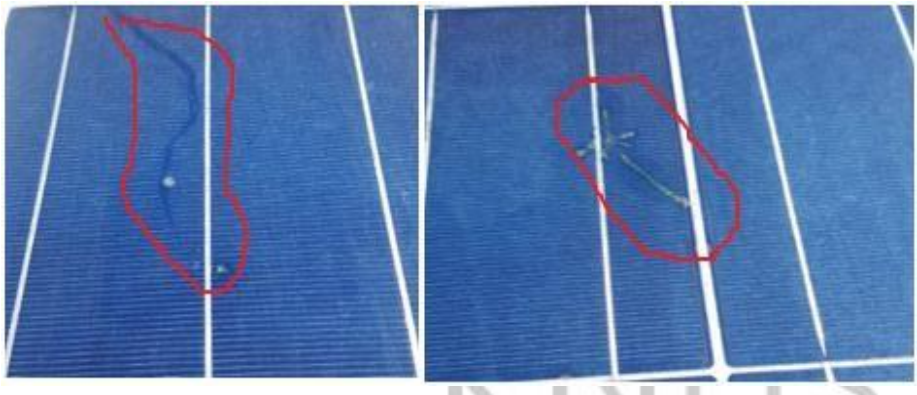
Snail crack propagating on module

Cell interconnect discoloration
