KWAME NKRUMAH UNIVERSITY OF SCIENCE AND TECHNOLOGY

Durability of Locally-Produced Burnt Clay Bricks

A thesis submitted to

Master of Science in Environmental Resources Management

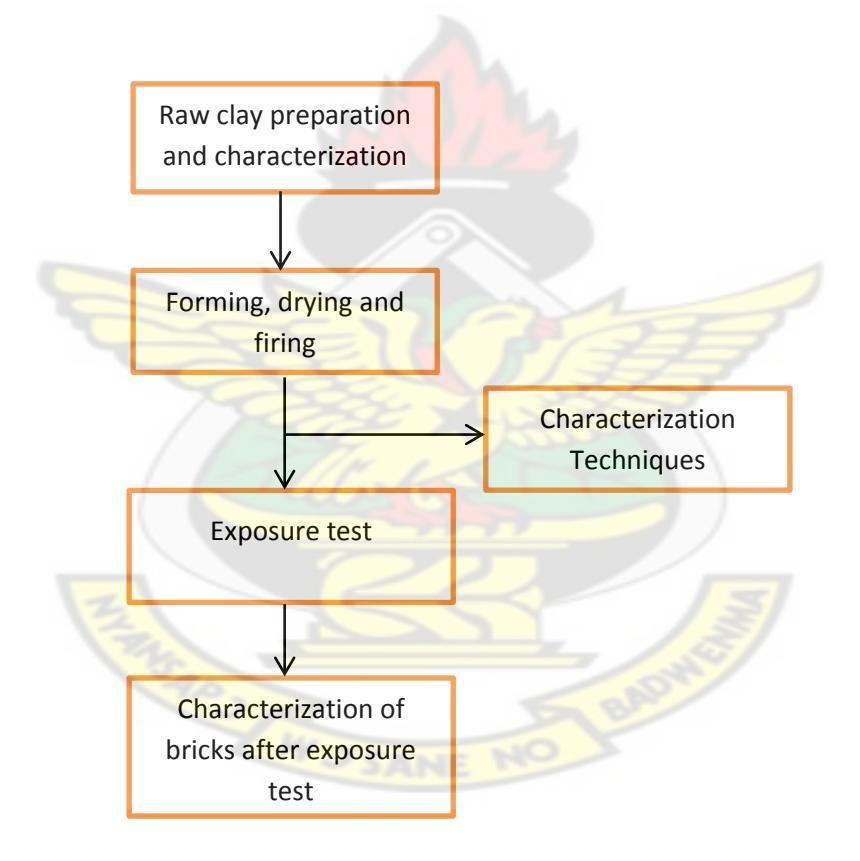
Figure 3.1: Flow diagram showing the processes involved in assessing the durability of locally-produced burnt clay bricks

This chapter gives an outline of the specific experimental procedure used for the production of burnt clay bricks from Mankranso, Mfensi and Nyamebekyre clays. The methods used in characterising the clays and fired bricks are described into details. A flow diagram describing the process of production and characterisation of burnt clay bricks is shown in Figure 3.1.

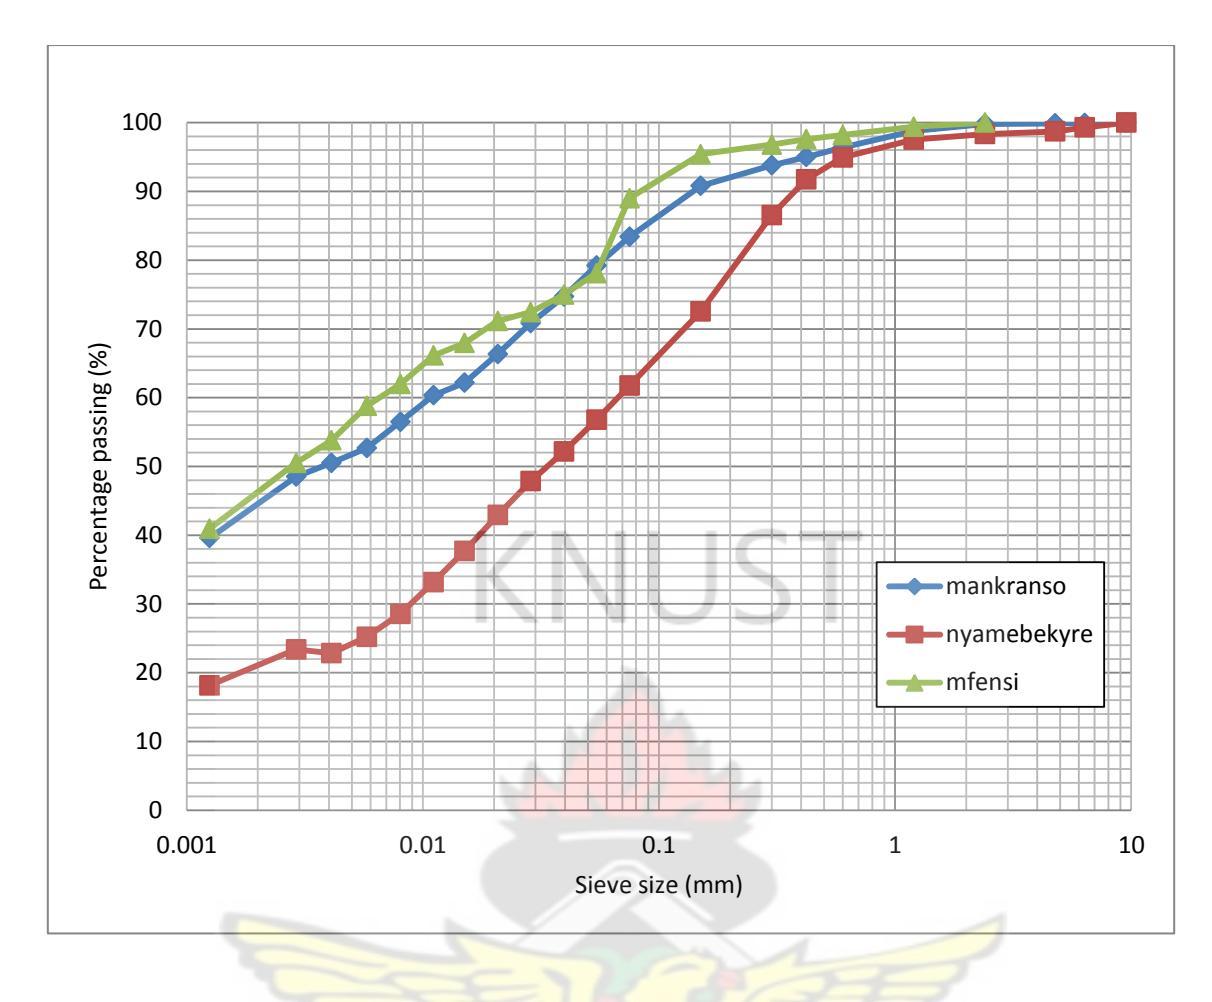
Figure 4.2: Particle size distribution of clay samples

Figure 4.2 shows the particle size analysis of the clay powders. The analysis of the granulometric curves revealed that the average size particles of Nyamebekyre was the highest followed by Mankranso and Mfensi, respectively. The particle size distribution of clay is important for strength development during firing which subsequently impacts on the durability of the burnt clay bricks. Independently from other manufacturing processes, it can be said that raw materials with uniform particle size distribution can give good compactness which results in low porosity (Elert *et al.*, 2003). Table 4.3 shows the analyses of the particle size distribution of the various clays. It could be seen that Mfensi clay had the highest clay content followed by Mankronso and Nyamebekyre clays, respectively. Thus Mfensi clay had small particle sizes and hence will enhance inter-particle packing and reduce inter-particle void. This will minimize intrusion of water and hence improve brick durability (Weng *et al.*, 2003)

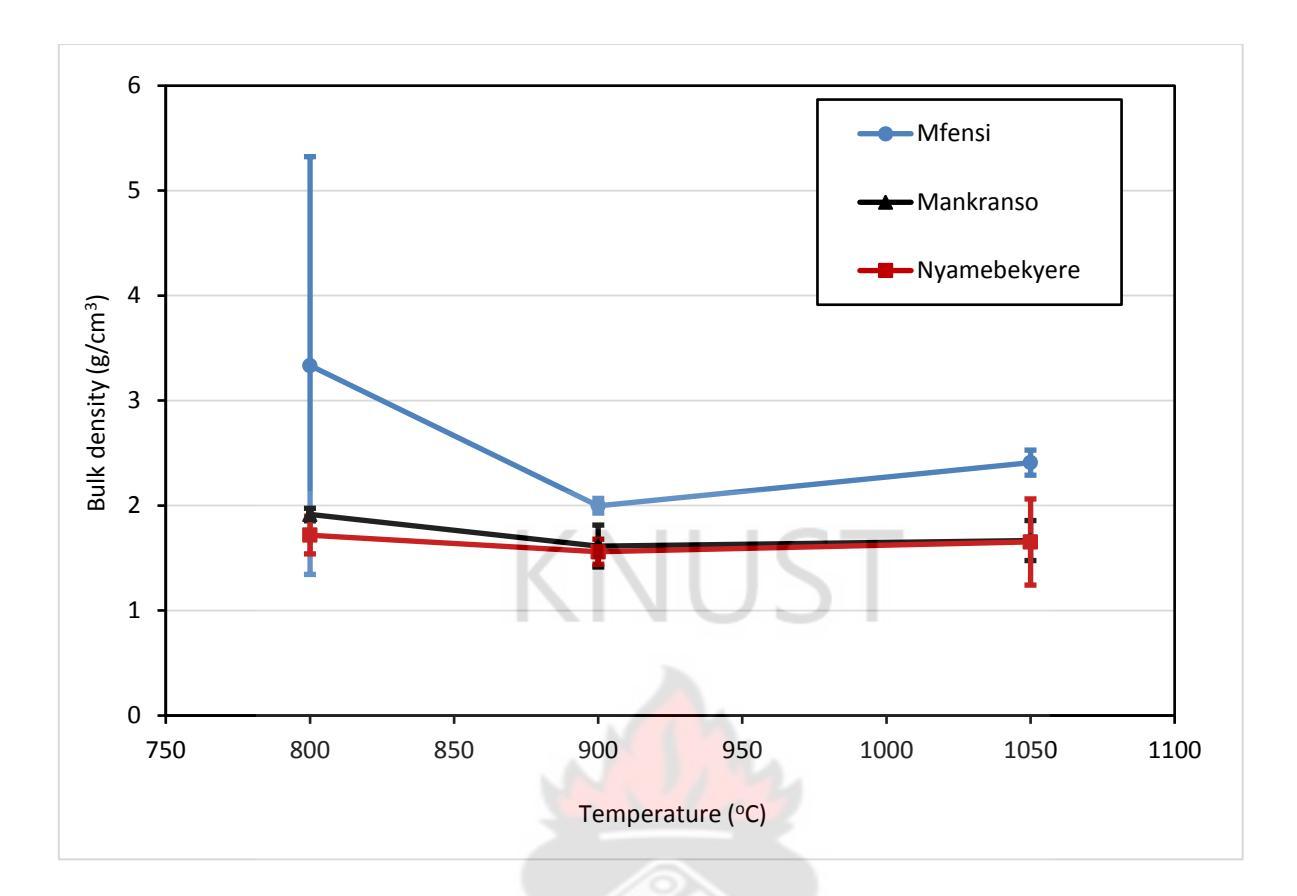
Figure 4.3: Effect of firing temperature on the bulk density of burnt bricks produced from

Figures 4.3 and 4.4 show the influence of firing temperature on the bulk densities of laboratory and commercial burnt clay bricks, respectively. The bulk densities of laboratoryproduced samples decreased slightly from 800°C to 900°C and increased at 1050°C. On the one hand, Mfensi bricks produced in the laboratory had the highest bulk densities at the various firing temperature. This could be due to the high amounts of finer particles which resulted in high inter-particle packing. On the other hand, commercial bricks produced from Mankranso had the highest bulk density. It is interesting to note that the bulk densities of laboratory-produced bricks were higher than commercially-produced bricks for all brick types. This could be due to lack of compactness in the process of forming which creates voids in the bricks extruded thereby reducing their bulk density. The commercial bricks were fired at temperatures between 900 and 1050°C. However, the specific firing temperature is not known since the kilns used do not have built-in thermocouples for temperature readings. According to Weng et al. (2003) and Somayaji (1995), bulk density of burnt clay bricks is dependent on the specific gravity, the method of manufacture and degree of burning which usually exceeds 1.6 g/cm³. Increasing firing temperature results in a corresponding increase in the bulk density of bricks. At lower temperatures, bricks exhibit larger pore sizes which results in lower density and a corresponding increase in water absorption which is not desirable for brick durability (Weng et al., 2003). Increase in bulk density is the result of increased number of fine particle sizes which also affects plasticity.

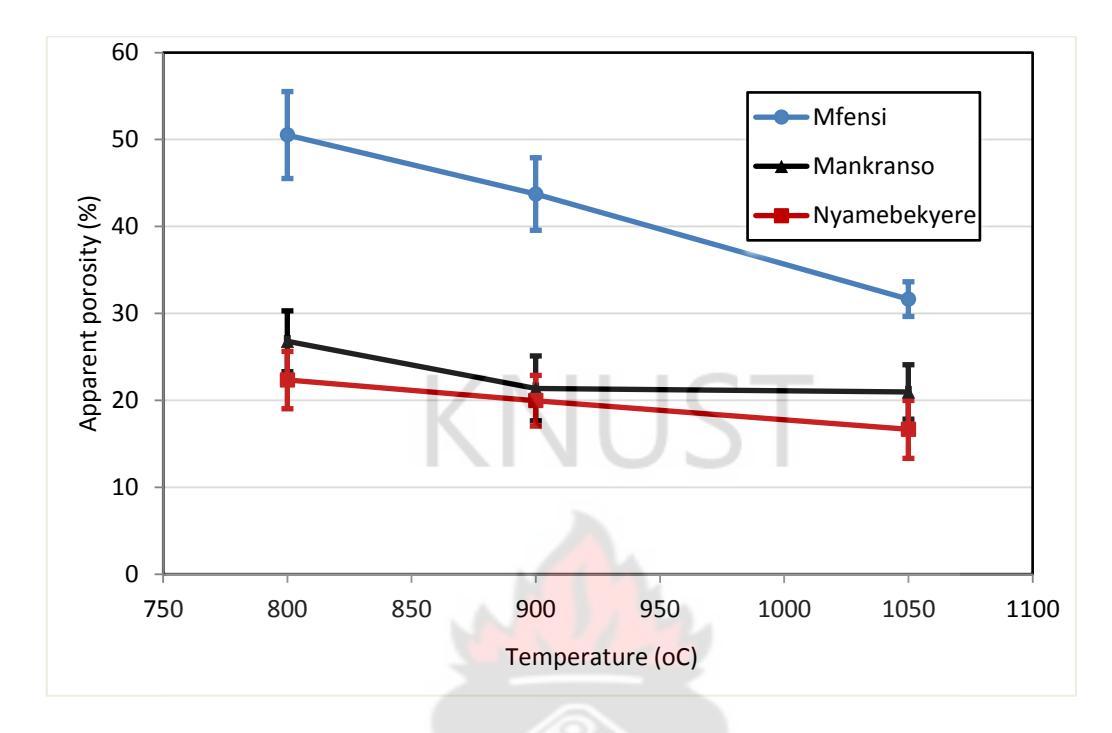
Figure 4.5: Effect of firing temperature on the apparent porosity of burnt bricks produced

Figure 4.5 shows the effect of firing temperature on the apparent porosity of burnt bricks produced from the various clays. Generally, burnt bricks produced from Mfensi clay had the highest apparent porosity at the various firing temperatures. For instance, at 800°C, the apparent porosity of Mfensi burnt bricks was 50%, whilst those of Mankranso and Nyamebekyre were 27% and 22%, respectively. It was noted that apparent porosity decreased with increasing firing temperature for all investigated clays. The decrease was more significant in Mfensi burnt bricks than those of Mankranso and Nyamebekyre. This could be due to the high organic matter content in the Mfensi clay. The organic matter content as indicated in the chemical composition (LOI) of Mfensi clay was higher (5.3%) than that of Mankranso (4.5%) and Nyamebekyre (4.8%). The organic matter increased vitrification which resulted in closure of small pores and the development of atomic bonding between particles by solid state diffusion. Vitrification refers to the process of converting a material into glassy amorphous solid free from crystalline structure and occurs at the glass transition temperature just below the melting point. This is followed by grain growth which creates a dense structure thereby increasing the technical quality and durability of such bricks (Barsoum, 1997; Warren 1992). Increasing firing temperature results in full solid state sintering of individual clay particles, reducing porosities present within the microstructure (Johari et al., 2010). This is due to the formation of glass phase which fills the pores inside the body of the bricks resulting in reduction of pore ratio (Junse, 1994).

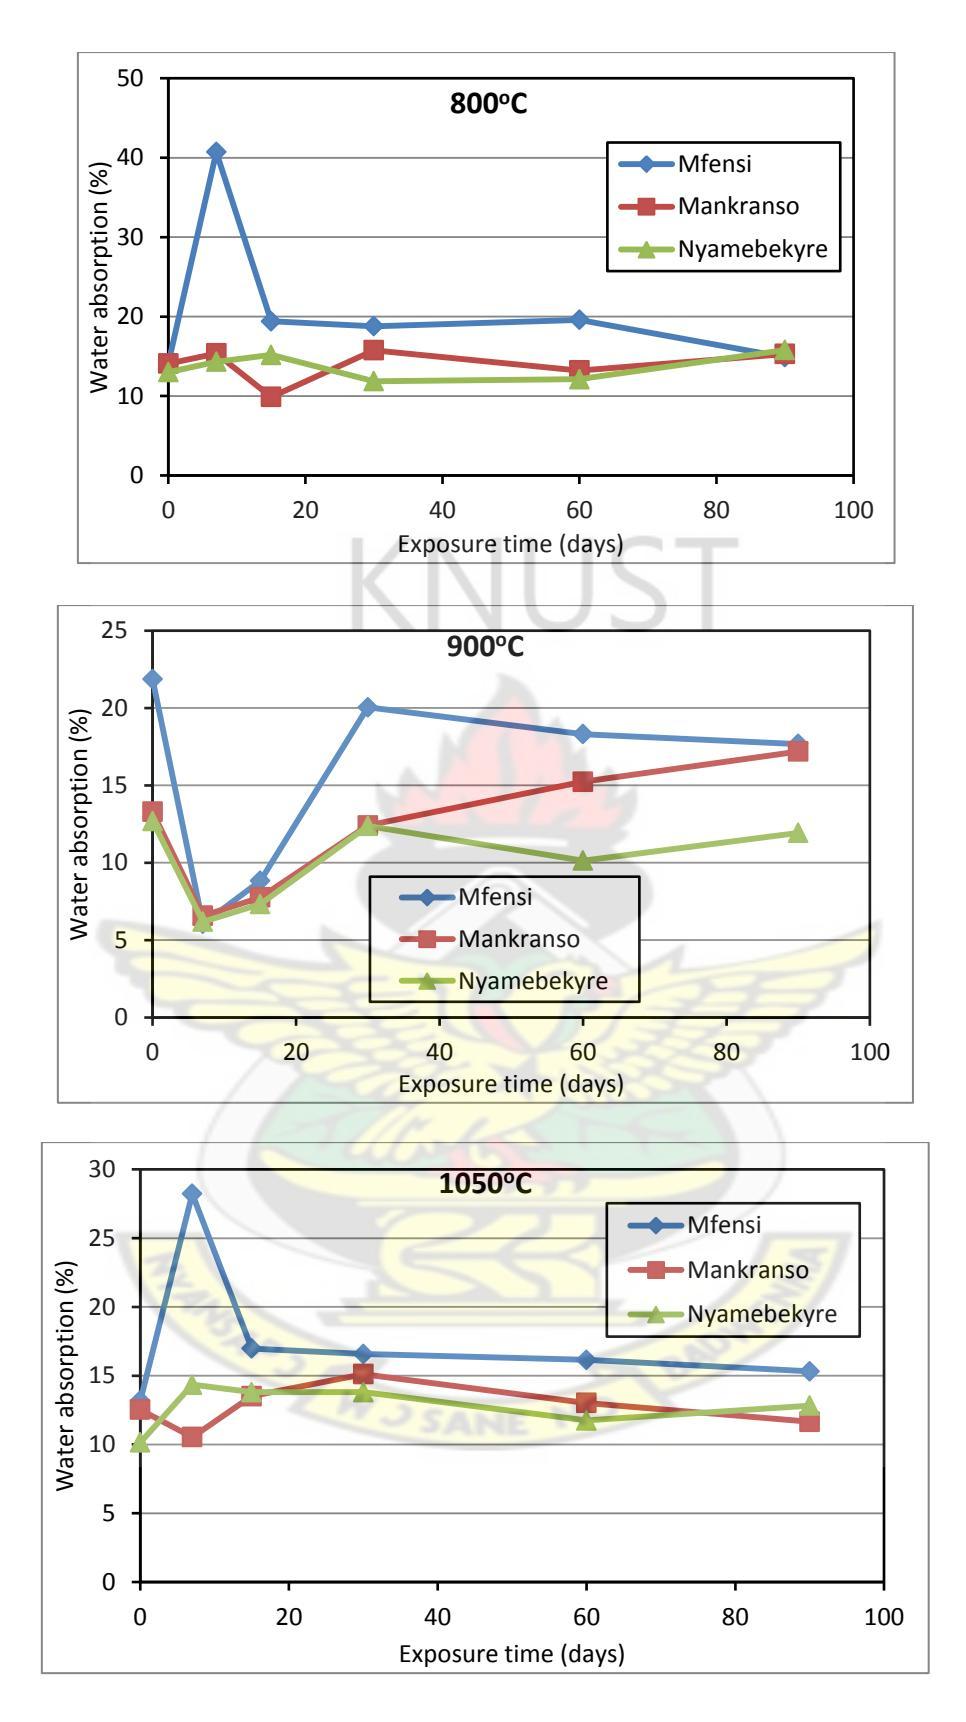
Figure 4.12: Effect of exposure time on the water absorption of burnt bricks produced from

The initial increase in water absorption values is due to sea salt crystal growth within the pores of the bricks causing superficial material loss as well as internal micro-cracks. This increases the volume of the voids and also produces additional ones for more incoming solution as the exposure time increased (Scherer, 2004). At the end of the 90 days exposure to seawater Mankranso bricks fired at 900°C had highest percentage increase of 29.3% in water absorption with Nyamebekyre bricks fired at 1050°C having the highest percentage decrease of 26.3% in water absorption. Generally, bricks fired at 1050°C had lower percentage increase in water absorption due to the presence of smaller pores which reduces deterioration as a result of chloride crystal growth within the pores of the bricks.

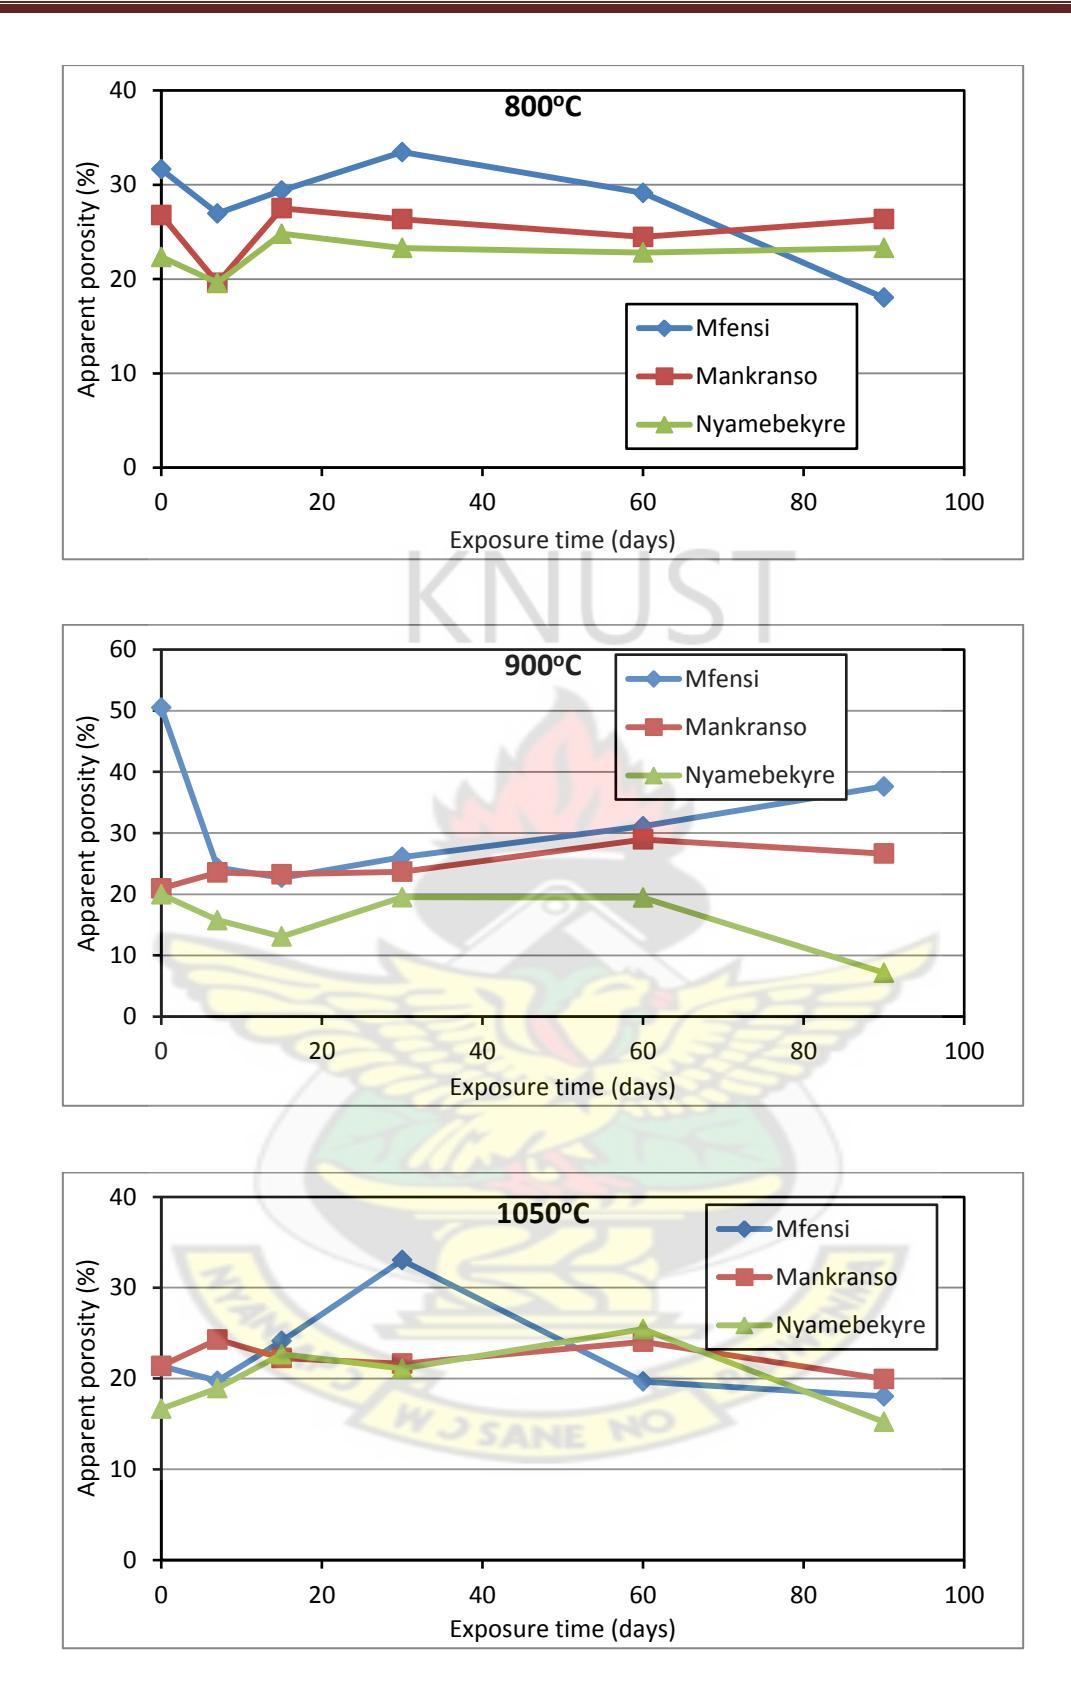
Figure 4.13: Effect of exposure time on the apparent porosity of burnt bricks produced from different clay materials in 0.5 M NaCl

Figure 4.13 shows the effect of exposure time on the apparent porosity of burnt bricks produced from different clay materials in 0.5 M NaCl. Similar behaviour of burnt bricks could be observed as in seawater environment. At 800°C, Mankranso and Nyamebekyre burnt bricks recorded an increase in apparent porosity values by 17% and 4.2%, respectively. On the other hand, Mfensi burnt bricks experienced 43% reduction in apparent porosity after 90 days exposure period. As temperature increased to 900°C, the apparent porosity values of Mfensi and Nyamebekyre burnt bricks decreased whilst Mankranso increased after exposure period. Further increase in firing temperature to 1050°C resulted in a slight variation in apparent porosity values of Mankranso, Nyamebekyre and Mfensi burnt bricks. Similar reasons provided for the behaviour in seawater could also be provided in 0.5 M NaCl. Increasing firing temperature reduced the apparent porosities in the burnt bricks (Cultrone *et al.*, 2000). Thus burnt bricks fired at 1050°C had marginal differences in apparent porosity values compared to bricks fired at 800 and 900°C.

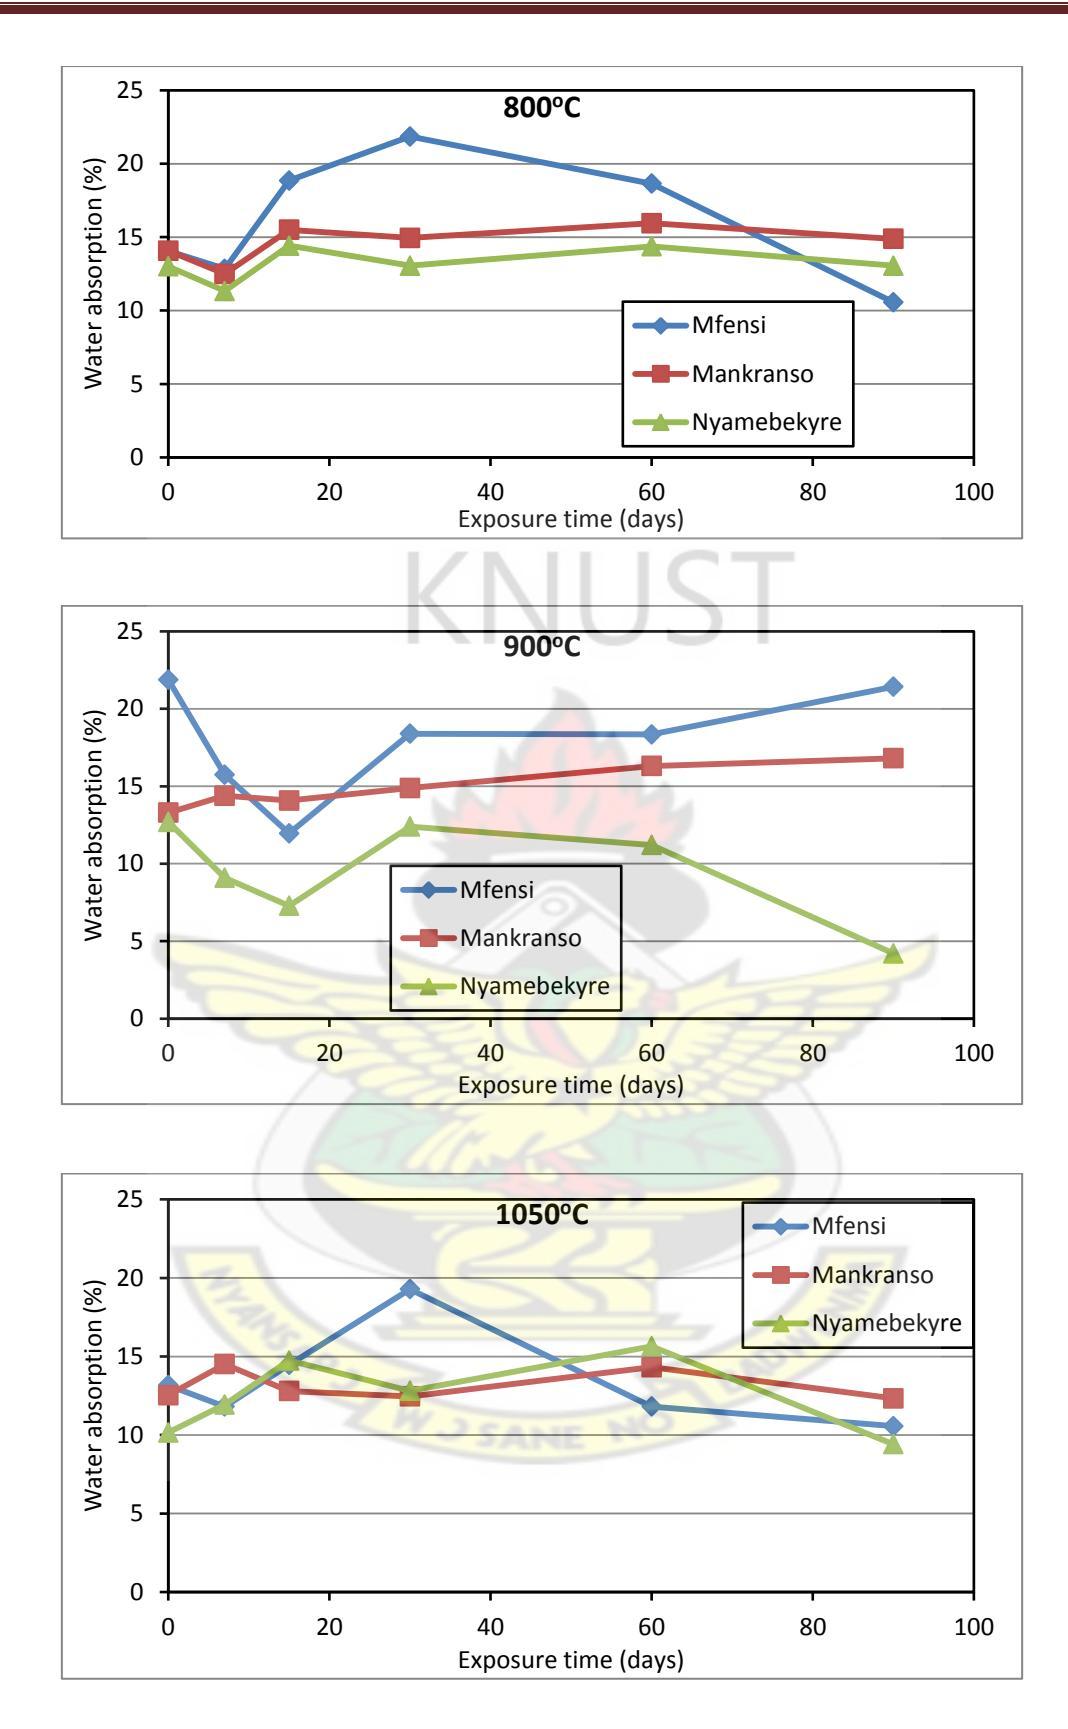
Figure 4.14: Effect of exposure time on the water absorption of burnt bricks produced from different clay materials in 0.5 M NaCl

Figure 4.14 shows the effect of exposure time on water absorption of burnt bricks produced from different clay materials in 0.5 M NaCl. Bricks produced at different temperatures have been compared. At low firing temperature (800°C), there was marginal percentage increase of 5.7% and 0.4% in the water absorption of Mankranso and Nyamebekyre bricks, respectively after the exposure period. Mfensi bricks experienced a decrease of 24.9% in water absorption value over the exposure period. At 900°C, Mankranso experienced an increase of 26.4% whilst Mfensi and Nyamebekyre recorded reductions of 2.1% and 66.9%, respectively in their water absorption values. At 1050°C, decreases of 19.8%, 2% and 20.9% were recorded for Mfensi, Mankranso and Nyamebekyre bricks, respectively.

Water absorption values increased gradually after an initial reduction and this can be attributed to chloride crystal growth within the pore spaces of the bricks. However, bricks fired at 1050°C experienced variation in water absorption. This is because the rate of physical damage by salt crystallization does not depend on only pore size but also a function of several parameters such as moisture supersaturation, magnitude of repulsive forces between salts, rates of elements supply and water evaporation (Scherer, 2004; Fonseca *et al.*, 2013). At the end of the 90 days exposure to NaCl, Mankranso bricks fired at 900°C had highest water absorption of 26.4% with Nyamebekyre bricks fired at 900°C having the highest reduction in water absorption of 66.9%. Burnt bricks fired at 1050°C had water absorption values decreasing with increasing exposure time as a result of the presence of smaller pores.

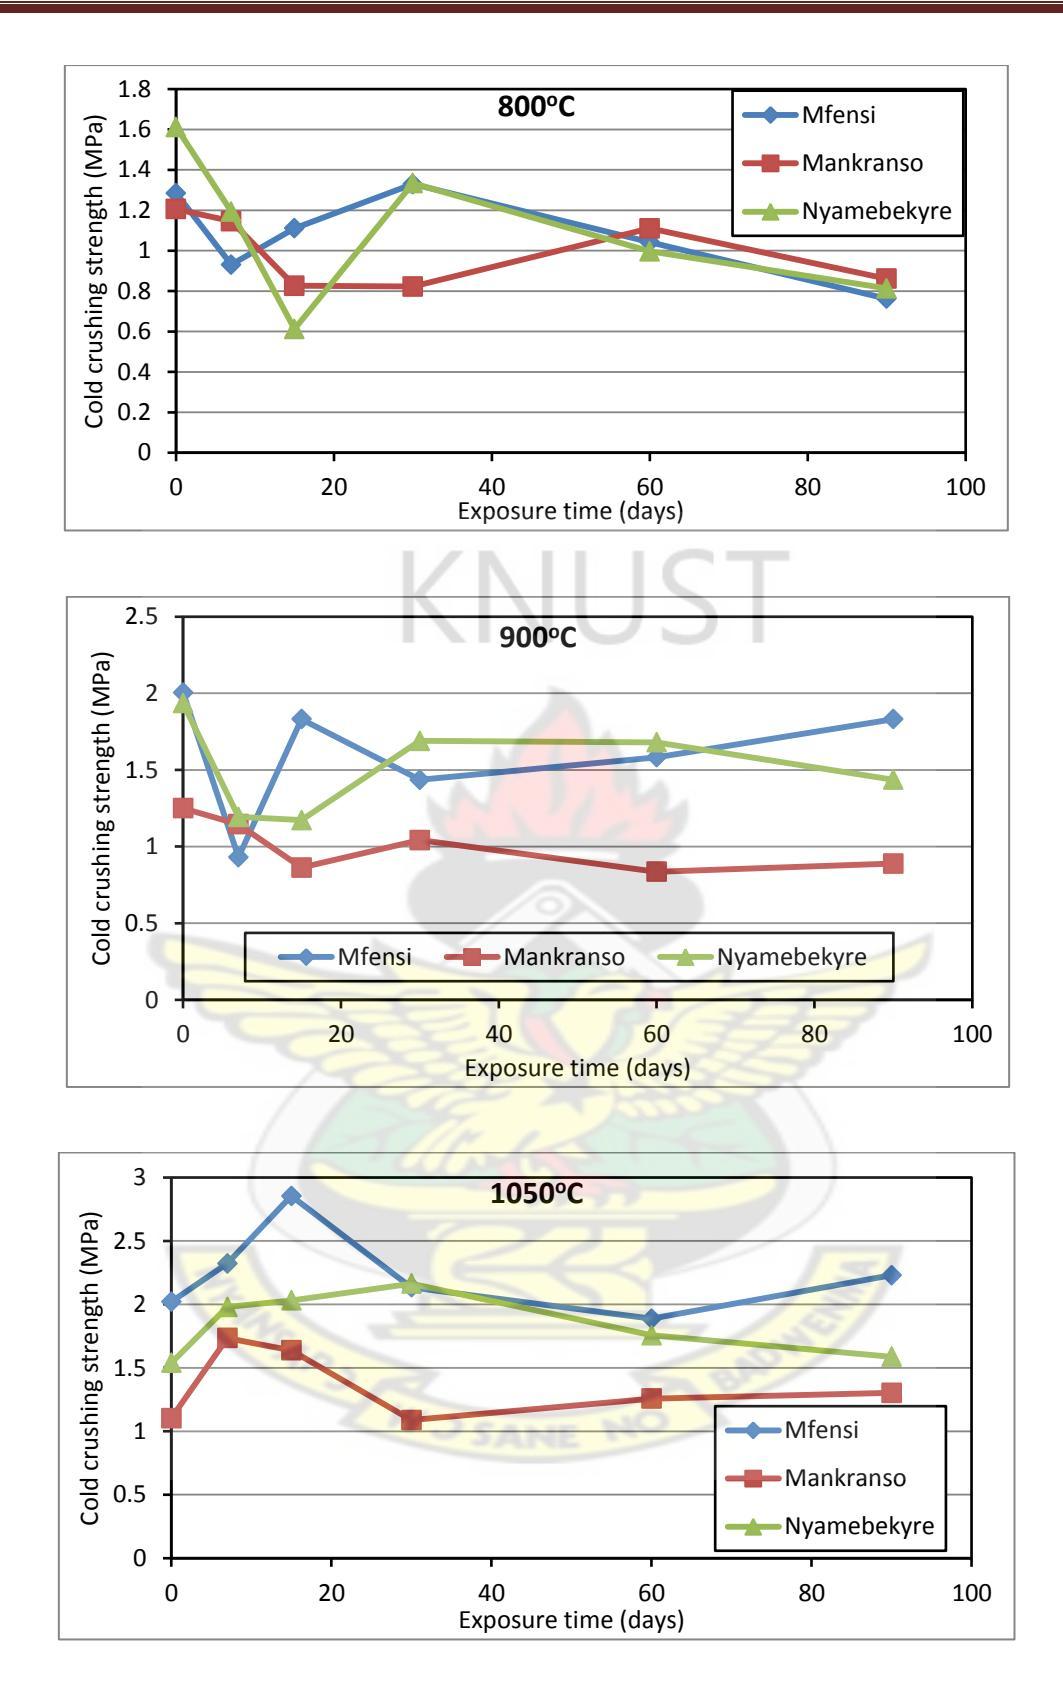
Figure 4.15: Effect of exposure time on the cold crushing strength of burnt bricks produced from different clay materials in seawater

Figure 4.15 show the effect of exposure time on the cold crushing strength of burnt bricks produced from different clay materials in seawater. Bricks produced at different temperatures have been compared. The cold crushing strength of bricks fired at 800°C decreased by 40.6%, 34.4% and 49.5% for Mfensi, Mankranso and Nyamebekyre, respectively after exposure. The strength of bricks fired at 900°C also declined experiencing decreases of 8.6%, 28.9%, and 25.8% for Mfensi, Nyamebekyre and Mankranso bricks, respectively. At 1050°C, the cold crushing strength increased for all brick types with Mfensi, Mankranso and Nyamebekyre bricks recording 10.4%, 10.4% and 3.1%, respectively. Thus the strength values of bricks fired at 800 and 900°C declined whilst strength values of bricks fired at 1050°C increased. Additionally, burnt bricks exposed to seawater environment initially gained strength but prolong exposure resulted in a significant loss of strength. The initial gain could be due to partial filling of the pores by chloride crystals which causes an increase in compressive strength. This is consistent with studies done by Fonseca *et al.* (2013). However, a significant decrease was noted after prolong exposure. The effect of the salts had a clearly negative influence on the strength properties of the clay materials (Fonseca *et al.*, 2013).

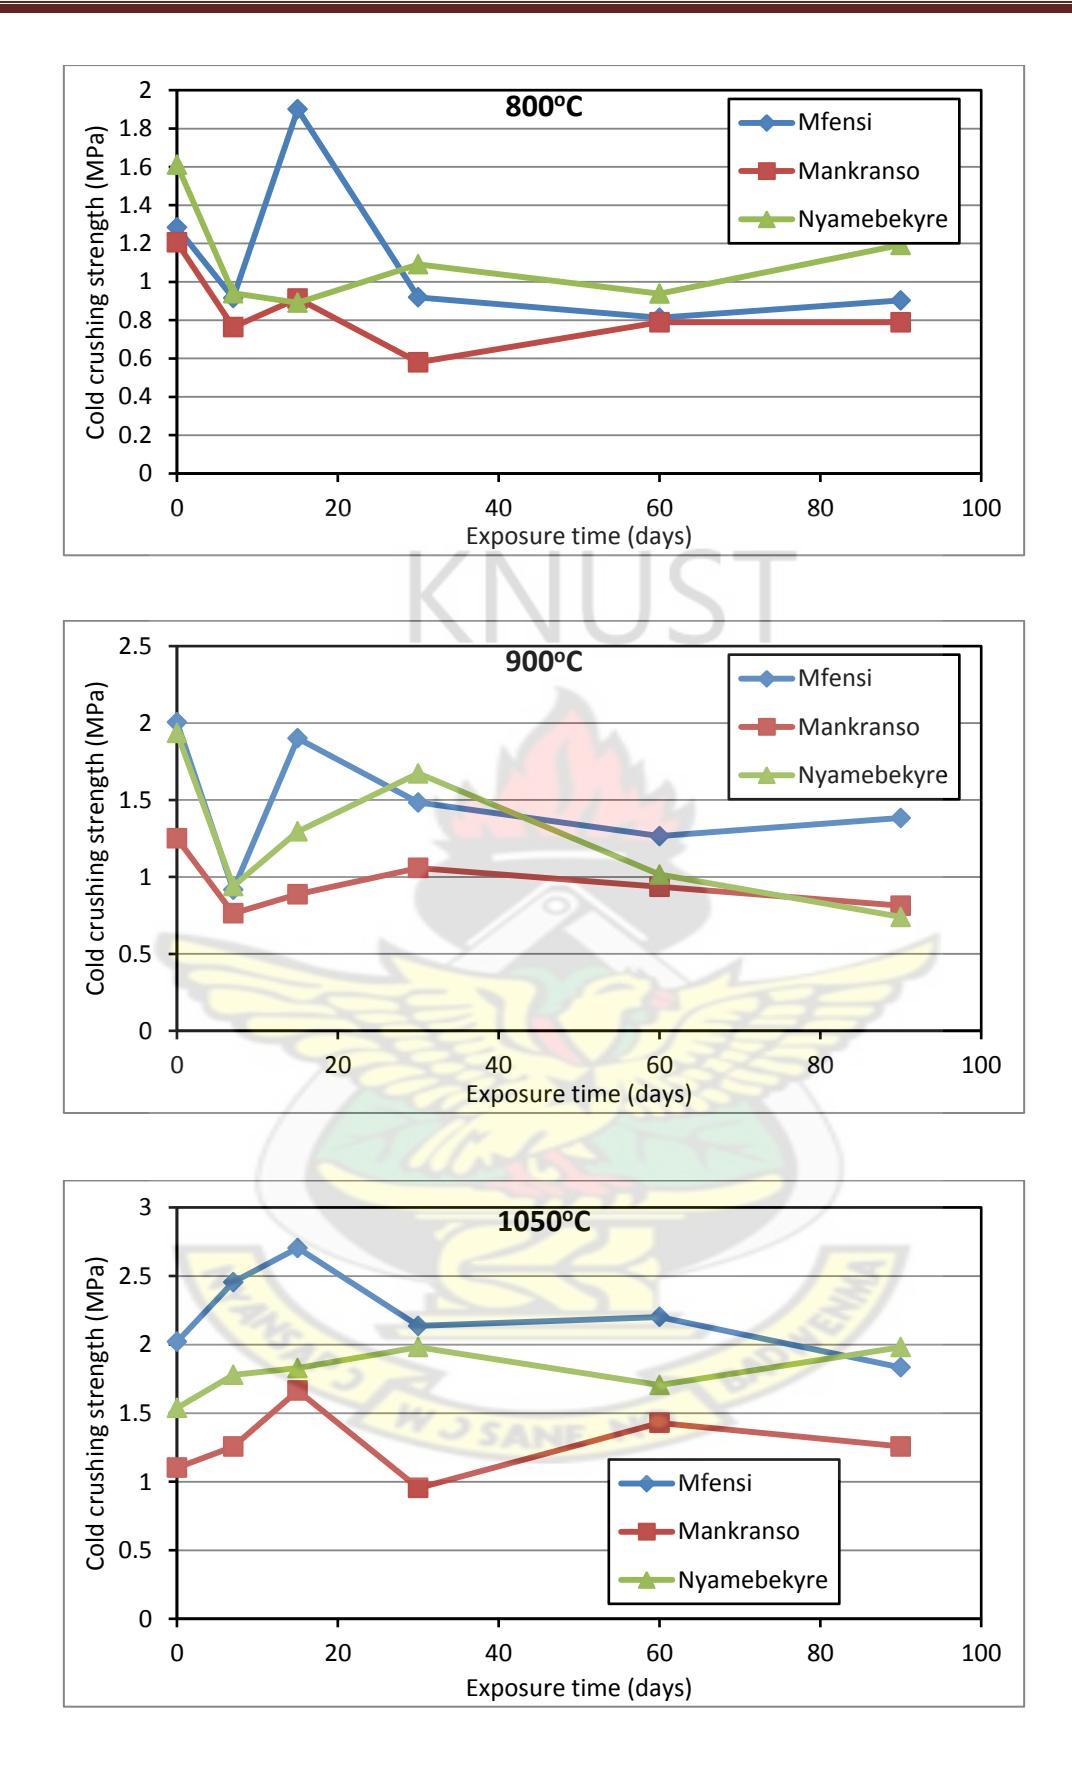
Figure 4.16: Effect of exposure time on the cold crushing strength of burnt bricks produced

Figure 4.16 shows the effect of exposure time on cold crushing strength of burnt bricks produced from different clay materials in 0.5 M NaCl. Bricks fired at different temperatures have been compared. The cold crushing strength of burnt bricks from Nyamebekyre and Mankranso clay fired at 800°C showed a decrease of 25.9% and 34.6%, respectively at the end of the 90 days exposure period. The strength of Mfensi burnt bricks decreased by 29.7%. At 900°C, the strength of Mfensi, Mankranso and Nyamebekyre burnt bricks decreased by 31.0%, 35.0% and 61.8%, respectively. At 1050°C, an increase in strength values were observed for Mankranso and Nyamebekyre bricks whilst slight decrease was recorded for Mfensi bricks. The observed trend was a decline in strength of bricks exposed to NaCl environment. At the end of the 90 days exposure to NaCl, Nyamebekyre bricks fired at 900°C had highest reduction of 61.8% in cold crushing strength. These findings were consistent with those exposed to seawater.

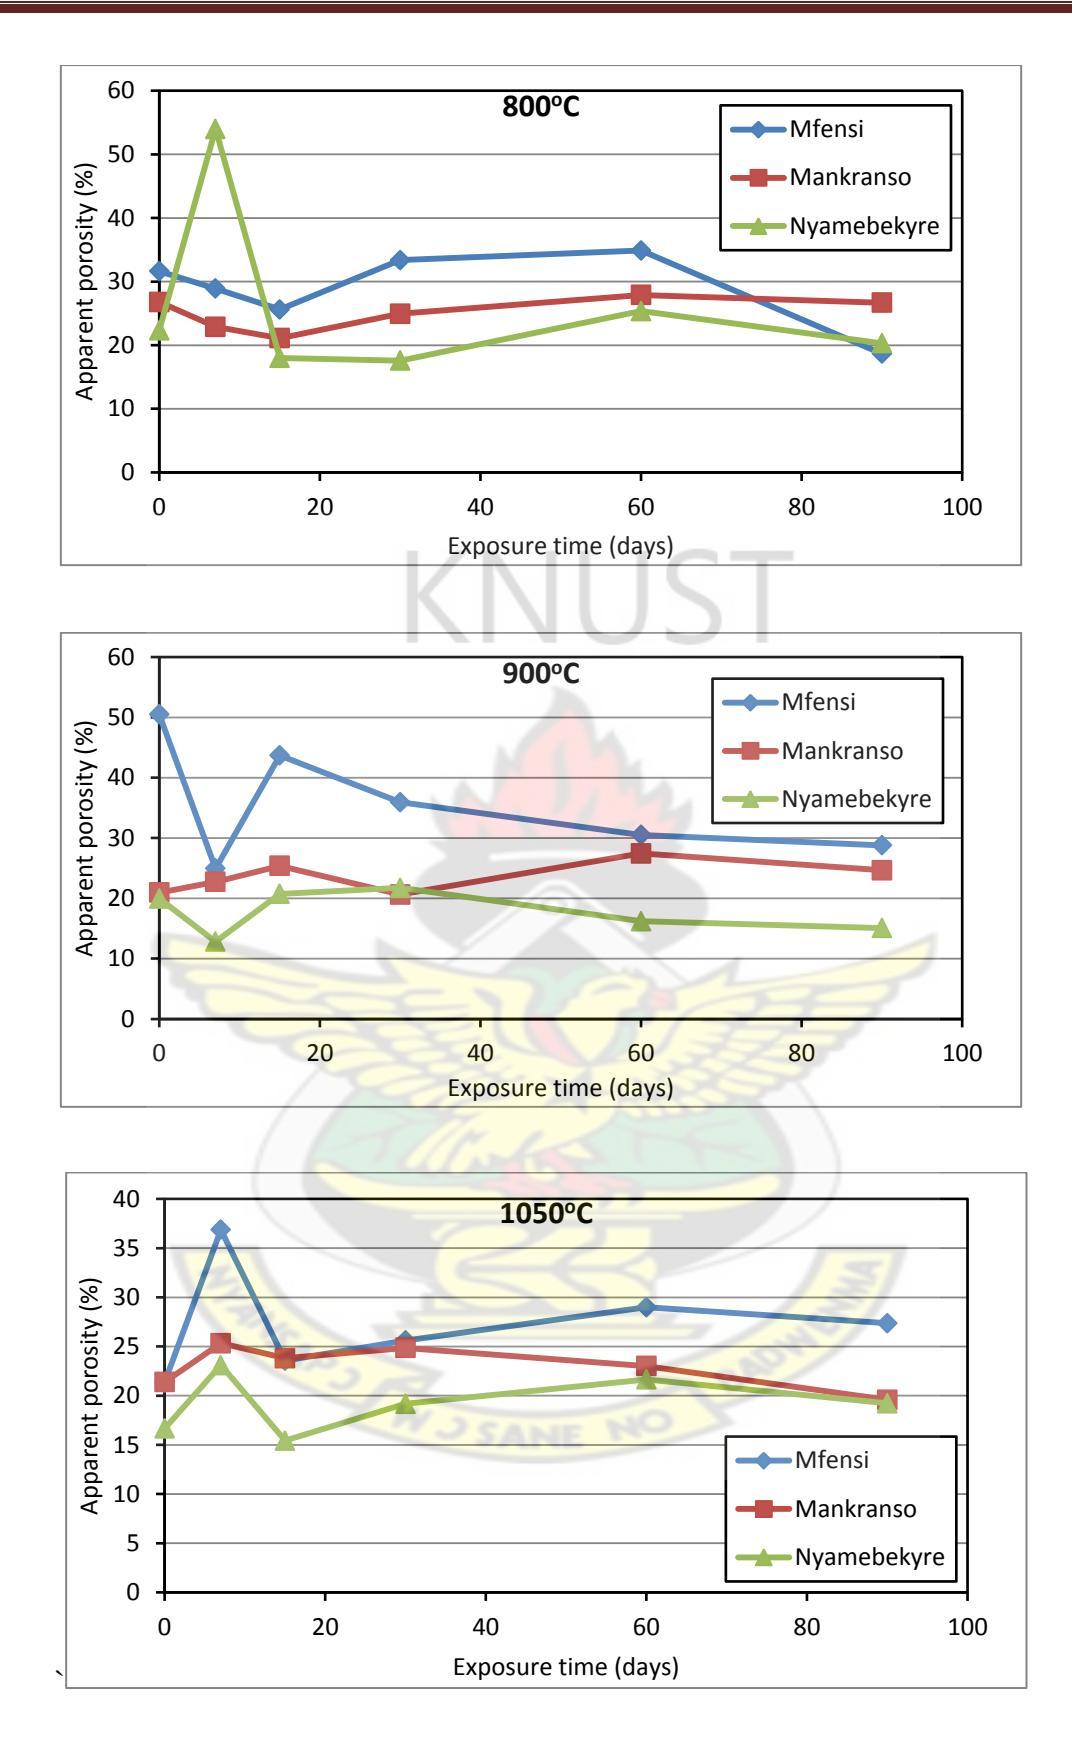
Figure 4.17: Effect of exposure time on the apparent porosity of burnt bricks produced from different clay materials in 0.5 M Na₂SO₄

Figure 4.17 shows the effect of exposure time on apparent porosity of burnt bricks produced from different clay materials in 0.5 M Na₂SO₄. Bricks produced at different temperatures have been compared. At 800°C, the apparent porosity of all the brick types decreased after the exposure period; Mfensi bricks decrease from 31.6% to 20.3%, Mankranso bricks decreased marginally from 26.8% to 26.7%, and Nyamebekyre bricks decreased from 22.3% to 20.3%. At 900°C, apparent porosities of Mfensi and Nyamebekyre bricks decreased by 43% and 24.4%, respectively whilst Mankranso bricks increased by 17.7% after 90 days exposure. Further increase in firing temperature to 1050°C increased the apparent porosities of Mfensi and Nyamebekyre bricks decreased the apparent porosities of Mfensi and 15.4%, respectively whilst Mankranso bricks decreased the apparent porosities of market by 3.7%. The decrease in apparent porosity values could be due to the partial filling of the pores and micro cracks by sulphate crystals (La Iglesia *et al.*, 1997).

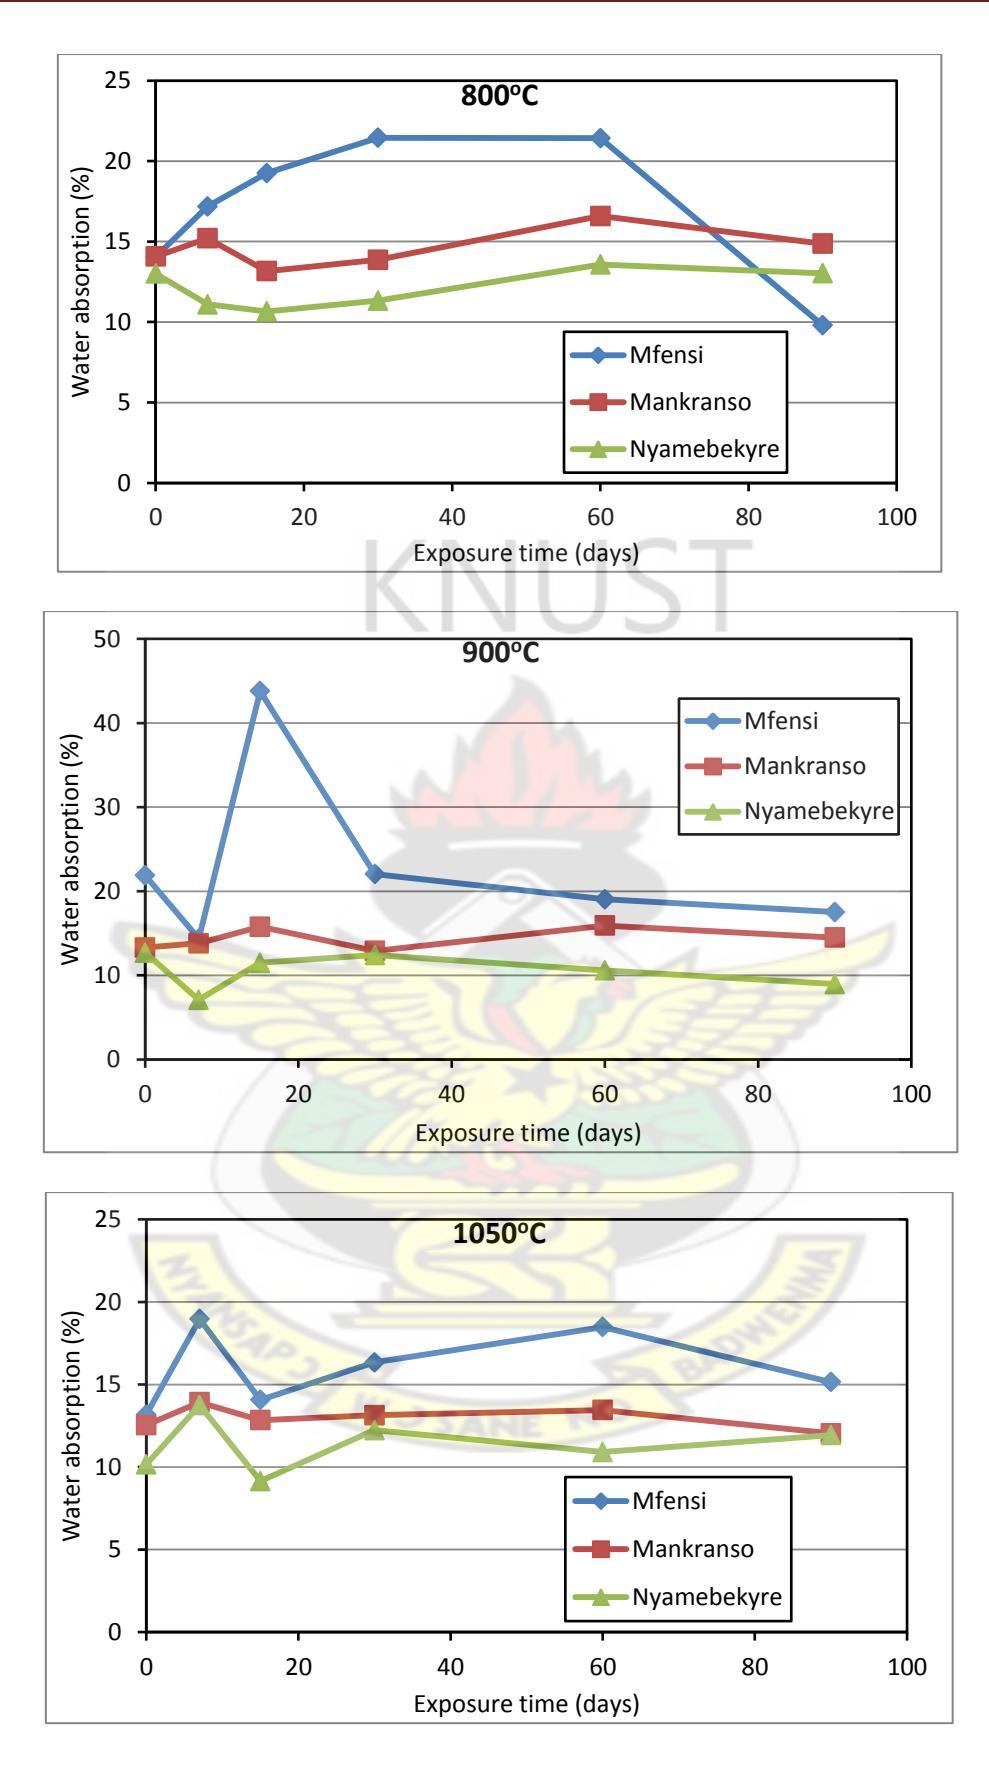
Figure 4.18 shows the effect of exposure time on the water absorption of burnt bricks produced from different clay materials in 0.5 M Na₂SO₄. Bricks produced at different temperatures have been compared. At 800°C, the water absorption for Mfensi bricks decreased by 30.4% whilst Nyamebekyre and Mankranso increased by 0.12% and 5.6%, respectively at the end of the 90 days exposure period. At 900°C, the water absorption of Mfensi and Nyamebekyre bricks decreased by 19.9% and 29.5%, respectively whilst Mankranso bricks increased by 9.0% after 90 days. At 1050°C, the water absorption of Mfensi and Mankranso bricks decreased by 15% and 9%, respectively while Nyambekyre bricks increased by 17.5% after 90 days of exposure.

The increase in water absorption values is due to the progressive disaggregation of the smaller pore walls as a result of pressure generated by the crystallization of sulphate salts. This allowed easy penetration of solution into the pore system increasing water absorption. The penetration and the residence of salts in the materials depend mainly on their pore structure (Benavente *et al.*, 2003). Studies carried out by Cultrone *et al.*, (2004) showed that abundant smaller pores exist within burnt clay bricks fired below 900°C. At 900°C and above when vitrification begins, the material becomes rigid. This favours breakage due to pressure generated by salt crystallization (Benavente *et al.*, 2003). This enhances greater penetration of sulphate solution accounting for the behaviour of bricks fired at 1050°C.

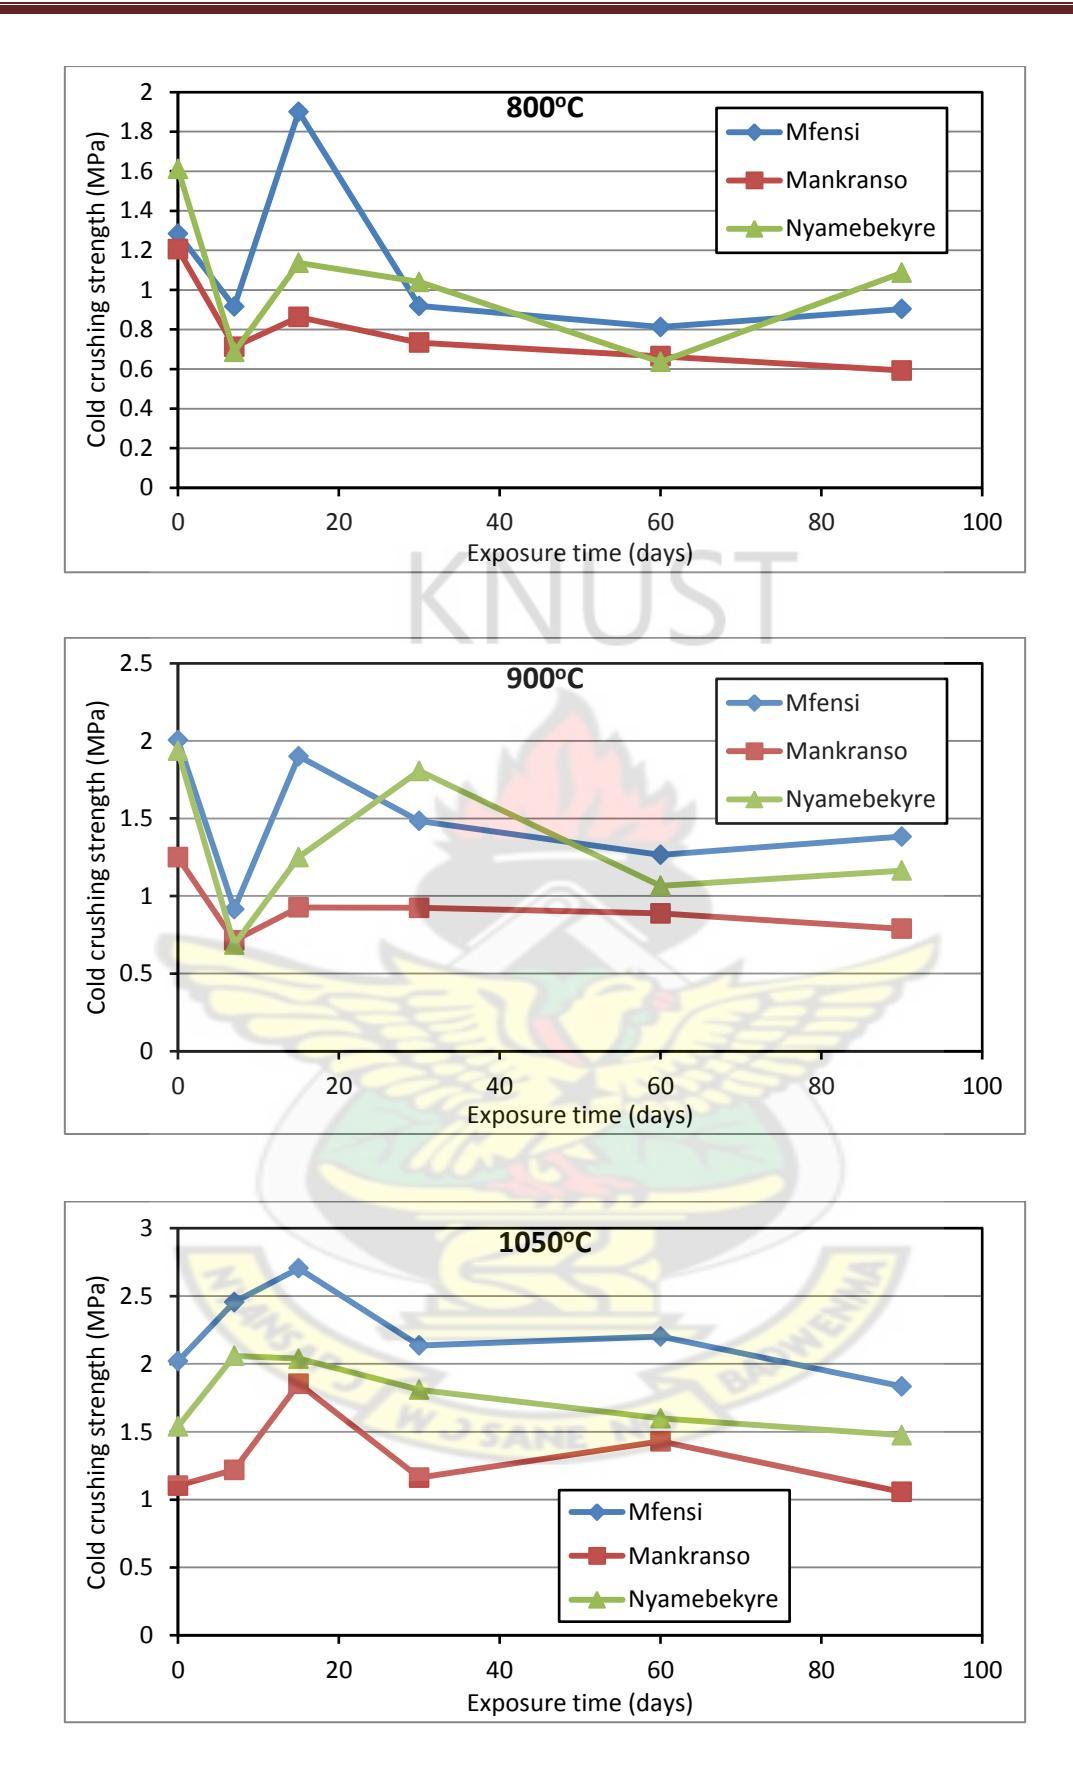
Figure 4.19: Effect of exposure time on the cold crushing strength of burnt bricks produced

The manufacturing processes such as moulding, higher firing temperatures and reductions in porosity bring about an increase in cold crushing strength. At firing temperatures of 800°C and 900°C, the strength values decreased after 7 days exposure period. This could be explained by initial superficial material loss and internal micro-cracks. Several factors could influence physical damage by salt crystallization. This includes moisture supersaturation, magnitude of the repulsive forces between the salts and the confining pore walls, rates of elements supply, water evaporation and the pore size (Scherer, 2004). It was observed that bricks fired at 800°C had highest percentage decrease in cold crushing strength whilst bricks fired at 1050°C exhibited greater resistance to deterioration.
