KWAME NKRUMAH UNIVERSITY OF SCIENCE AND TECHNOLOGY

Durability of Locally-Produced Burnt Clay Bricks

A thesis submitted to

Master of Science in Environmental Resources Management

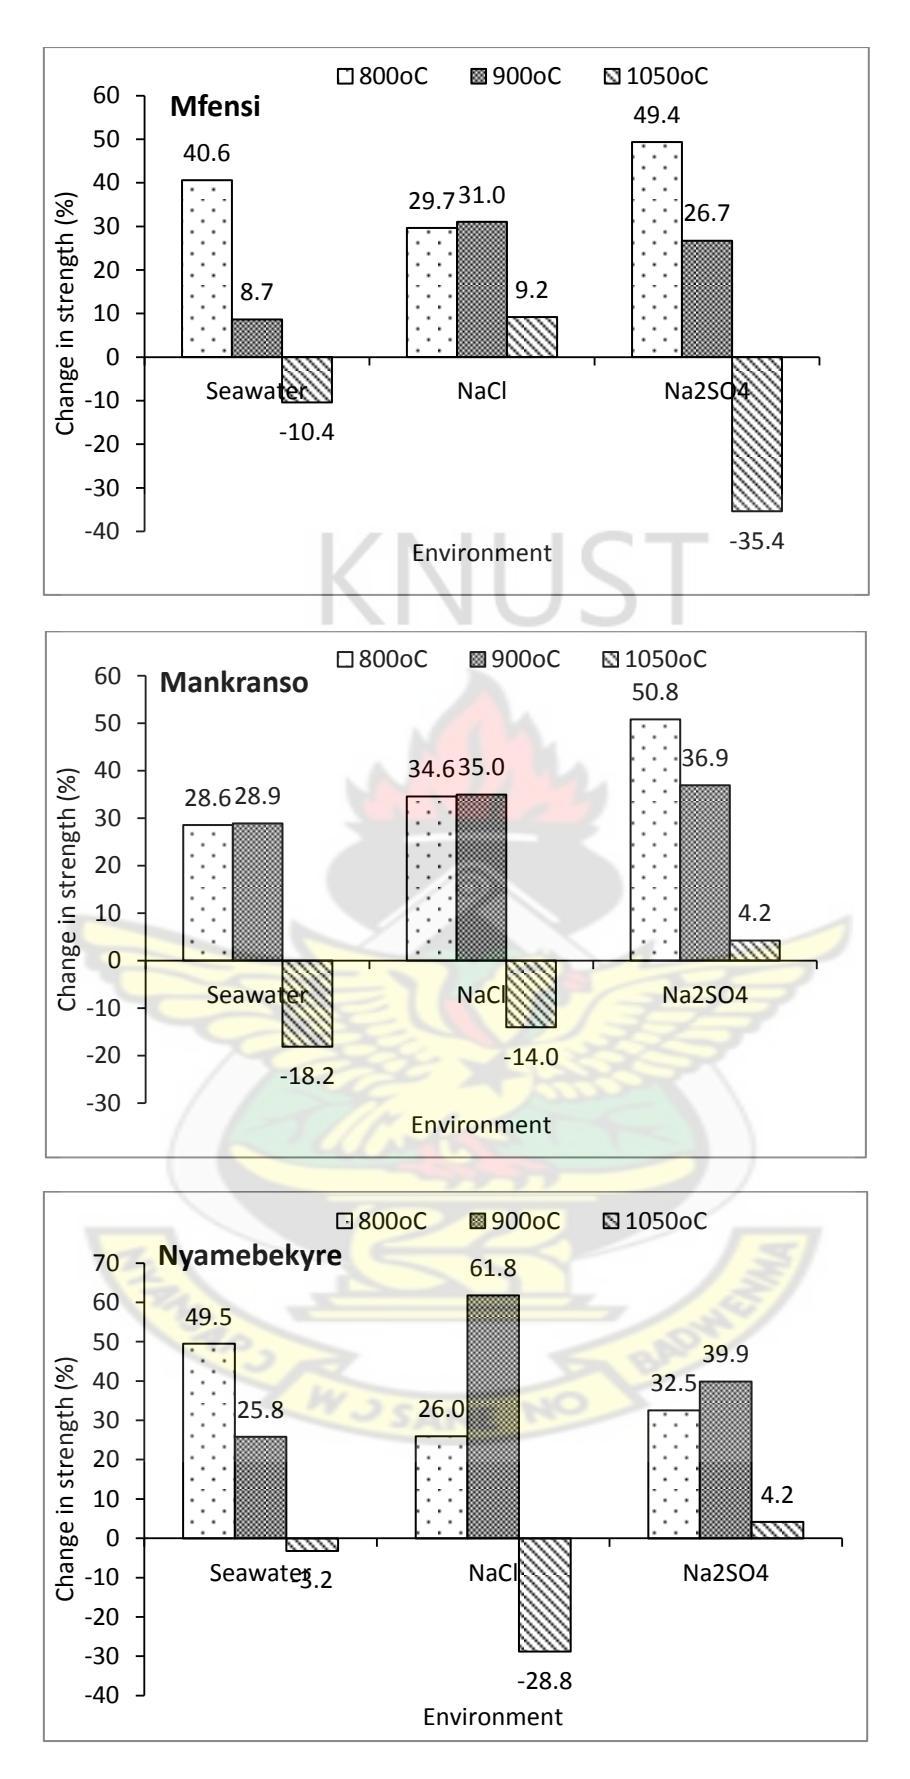
Figure 4.20: Change in strength of burnt bricks fired at different temperatures after 90 days

Mankranso burnt clay bricks fired at 1050°C also increased in strength in sea water and NaCl media by 18.2% and 14.0%, respectively. Bricks fired at 800 and 900°C had reduction in strength values in all environments with more damaging effect in Na₂SO₄. The results show that burnt bricks fired at high temperatures are more durable and have better chances of survival in aggressive environments than bricks fired at low temperatures. Nyamebekyre burnt clay bricks also showed similar behaviour with bricks fired at 1050°C demonstrating high durability in seawater and NaCl media. It can therefore be concluded that brunt bricks fired at high temperatures have high durability in aggressive environments.

exposure in aggressive environments. Negative values signify increase in strength

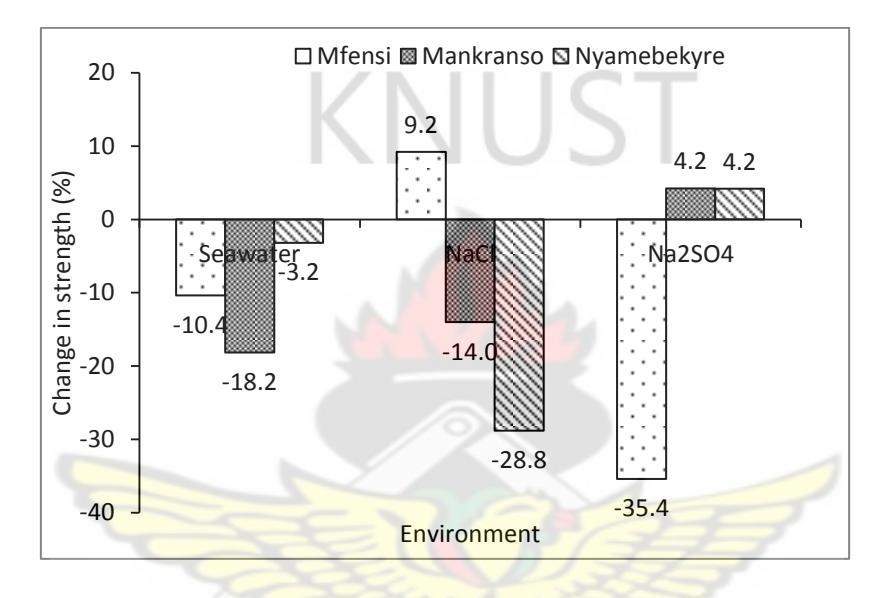
Figure 4.21: Change in strength of burnt bricks produced at 1050°C after 90 days exposure in aggressive environments. Negative values signify increase in strength

Figure 4.21 shows the change in strength of burnt bricks produced at 1050°C after 90 days exposure in different environments. Mfensi clay performed well in seawater and Na₂SO₄ environments but not NaCl. Likewise Mankranso and Nyamebekyre burnt bricks performed well in seawater and NaCl but not Na₂SO₄.

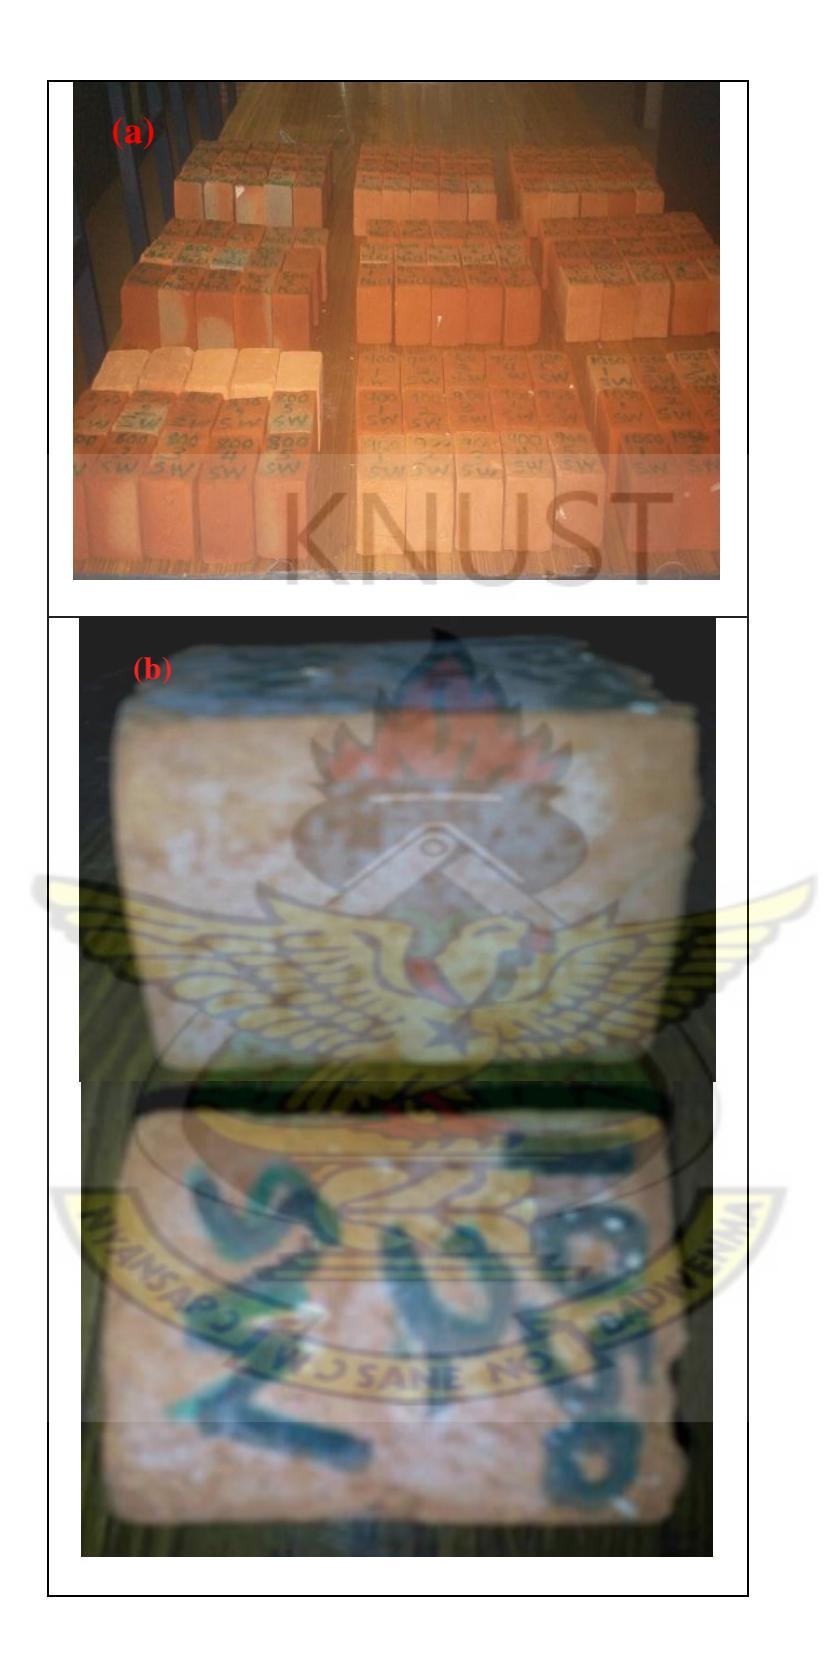
Figure 4.22: Images of burnt bricks before (a) and after (b) exposure to seawater showing

After curing samples in the various solutions for 90 days efflorescence test was carried out and visual observations made. Through observation, efflorescence and salt deposition were identified. Efflorescence caused samples to disintegrate especially at the edges. Images of efflorescence samples are shown in Figure 22. Efflorescence depends on several factors which include temperature, the supersaturation of the solution and the behaviour of fluids inside the pores (Rodríguez-Navarro et al., 1996).

efflorescence
